(19) **United States**(12) **Patent Application Publication**  
**Cheng et al.**(10) **Pub. No.: US 2011/0194041 A1**(43) **Pub. Date: Aug. 11, 2011**(54) **ARRAY SUBSTRATE OF LIQUID CRYSTAL  
DISPLAY DEVICE AND REPAIR METHOD  
THEREOF****Publication Classification**(51) **Int. Cl.**  
**G02F 1/1343** (2006.01)  
**H01L 21/30** (2006.01)  
(52) **U.S. Cl.** ..... **349/38; 438/4; 257/E21.211**(76) Inventors: **I-Ming Cheng, Shen-zhen (CN);  
De Bian, Shen-zhen (CN)**(57) **ABSTRACT**(21) Appl. No.: **12/818,178**(22) Filed: **Jun. 18, 2010**(30) **Foreign Application Priority Data**

# ARRAY SUBSTRATE OF LIQUID CRYSTAL DISPLAY DEVICE AND REPAIR METHOD THEREOF

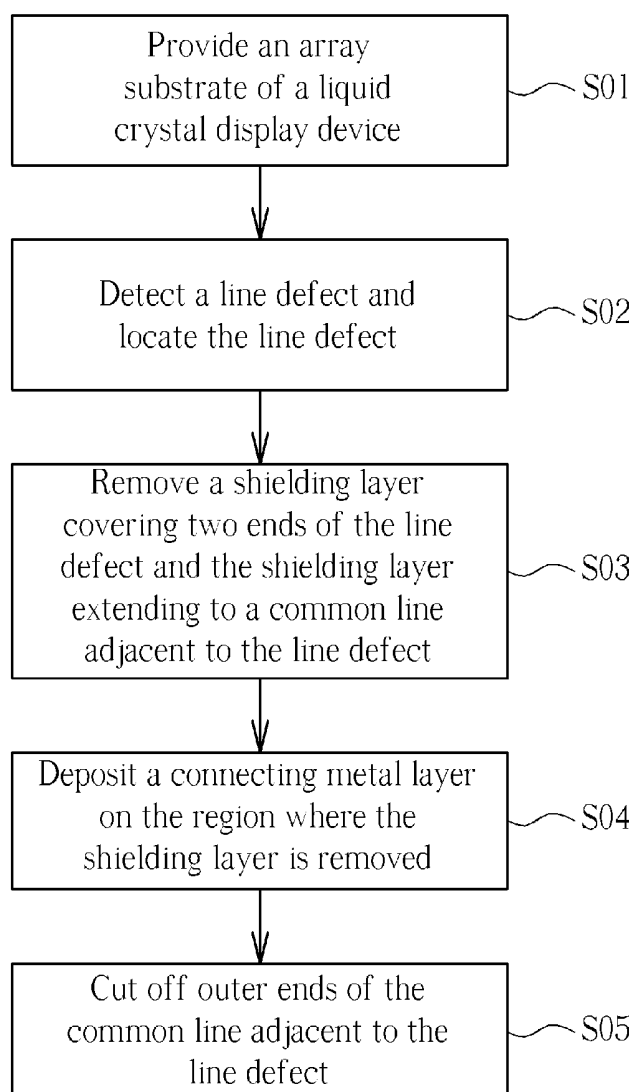
A repair method for an array substrate of a liquid crystal display device includes, providing an array substrate for a liquid crystal display device, detecting a line defect of a signal transmitting wire and locating the line defect, performing a removal process to remove a shielding layer covering two ends of the line defect and the shielding layer extending to a common line adjacent to the line defect, performing a deposition process to deposit a connecting metal layer the region where the shielding layer is removed, and performing a cutting process to cut outer ends of the common line adjacent to the line defect to form a common line section. The signal transmitting wire forms an electrical circuit with the common line section.

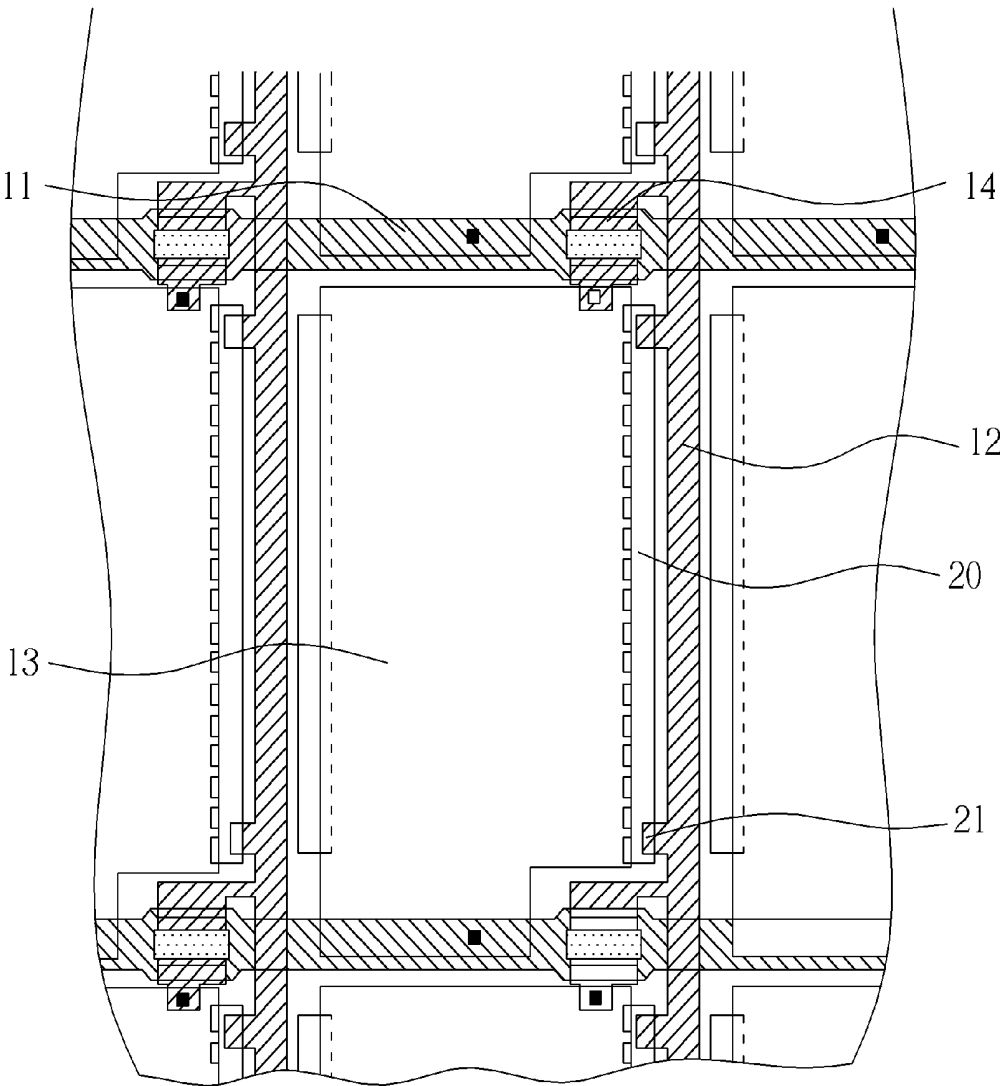
FIG. 1 PRIOR ART

[0006] FIG. 1 is a schematic diagram illustrating a repair of a data line in accordance with a conventional laser repair method. As illustrated in FIG. 1, a scan line 11 and a data line 12 are perpendicularly intersected with one another to define a pixel region, wherein the data line 12 includes a plurality of protrusions 21. A pixel electrode 13, which is made of indium tin oxide (ITO), is disposed in the pixel region, and the pixel electrode 13 is electrically connected to the scan line 11 and the data line 12 respectively through a thin film transistor 14. A shielding wire 20 is disposed between the pixel electrode 13 and the data line 12, and the shielding wire 20 is disposed parallel to the data line 12 and overlapping the protrusions 21 of the data line 12. When a line defect occurs at the data line 12, a laser repair method is performed to connect the protrusion 21 to the shielding wire 20, so that the data signals can bypass the broken data line 12, and continue the transmission via the shielding wire 20, improving the yield of the panel. Although the method above can repair the line defects, the laser repair method requires additional structure designs (e.g. the designs of the protrusions 21), which greatly increases the complexity of the pixel structure as well as the difficulty of the process of manufacturing. Furthermore, other defects may be

[0026] FIG. 1 is a schematic diagram illustrating a repair of a data line in accordance with a conventional laser repair method.

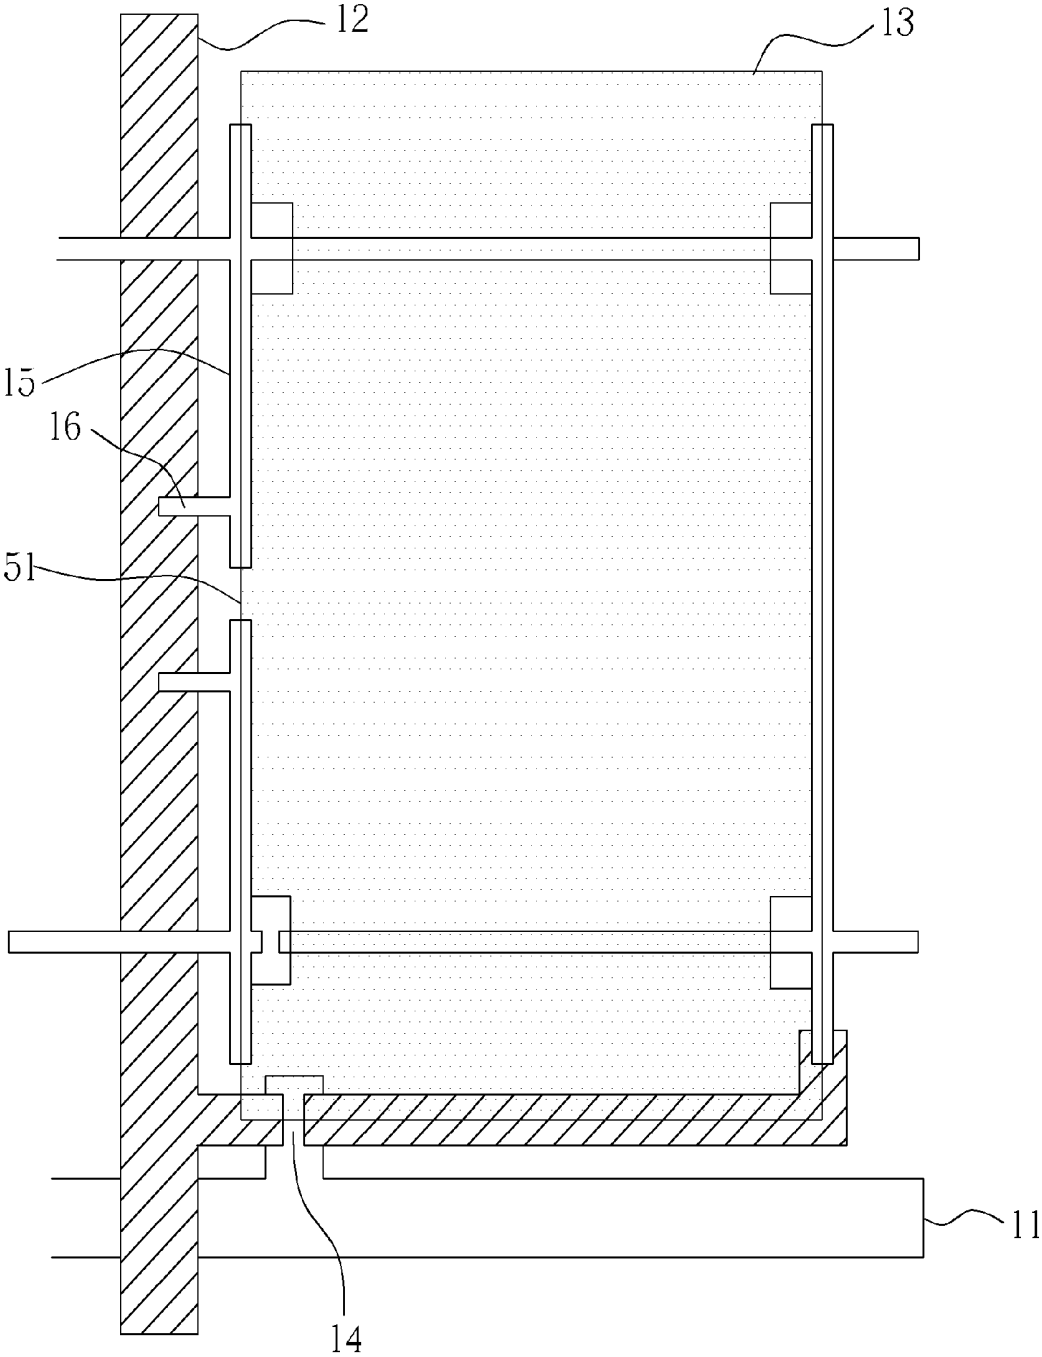
FIG. 2 PRIOR ART

[0007] FIG. 2 is a schematic diagram illustrating a repair of a data line in accordance with another conventional laser repair method. As illustrated in FIG. 2, a scan line 11 and a data line 12 are perpendicularly intersected with each other to define a pixel region. A pixel electrode 13, which is made of ITO, is disposed in the pixel region, and the pixel electrode 13 is electrically connected to the scan line 11 and the data line 12 respectively via a thin film transistor 14. A common line 15 is disposed in the peripheral region of the pixel electrode 13, and the common line 15 is disposed parallel to the scan line 11 or the data line 12, wherein a portion of the common line 15 disposed parallel to the data line 12 includes an opening part 51. The opening part 51 divides the common line 15 into two sections, and an extension part 16 of the common line 15 partially overlaps the data line 12. When a line defect occurs at the data line 12, the overlapping region between the extension part 16 and the data line 12 are connected by a laser repair method, so that the data signals can bypass the broken data line 12 and complete the transmission via the common line 15, improving the yield of the panel. Although such method is less complicated, the extension part 16 would generate a parasitic capacitance, which adversely affects the display quality.

[0027] FIG. 2 is a schematic diagram illustrating a repair of a data line in accordance with another conventional laser repair method.

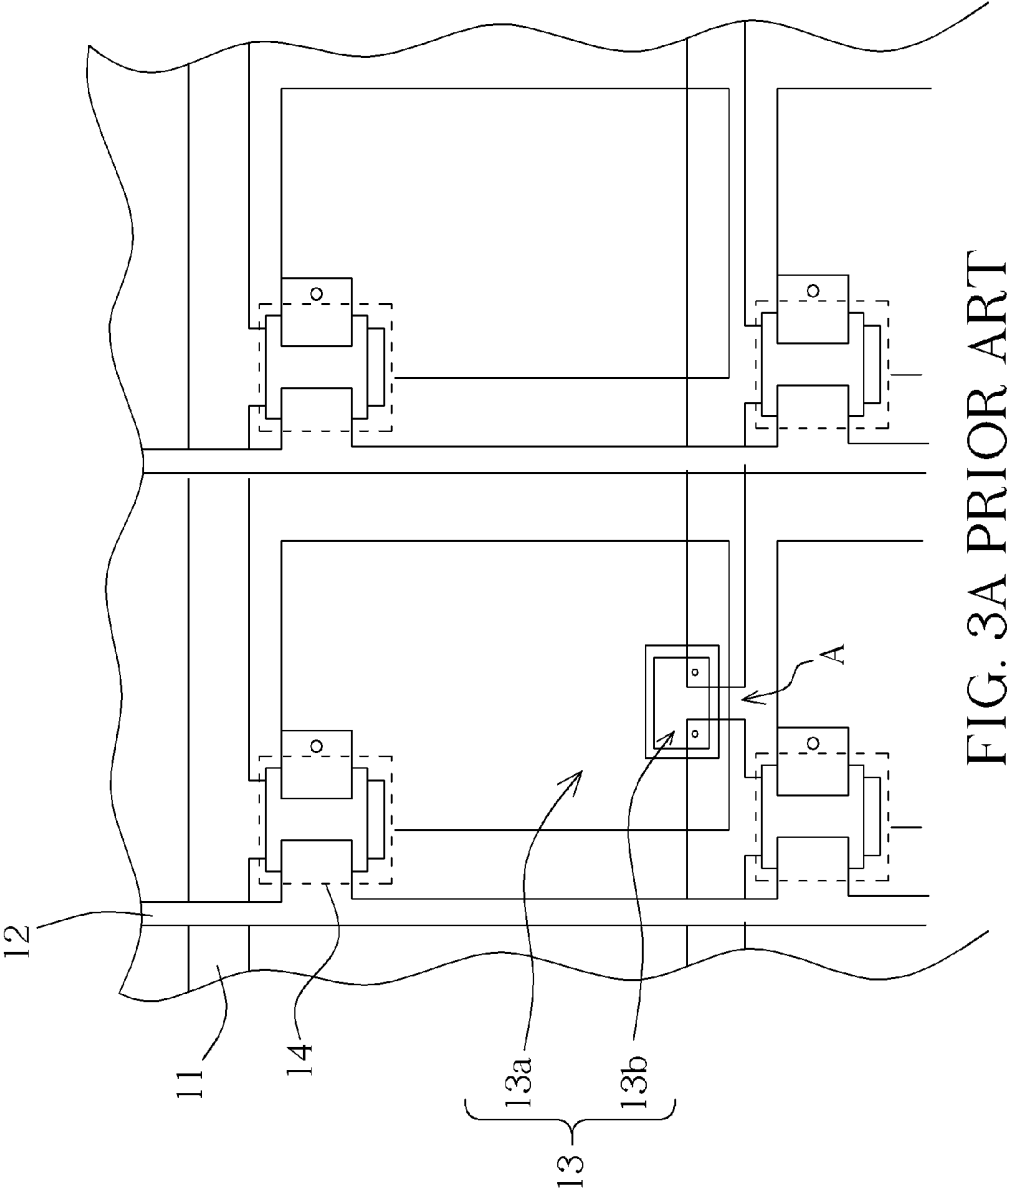
[0008] FIG. 3A is a schematic diagram illustrating a repair of a scan line in accordance with another conventional laser repair method. As illustrated in FIG. 3A, a scan line 11 and a data line 12 are perpendicularly intersected to define a pixel region. A pixel electrode 13, which is made of ITO, is disposed in the pixel region, and the pixel electrode 13 is electrically connected to the scan line 11 and the data line 12 respectively via a thin film transistor 14. When a line defect A occurs at the scan line 11 between two adjacent data lines 12, the repair method includes: first, dividing the pixel electrode 13 above the line defect A into a display portion 13a and a repair portion 13b surrounded by the display portion 13a so that the display portion 13a and the repair portion 13b are electrically insulated from each other; and then electrically connecting the repair portion 13b and the two ends of the broken scan line 11 with the line defect A via a laser repair method. Although such method can repair the scan line with the line defect, the aperture ratio of the display region is reduced, and therefore the display quality is adversely affected. Furthermore, since there are two layers existing between the pixel electrode and the scan line, the level of difficulties when connecting the pixel electrode with the scan line is increased. Consequently, the success rate of the repair is reduced.

[0028] FIG. 3A is a schematic diagram illustrating a repair of a scan line in accordance with another conventional laser repair method.

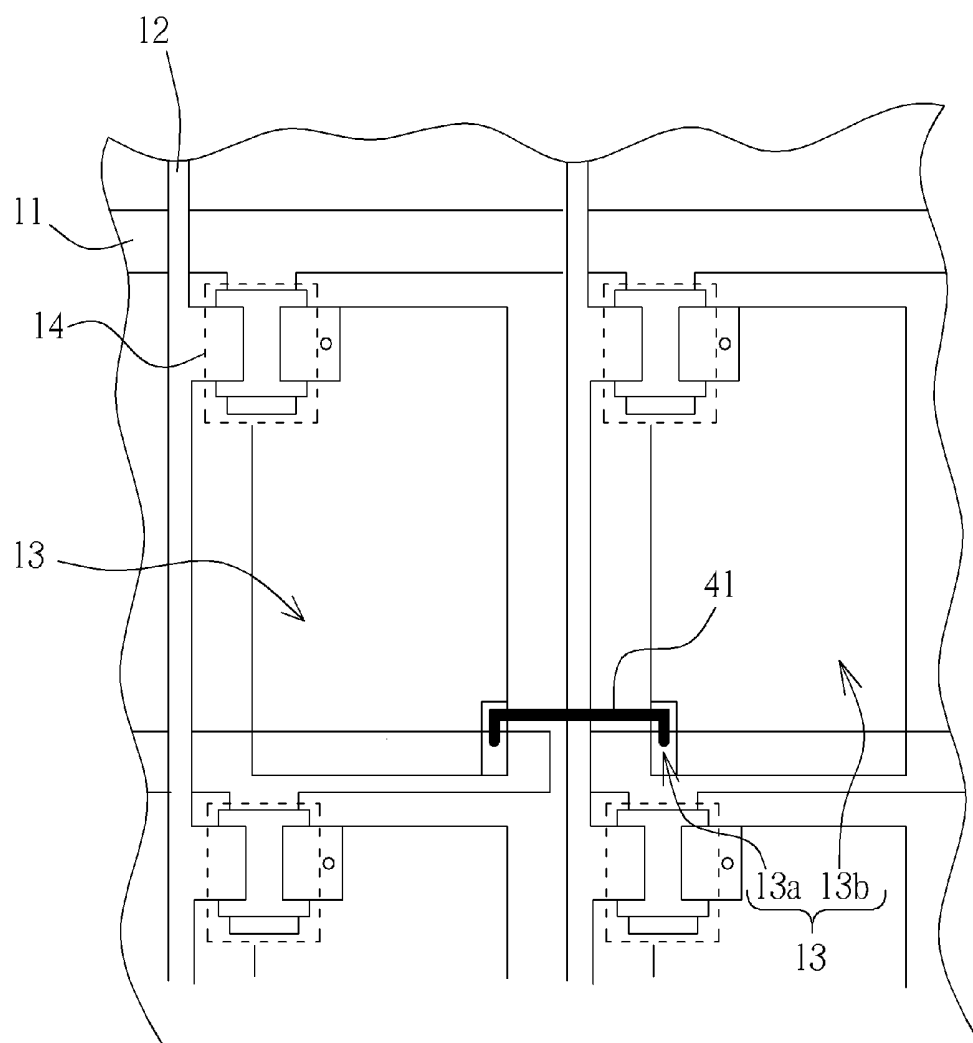
FIG. 3B PRIOR ART

[0009] FIG. 3B is a schematic diagram illustrating a repair of a scan line in accordance with another conventional laser repair method. As illustrated in FIG. 3B, a scan line 11 and a data line 12 are perpendicularly intersected to define a pixel region. A pixel electrode 13, which is made of ITO, is disposed in the pixel region, and the pixel electrode 13 is electrically connected to the scan line 11 and the data line 12 respectively via a thin film transistor 14. When a line defect occurs at the scan line 11 below the data line 12, the repair method includes: first, dividing the pixel electrodes 13 adjacent to the line defect into a display portion 13b and a repair portion 13a, which are electrically insulated with each other; and then depositing a metal film 41 on the repair portions 13a

[0029] FIG. 3B is a schematic diagram illustrating a repair of a scan line in accordance with another conventional laser repair method.

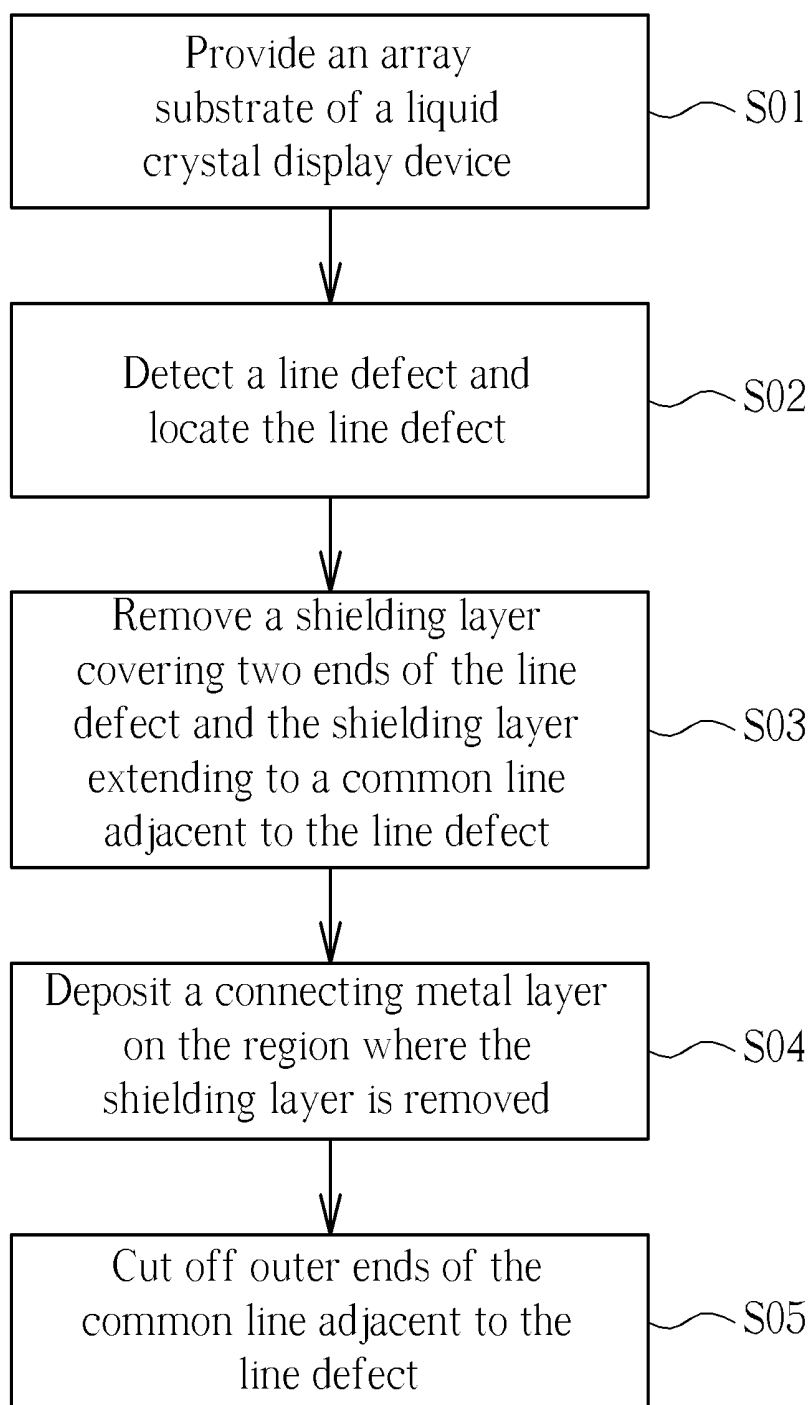
[0030] FIG. 4 is a schematic line defect repair process flow diagram in accordance with the present invention.

[0042] FIG. 4 is a schematic line defect repair process flow diagram in accordance with the present invention. As illustrated in FIG. 4, the repair process includes the following steps. First, provide an array substrate of a liquid crystal display device (S01); then, detect a line defect and locate the

line defect (S02). The detections may be executed by AOI machine or other methods/machines, e.g. a TESTER machine could detect, for detecting any line defect of the signal transmitting wires. The signal transmitting wires described above include a data line and a scan line. Then, locate the positions of the line defects at the data line or the scan line and remove a shielding layer covering two ends of the line defect and the shielding layer extending to a common line adjacent to the line defect (S03). The shielding layer located on the two ends of the signal transmitting wire adjacent to the line defect, and the shielding layer extending horizontally from the two ends to the space (line section) of the common line is removed by a laser light beam.

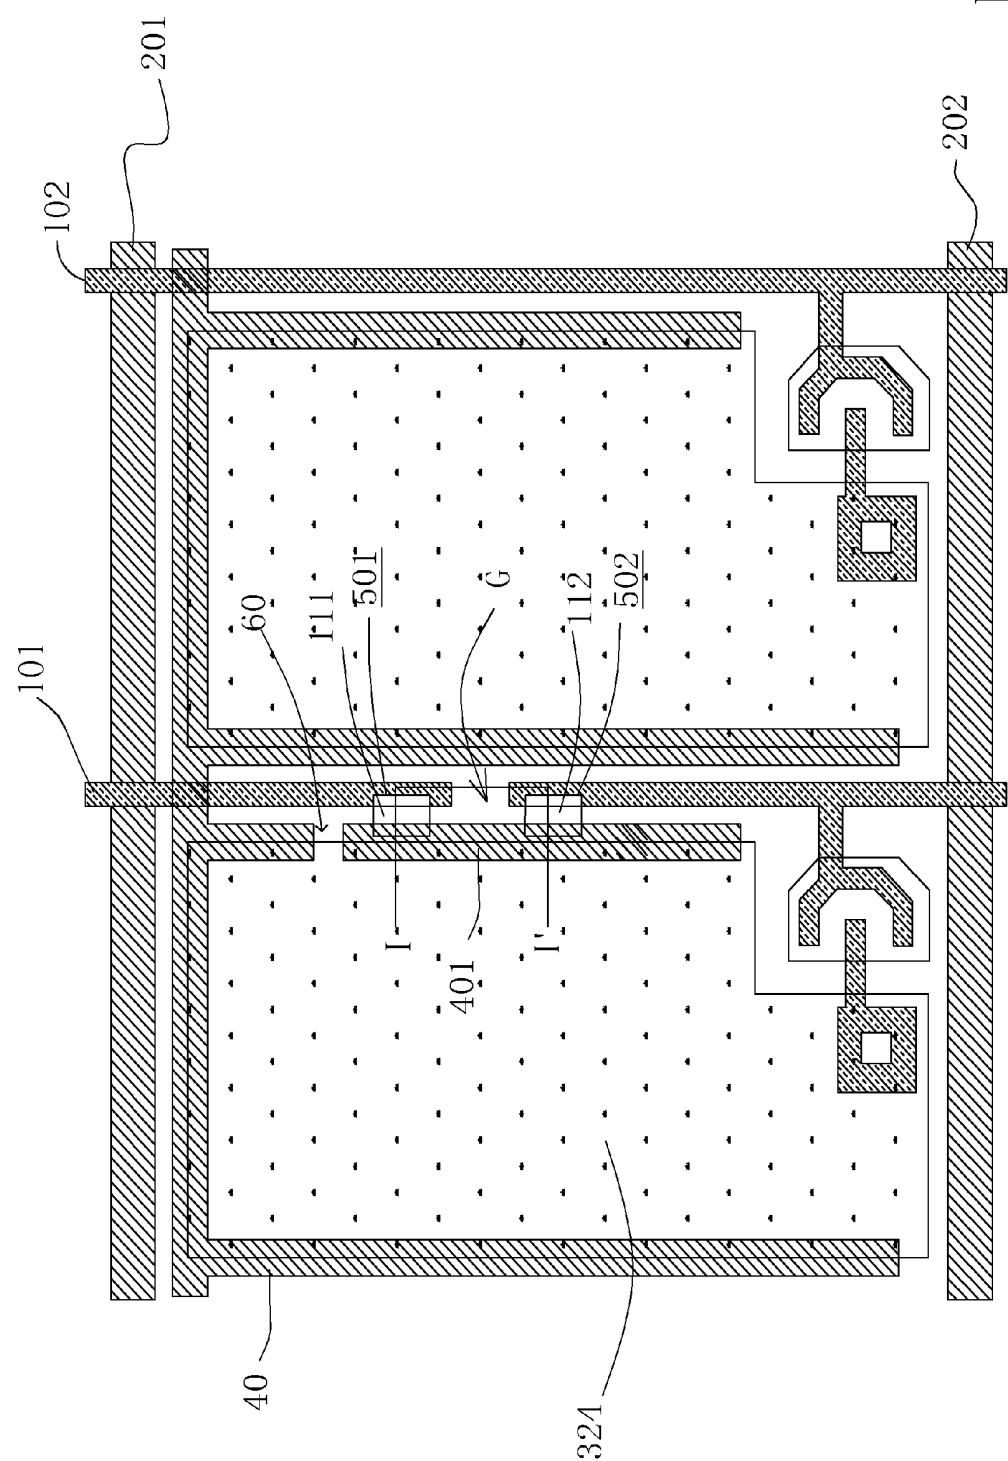
[0031] FIG. 5 is a schematic diagram illustrating a line defect in a "C" shaped common line in accordance with the present invention.

**[0046]** Referring to FIG. 5, FIG. 5 is a schematic diagram illustrating a line defect in a "C" shaped common line in accordance with the present invention. A first data line 101 is disposed perpendicular to a first scan line 201, the first data line 101 is disposed parallel to a second data line 102, the first scan line 201 is disposed parallel to a second scan line 202, the second scan line 202 is disposed perpendicular to the first data line 101, the second scan line 202 is disposed perpendicular to the second data line 102, and the second data line 102 is disposed perpendicular to the first scan line 201. The intersected data lines and the scan lines define a plurality of pixel units, wherein a common line 40 serving as a bottom electrode of a storage capacitor is disposed on top of the data lines and the scan lines, and the common line 40 forms the storage capacitor with the pixel electrode 324 in the pixel unit. The shape of the common line 40 in the pixel unit affects the magnitude of the storage capacitor directly. In the present embodiment, the common line 40 serving as the bottom electrode of the storage capacitor has a "C" shape, wherein a "C" shaped common line section 401 is the line section of the common line 40 after the cutting process and is not electrically connected to the original common line 40, i.e. the common line section 401 above the connecting metal layer 111 is cut off. The previously described cut off region is the opening 60, and the "C" shaped common line section 401 is partially coupled with the pixel electrode 324 and partially contacts the connecting metal layers 111 and 112. In addition, the connecting metal layers 111 and 112 are also partially connected to the first data line 101 having the line defect G. The connecting metal layers 111 and 112 are disposed adjacent to the two ends of the line defect G, but do not overlap the line defect G. Therefore, the repaired circuit described above allows the first data line 101 having the line defect G to complete the transmission via the common line section 401.

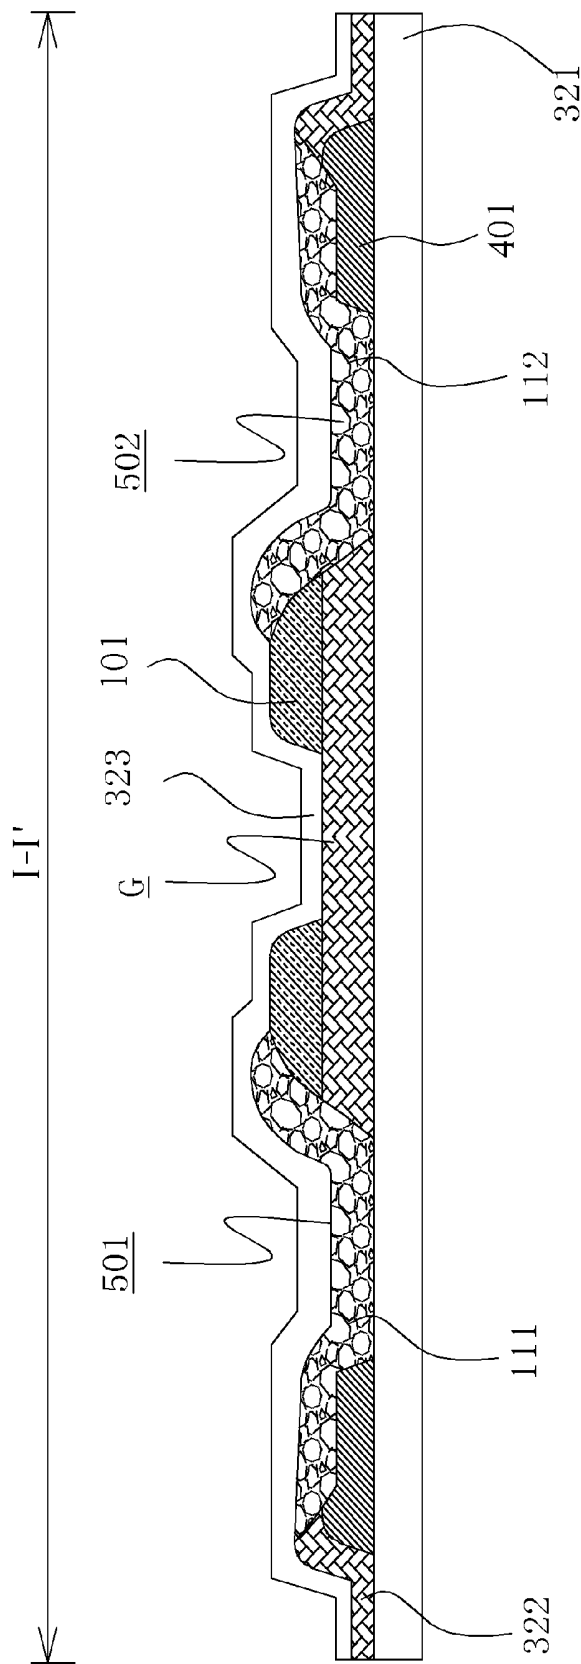
[0032] FIG. 6A and FIG. 6B are a schematic cross-sectional diagrams illustrating the line section across line I-I' of FIG. 5.

**[0047]** FIG. 6A is a schematic cross-sectional diagram illustrating the line section across line I-I' of FIG. 5. Referring to FIG. 5 and FIG. 6A, when the shielding layer includes only the shielding layer for metal (i.e. the third process without the deposition of the transparent electrode layer of the five processes in fabricating a TFT-LCD, and the line defect is detected and repaired), the common line section 401, the shielding layer for metal 322 and the connecting metal layers 111 and 112 are disposed on a glass substrate 321. A portion

of the shielding layer for metal 322 previously described is disposed on a portion of the common line section 401, and the first data line section 401 is disposed on the other portion of the shielding layer for metal 322. During the third process without the deposition of a passivation layer 323 of the five processes in fabricating a TFT-LCD, the detection detects the line defects and proceeds to the repairing immediately. The IR with a wavelength between 1000 nm and 1500 nm or the green light with a wavelength between 450 nm and 600 nm removes the shielding layer for metal 322, and the regions of removal are positions of connection holes 501 and 502 as illustrated in the figure (the regions of removal also includes the shielding layer described above located adjacent to the two ends of the line defect, and the space (line sections) extending horizontally from these two ends to the common line section). Also, the positions of the connection holes 501 and 502 are covered by the connecting metal layers 111 and 112. Therefore, the laser chemical vapor deposition (L-CVD) repairing apparatus is used using a tungsten-carbon compound as its target material to deposit the connecting metal layer 111 and 112 on the regions where the first data line 101 and the common line section 401 are exposed, i.e. to deposit the connecting metal layers 111 and 112 on the connection holes 501 and 502 in order to repair the line defect G of the first data line 101. Typically, the connecting metal layers 111 and 112 are slightly larger than the exposed regions of the first data line 101 and the common line section 401, i.e. the connection holes 501 and 502, so that the connecting metal layers 111 and 112 cover a portion of the first data line 101 and a portion of the common line section 401. Then the laser light beam is used to disconnect the common line section 401 located above the connecting metal layer 111, so that the common line 40 is not affected by the signal of the first data line 101 having the line defect G, and the signal of the first data line 101 may also complete the transmission via the common line section 401 between the connecting metal layers 111 and 112 in order to complete the signal transmission. Then the following manufacturing process of the array substrate is continued to form the passivation layer 323 and the transparent electrode layer (not illustrated in the figure).

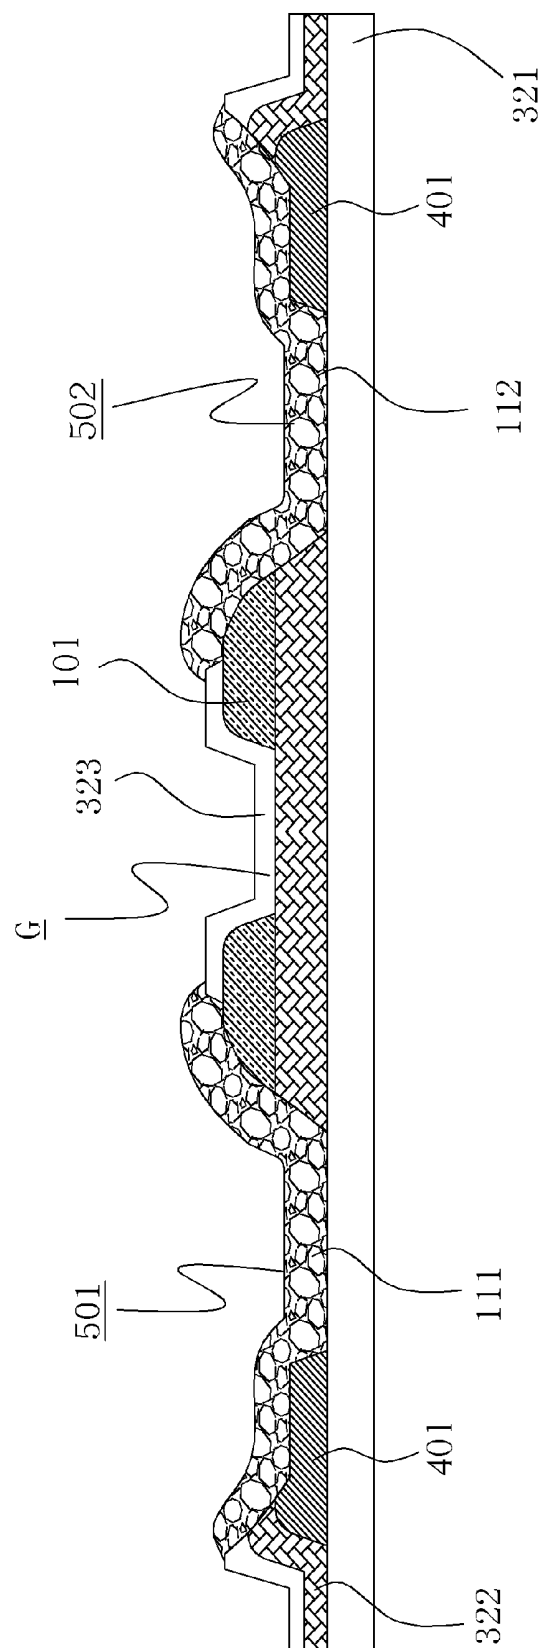
FIG. 6B

**[0048]** FIG. 6-B illustrates when the shielding layer includes the insulation layer and the transparent electrode layer (i.e. the five processes in fabricating a TFT-LCD are completed, and the line defect is detected and repaired). Referring to FIG. 5 and FIG. 6B, the common line section 401, the shielding layer for metal 322 and the connecting metal layers 111 and 112 are disposed on the glass substrate 321, and the passivation layer 323 is further disposed thereon. In addition, a portion of the shielding layer for metal 322 mentioned above is disposed on a portion of the common line section 401, the passivation layer 323 is further covered on the metal shielding layer 322, the first data line section 401 is disposed on another portion of the shielding layer for metal 322, and the passivation layer 323 is further partially covered on the first data line section 401. After completing the five processes of manufacturing the TFT, the line defect is detected and repaired. The IR with a wavelength between 1000 nm and 1500 nm or the green light with a wavelength between 450 nm and 600 nm removes the shielding layer for metal 322 and the passivation layer 323, and the regions of removal are positions of the connection holes 501 and 502 as illustrated in the figure (the regions of removal also includes the shielding layer described above located adjacent to the two ends of the line defect, and the space (line sections)

extending horizontally from the two ends to the common line section). Also, the positions of the connection holes 501 and 502 are covered by the connecting metal layers 111 and 112. Thereafter, the laser chemical vapor deposition (L-CVD) repairing apparatus is used using a tungsten-carbon compound as its target material to deposit the connecting metal layer 111 and 112 on the regions where the first data line 101 and the common line section 401 are exposed, i.e. the connection holes 501 and 502, to repair the line defect G of the first data line 101. Typically, the connecting metal layers 111 and 112 are slightly larger than the exposed regions of the first data line 101 and the common line section 401, i.e. the connection holes 501 and 502, so that the connecting metal layers 111 and 112 cover a portion of the first data line 101 and a portion of the common line section 401. Then the laser light beam is used to disconnect the common line section 401 located above the connecting metal layer 111, so that the common line 40 is not affected by the signal of the first data line having the line defect G, and the signal of the first data line 101 may also complete the transmission via the common line section 401 between the connecting metal layers 111 and 112.

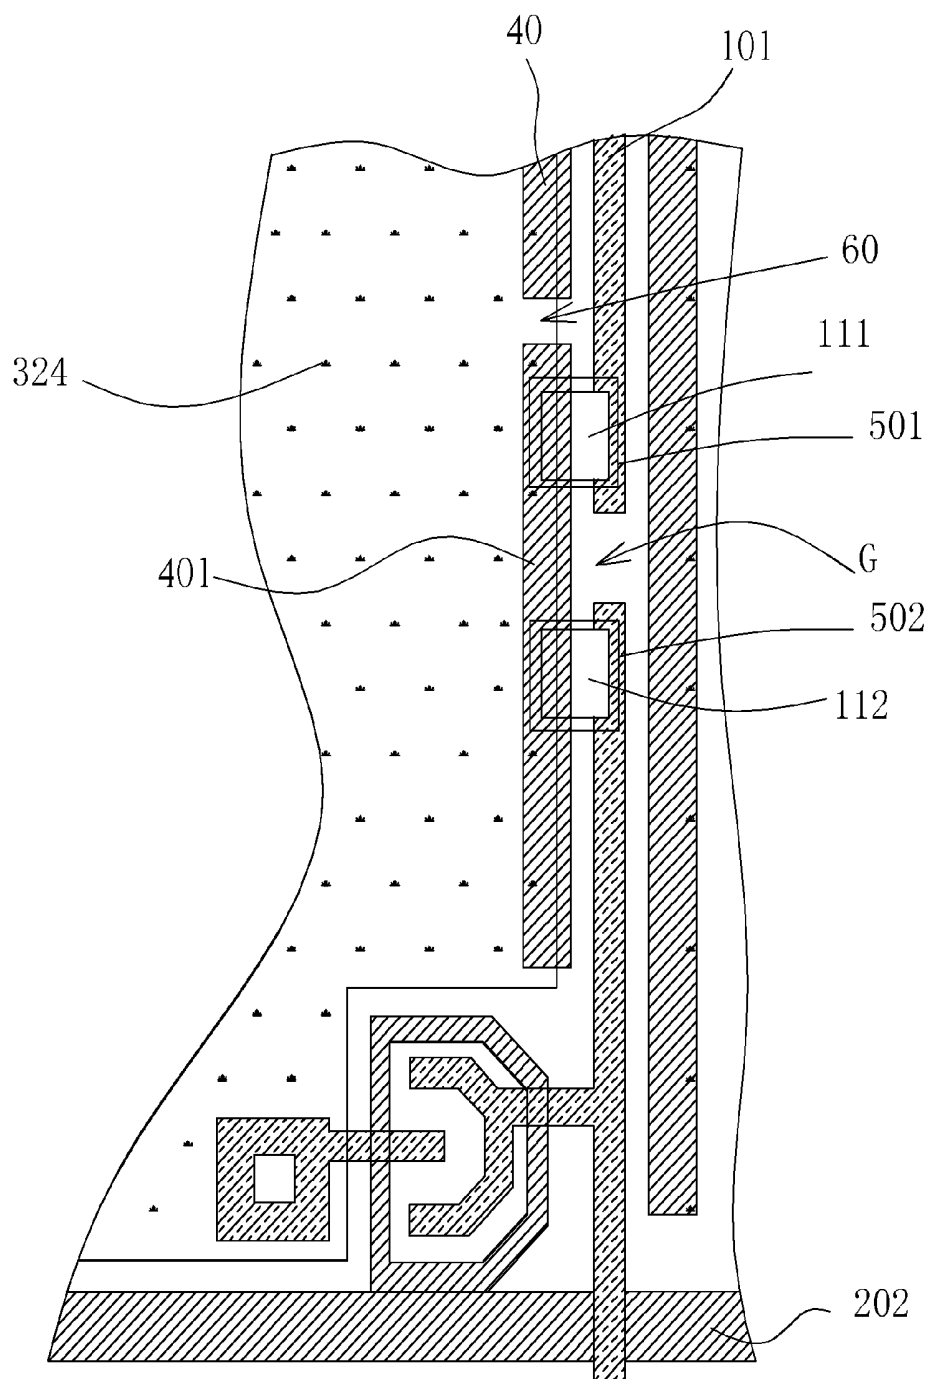
[0033] FIG. 7 is a sectional zoomed-in diagram of FIG. 5.

[0049] FIG. 7 is a sectional zoomed-in diagram of FIG. 5. Referring to FIG. 5 and FIG. 7, in the present embodiment, the common line 40 serving as the bottom electrode of the storage capacitor has a "C" shape, wherein the "C" shaped common line section 401 is the line section of the common line 40 after the cutting process and is not electrically connected to the original common line 40, i.e. the common line section 401 above the connecting metal layer 111 is cut off. The previously described cut off region is the opening 60, and the "C" shaped common line section 401 is partially coupled with the pixel electrode 324 and partially contacts the connecting metal layers 111 and 112. The pixel electrode 324 on the overlapping region of the common line section 401 and the pixel electrode 324 electrically connected to the connecting metal layers 111 and 112 is removed, and the removed portion is slightly larger than the connecting metal layers 111 and 112, so that the first data line 101 and the pixel electrode 324 are not electrically connected. In addition, the connecting metal layers 111 and 112 are also partially overlapping the first data line 101 having the line defect G, wherein the connecting metal layers 111 and 112 are disposed adjacent to the two ends of the line defect G, but do not overlap the line defect G. Therefore, the repaired circuit described above allows the first data line 101 having the line defect G to complete the transmission via the common line section 401. However, when the shielding layer includes the insulation layer and the transparent electrode layer, method 1 is employed. When a higher energy laser light beam is used to remove the shielding layer, the laser chemical vapor deposition (L-CVD) repairing apparatus is used using a tungsten-carbon compound as its target material to deposit the connecting metal layer 111 and 112 on the regions where the first data line 101 and the common line section 401 are exposed, i.e. the connection holes 501 and 502, for repairing the line defect G of the first data line 101. Here, the connecting metal layers 111 and 112 are respectively smaller than the exposed regions of the first data line 101 and the common line section 401, i.e. the positions of the connection holes 501 and 502. Then the laser light beam is used to cut off the common line section 401 above the connecting metal layer 111 to form the opening 60. Meanwhile, the first data line 101 signal passes through the com-

mon line section 401 between the connecting metal layers 111 and 112 to complete the signal transmission.

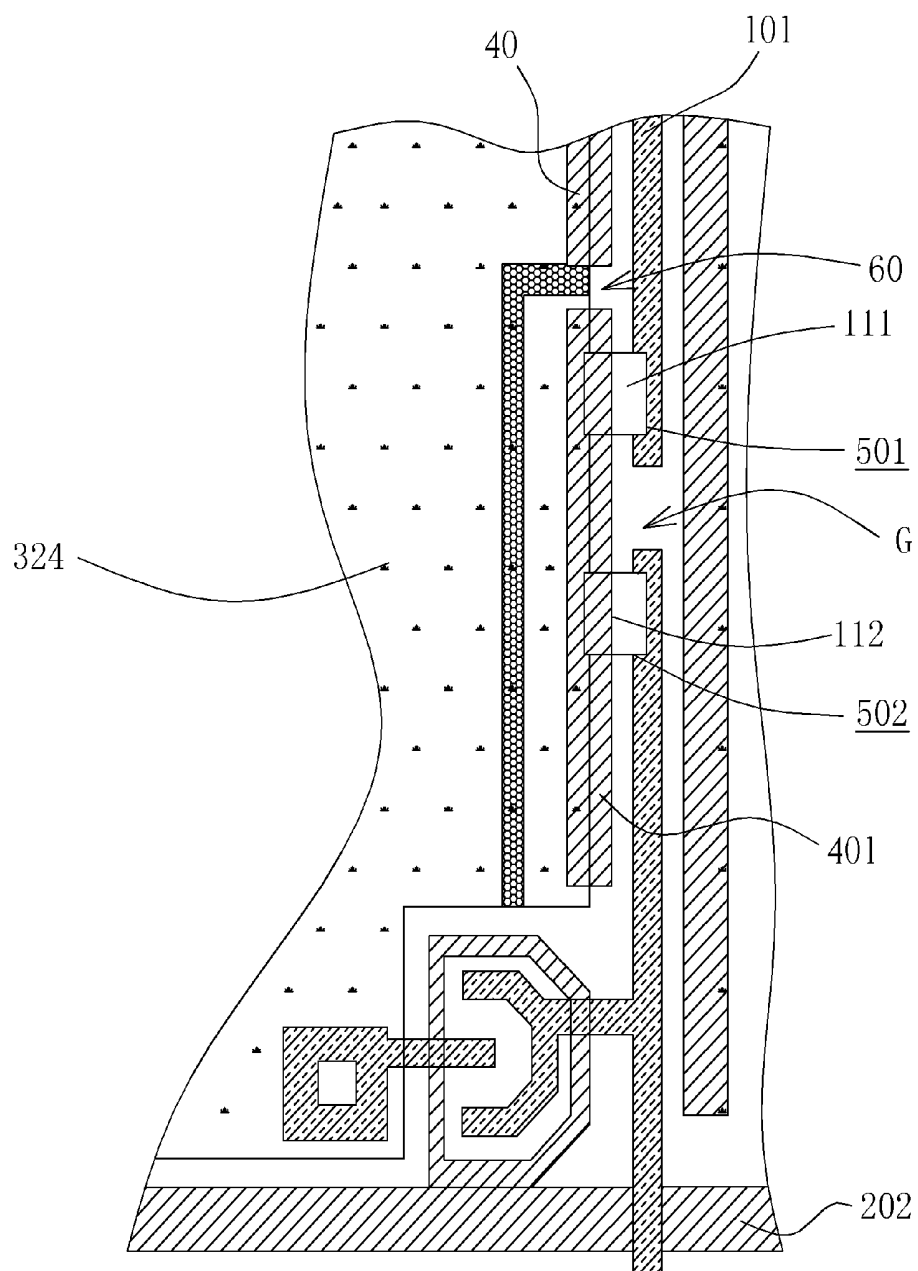
[0034] FIG. 8 is another sectional zoomed-in diagram of FIG. 5.

[0050] FIG. 8 is another sectional zoomed-in diagram of FIG. 5. Referring to FIG. 5 and FIG. 8, when the shielding layer includes the shielding layer for metal, the passivation layer and the pixel electrode, method 2 is employed. First the shielding layer for metal, the passivation layer and the pixel electrode are removed as mentioned above, to form the connection holes 501 and 502; then the laser chemical vapor deposition (L-CVD) repairing apparatus is used using a tungsten-carbon compound as its target material to deposit the connecting metal layer 111 and 112 on the regions where the first data line 101 and the common line section 401 are exposed, i.e. the connection holes 501 and 502, to repair the line defect G of the first data line 101. Typically, the connecting metal layers 111 and 112 are slightly larger than the exposed regions of the first data line 101 and the common line section 401, i.e. the connection holes 501 and 502, so that the connecting metal layers 111 and 112 cover a portion of the first data line 101 and a portion of the common line section 401. Then the laser light beam is used to disconnect the common line section 401 located above the connecting metal layer 111, to form the opening 60. Finally, a thin channel 701 is formed in the pixel electrode 324 around the common line section 401 by the laser light beam, so that the common line section 401 between the connecting metal layers 111 and 112 is not electrically connected to the pixel electrode 324. Meanwhile, the signal of the first data line 101 passes through the common line section 401 between the connecting metal layers 111 and 112 to complete the signal transmission.

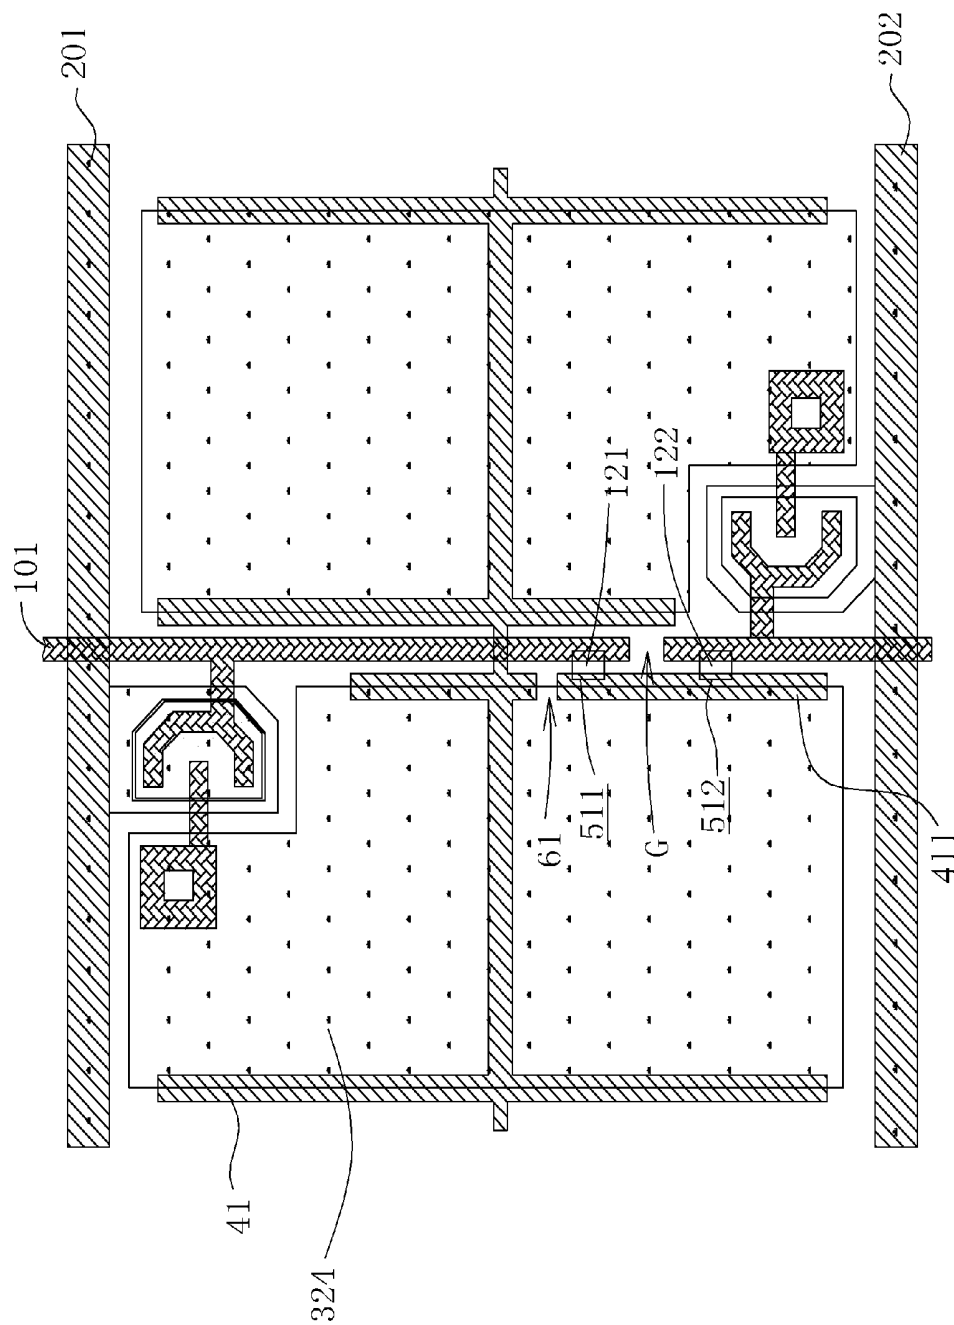
[0035] FIG. 9 is a schematic diagram illustrating a line defect in an "H" shaped common line in accordance with the present invention.

[0052] FIG. 9 is a schematic diagram illustrating a line defect in an "H" shaped common line in accordance with the present invention. In the present embodiment, the common line serving as the bottom electrode of the storage capacitor, has an "H" shape. A first data line 101 and a first scan line 201 are disposed perpendicularly, the first scan line 201 is disposed parallel to a second scan line 202, and the second scan line 202 is disposed perpendicular to the first data line 101. The intersected data lines and the scan lines define a plurality of pixel units, wherein a common line 41 serving as a bottom electrode of the storage capacitor is disposed on top of the data lines and the scan lines, and the common line 41 forms the storage capacitor with the pixel electrode 324 in the pixel unit. The shape of the common line 41 on the pixel unit affects the magnitude of the storage capacitor directly. In the present embodiment, the common line 41 serving as the bottom electrode of the storage capacitor has an "H" shape, wherein an "H" shaped common line section 411 is the line section of the common line 41 after the cutting process and is not electrically connected to the original common line 41, i.e. the common line section 411 above the connecting metal layer 121 is cut off. The previously described cut off region is an opening 61, and the "H" shaped common line section 411 is partially coupled with the pixel electrode 324 and partially contacts connecting metal layers 121 and 122. In addition, the connecting metal layers 121 and 122 are also partially connected with the first data line 101 having the line defect G. The connecting metal layers 121 and 122 are disposed adjacent to the two ends of the line defect G, but do not overlap with the

line defect G. Therefore, the repaired circuit described above allows the first data line **101** having the line defect G to complete the transmission via the common line section **411**.

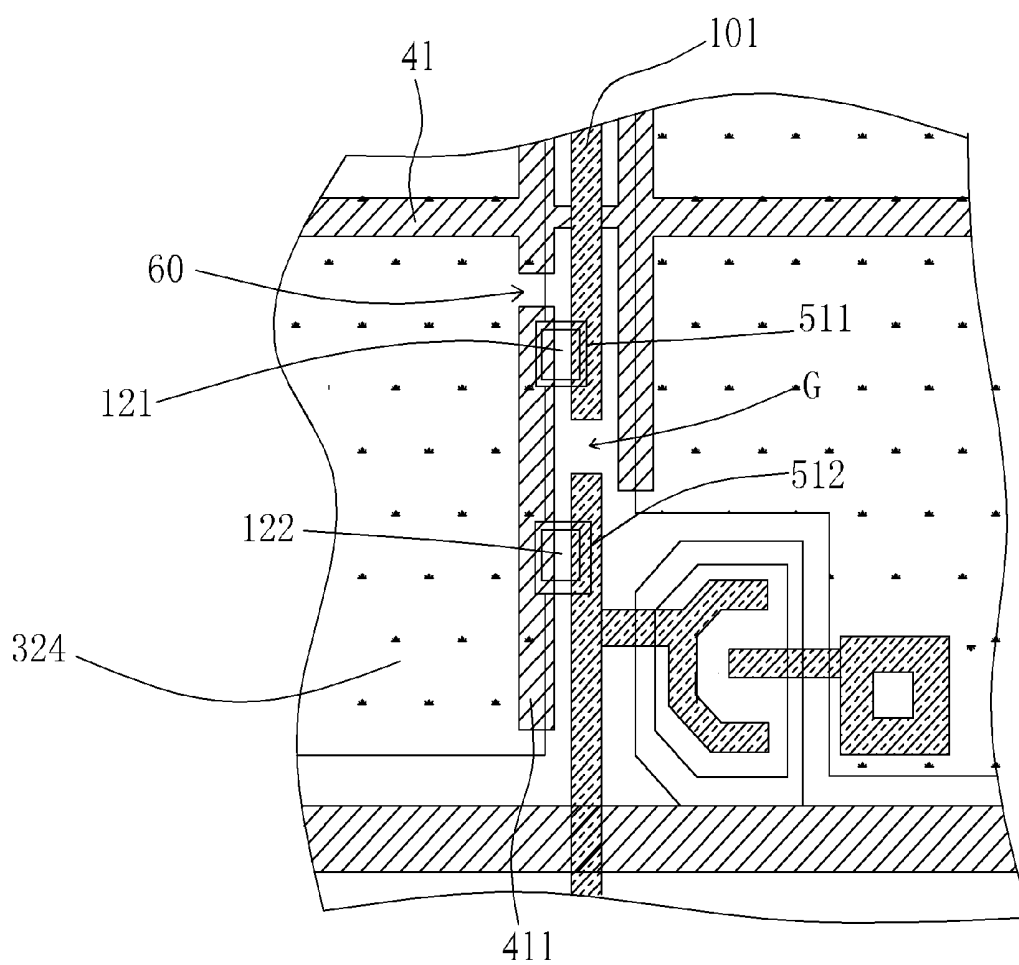
[0036] FIG. 10 is a schematic sectional zoomed-in diagram of FIG. 9.

**[0054]** When the shielding layer includes only the shielding layer for metal, the connecting metal layer is slightly larger than the exposed region of the data line and the common line, so that the electrical connection can be improved. When the shielding layer mentioned above includes the insulation layer and the transparent electrode layer, two different methods can be applied. In method 1, the connecting metal layer is slightly smaller than the exposed regions of the data line and common line, so that the transparent electrode layer is not electrically connected to the connecting metal layer, as illustrated in FIG. **10** where FIG. **10** is a schematic sectional zoomed-in diagram of FIG. **9**. In the present embodiment, the common line **41** serving as the bottom electrode of the storage capacitor has an “H” shape, wherein an “H” shaped common line section **411** is the line section of the common line **41** after the cutting process and is not electrically connected to the original common line **41**, i.e. the common line section **411** above the connecting metal layer **121** is cut off. The previously described cut off region is the opening **61**, and the “H” shaped common line section **411** is partially coupled with the pixel electrode **324** and partially contacts the connecting metal layer **121** and **122**. The pixel electrode **324** on the overlapping region of the common line section **411** and the connecting metal layers **121** and **122** is removed, and the removed portion is slightly larger than the connecting metal layers **121** and **122**, so that the first data line **101** and the pixel electrode **324** are not electrically connected. In addition, the connecting metal layers **121** and **122** also partially overlap the first data line **101** having the line defect G, wherein the connecting metal layers **121** and **122** are disposed adjacent to the two ends of the line defect G, but do not overlap the line defect G. Therefore, the repaired circuit described above allows the first

data line **101** having the line defect G to complete the transmission via the common line section **411**. However, when the shielding layer includes the insulation layer and the transparent electrode layer, method 1 is employed. When a higher energy laser light beam is used to remove the shielding layer, the laser chemical vapor deposition (L-CVD) repairing apparatus is used using a tungsten-carbon compound as its target material to deposit the connecting metal layers **121** and **122** on the regions where the first data line **101** and the common line section **411** are exposed, i.e. the connection holes **511** and **512**, for repairing the line defect G of the first data line **101**. Here, the connecting metal layers **121** and **122** are respectively smaller than the exposed regions of the first data line **101** and the common line section **411**, i.e. the positions of the connection holes **511** and **512**. Then the laser light beam is used to cut off the common line section **411** above the connecting metal layer **121** to form the opening **60**. Meanwhile, the signal of the first data line **101** passes through the common line section **411** between the connecting metal layers **121** and **122** to complete the signal transmission.
