(19) **United States**(12) **Patent Application Publication**  
**Cheng et al.**(10) **Pub. No.: US 2011/0194041 A1**(43) **Pub. Date: Aug. 11, 2011**(54) **ARRAY SUBSTRATE OF LIQUID CRYSTAL  
DISPLAY DEVICE AND REPAIR METHOD  
THEREOF****Publication Classification**(51) **Int. Cl.**  
**G02F 1/1343** (2006.01)  
**H01L 21/30** (2006.01)  
(52) **U.S. Cl.** ..... **349/38; 438/4; 257/E21.211**(76) Inventors: **I-Ming Cheng, Shen-zhen (CN);  
De Bian, Shen-zhen (CN)**(57) **ABSTRACT**(21) Appl. No.: **12/818,178**(22) Filed: **Jun. 18, 2010**(30) **Foreign Application Priority Data**

# ARRAY SUBSTRATE OF LIQUID CRYSTAL DISPLAY DEVICE AND REPAIR METHOD THEREOF

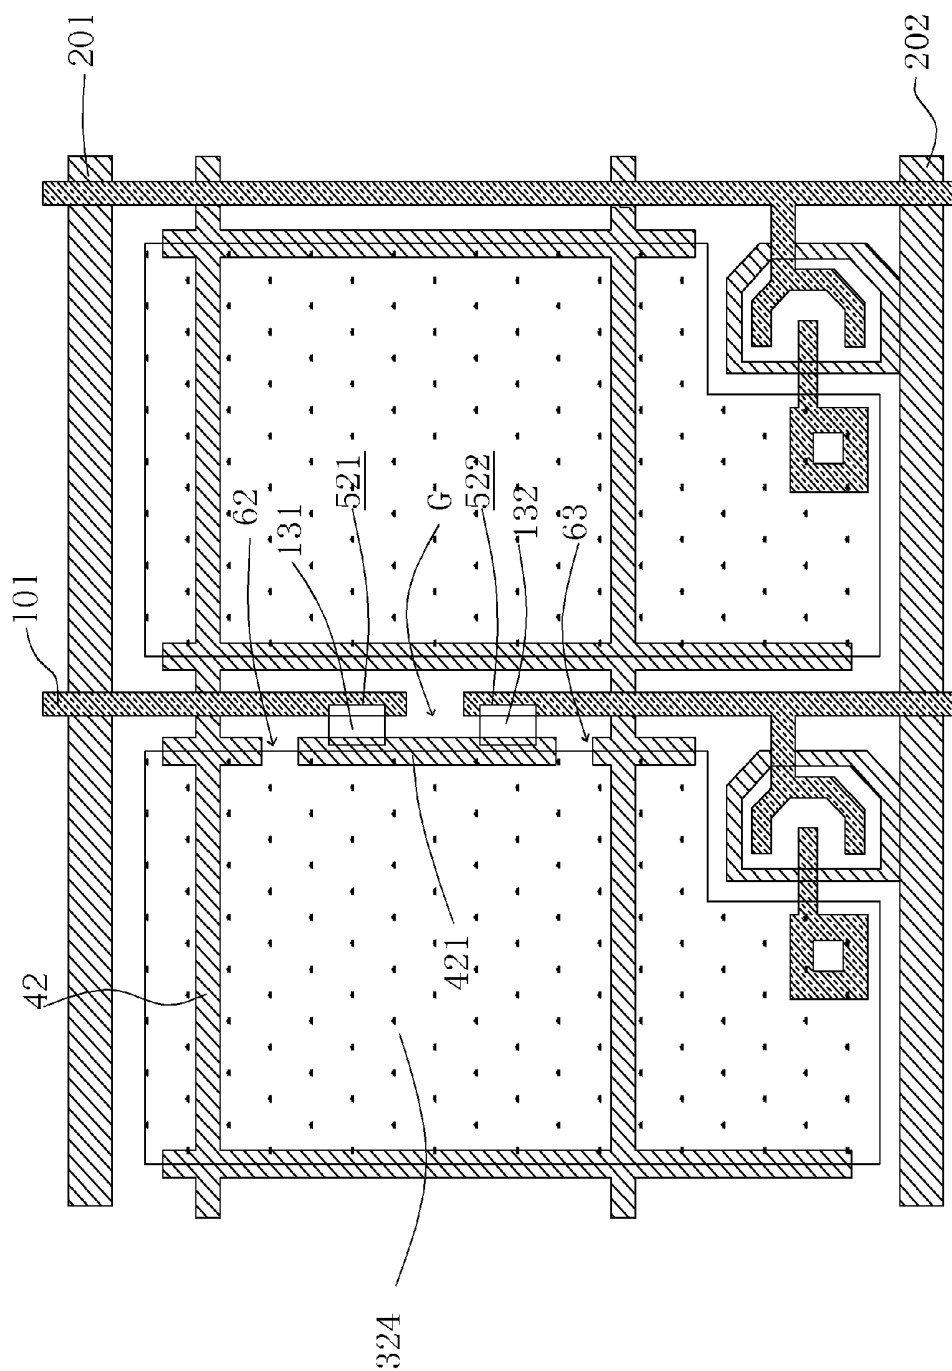
[0037] FIG. 11 is a schematic diagram illustrating a line defect in a hollow square shaped common line of the present invention.

**[0057]** FIG. **11** is a schematic diagram illustrating a line defect in a hollow square shaped common line of the present invention. In the present embodiment, the common line **42** serving as the bottom electrode of the storage capacitor has a hollow square shape. A first data line **101** is disposed perpendicular to a first scan line **201**, the first scan line **201** is disposed parallel to a second scan line **202**, and the second scan line **202** is disposed perpendicular to the first data line **101**. The intersected data lines and the scan lines define a plurality of pixel units, wherein a common line **42** serving as a bottom electrode of the storage capacitor is disposed on top of the data lines and the scan lines, and the common line **42** forms the storage capacitor with the pixel electrode **324** in the pixel unit. The shape of the common line **42** on the pixel unit affects the magnitude of the storage capacitor directly.

**[0058]** In the present embodiment, the common line **42** serving as the bottom electrode of the storage capacitor has a hollow square shape, wherein the common line section **421** is the line section of the common line **42** after the cutting process and is not electrically connected to the original common line **42**, i.e. the common line section **421** above the connecting metal layer **131** is cut. The previously described cut off region is the openings **62** and **63**, and the common line section **421** is partially coupled with the pixel electrode **324** and partially contacts the connecting metal layers **131** and **132**. In addition, the connecting metal layers **131** and **132** are also partially connected to the first data line **101** having the line defect G.

The connecting metal layers **131** and **132** are disposed adjacent to the two ends of the line defect G, but do not overlap the line defect G. Therefore, the repaired circuit described above allows the first data line **101** having the line defect G to complete the transmission via the common line section **421**.

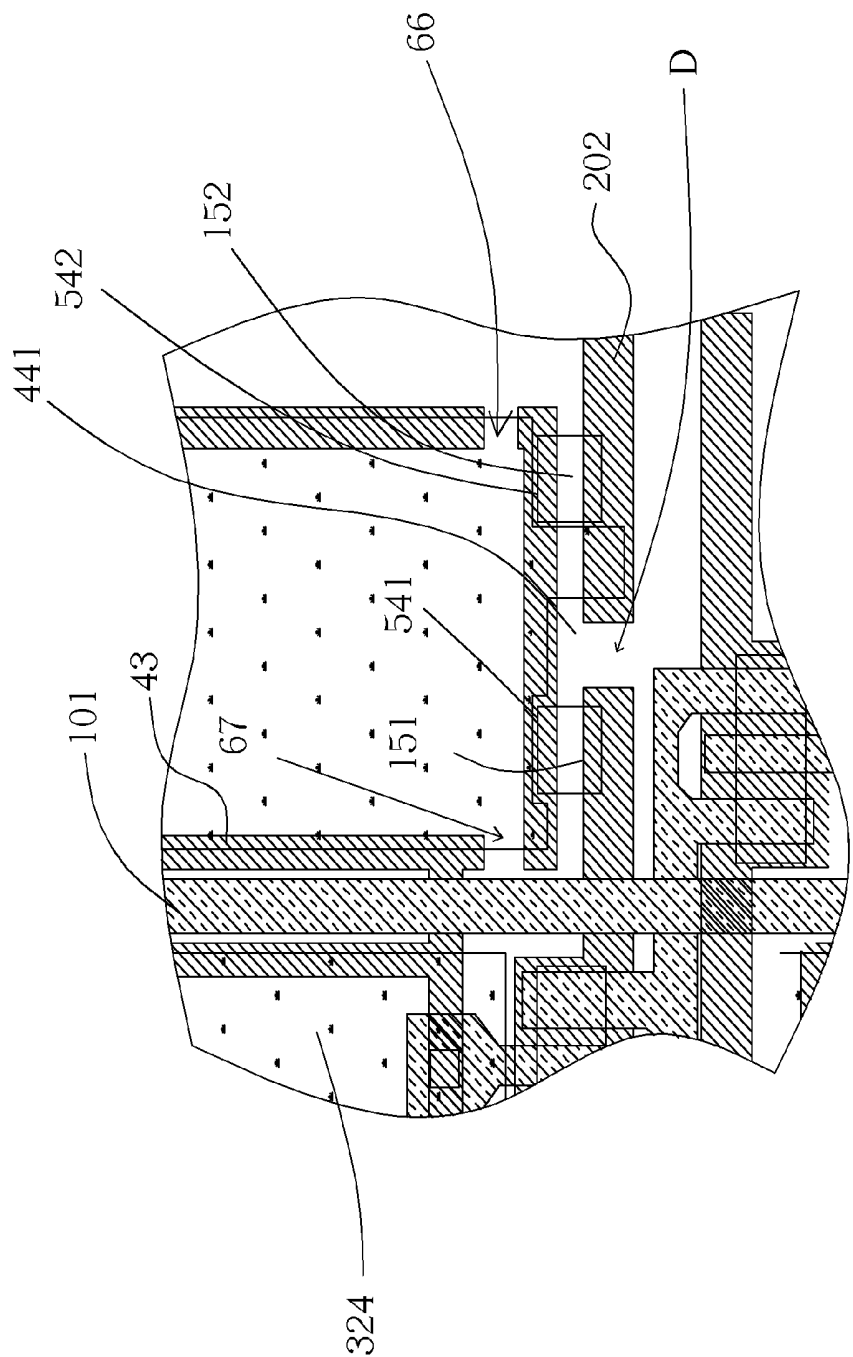
[0039] FIG. 13 is a sectional zoomed-in diagram of FIG. 12.

**[0063]** Referring to upper portion of FIG. 12 and FIG. 13, the common line **43** serving as the bottom electrode of the storage capacitor has the hollow square shape, wherein the common line section **441** is the line section of the common line **43** after the cutting process and is not electrically connected to the original common line **43**, i.e. the common line section **441** above the connecting metal layers **151** and **152** is cut. The previously described cut off region is the openings **66** and **67**, and the common line section **441** is partially coupled with the pixel electrode **324** and partially contacts the connecting metal layer **151** and **152**. In addition, the connecting metal layer **151** and **152** also partially connect with the second scan line **202** having a line defect D. The connecting metal layers **151** and **152** are disposed adjacent to the two ends of the line defect D, but do not overlap the line defect D. Therefore, the repaired circuit described above allows the second scan line **202** having the line defect D to complete the transmission via the common line section **441**.

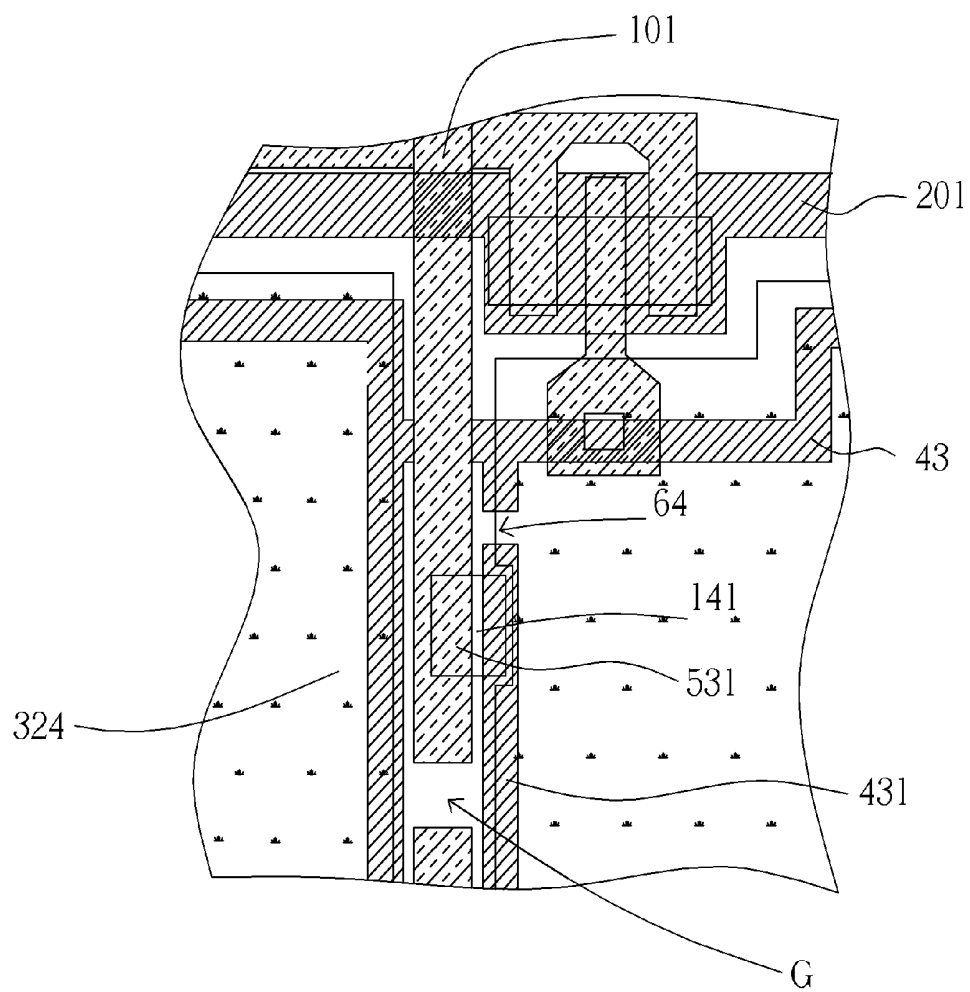
[0040] FIG. 14 is another sectional zoomed-in diagram of FIG. 12.
