(10) **Patent No.:** US 8,384,837 B2  
(45) **Date of Patent:** Feb. 26, 2013

- (57) **ABSTRACT**

# ARRAY SUBSTRATE OF LIQUID CRYSTAL DISPLAY DEVICE AND REPAIR METHOD THEREOF

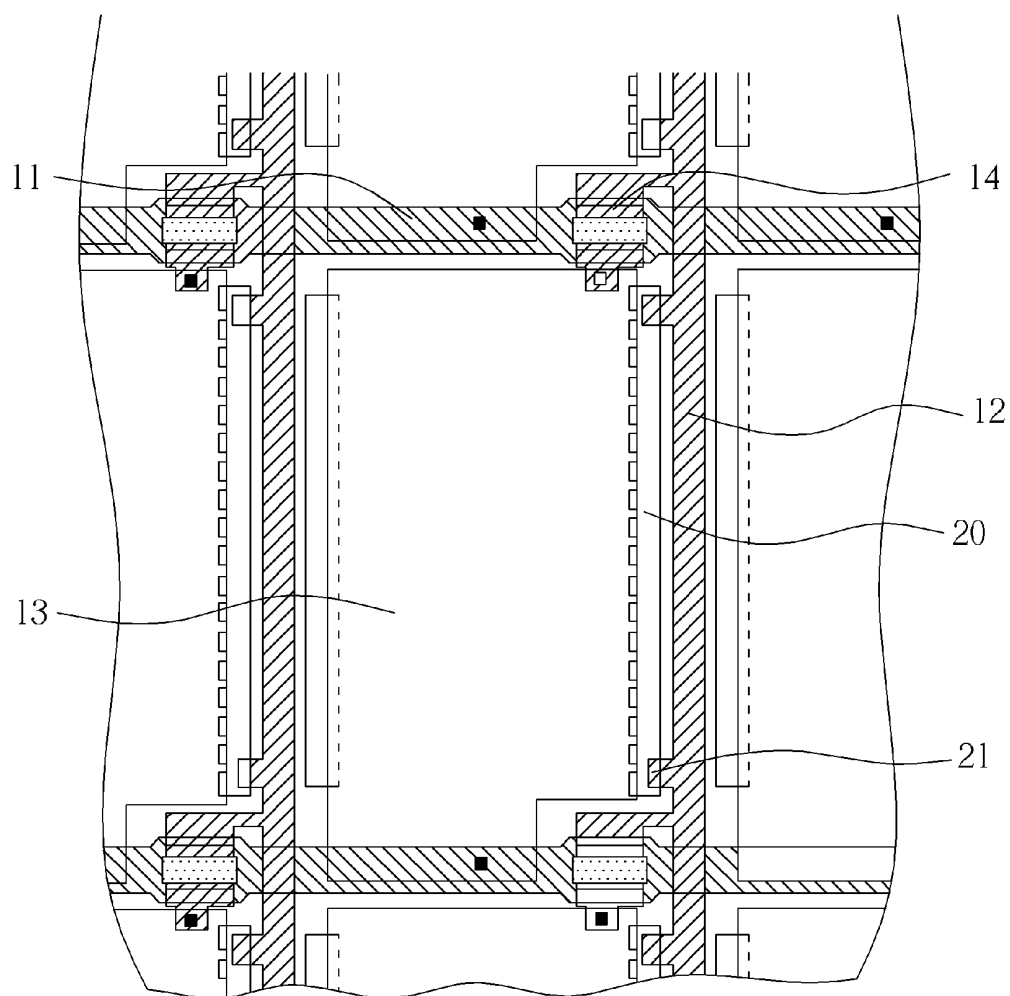
FIG. 1 PRIOR ART

FIG. 1 is a schematic diagram illustrating a repair of a data line in accordance with a conventional laser repair method. As illustrated in FIG. 1, a scan line 11 and a data line 12 are perpendicularly intersected with one another to define a pixel region, wherein the data line 12 includes a plurality of protrusions 21. A pixel electrode 13, which is made of indium tin oxide (ITO), is disposed in the pixel region, and the pixel electrode 13 is electrically connected to the scan line 11 and the data line 12 respectively through a thin film transistor 14. A shielding wire 20 is disposed between the pixel electrode 13 and the data line 12, and the shielding wire 20 is disposed parallel to the data line 12 and overlapping the protrusions 21 of the data line 12. When a line defect occurs at the data line 12, a laser repair method is performed to connect the protrusion 21 to the shielding wire 20, so that the data signals can bypass the broken data line 12, and continue the transmission via the shielding wire 20, improving the yield of the panel. Although the method above can repair the line defects, the laser repair method requires additional structure designs (e.g. the designs of the protrusions 21), which greatly increases the complexity of the pixel structure as well as the difficulty of the process of manufacturing. Furthermore, other defects may be introduced during the method described above, e.g. contami-

FIG. 1 is a schematic diagram illustrating a repair of a data line in accordance with a conventional laser repair method.

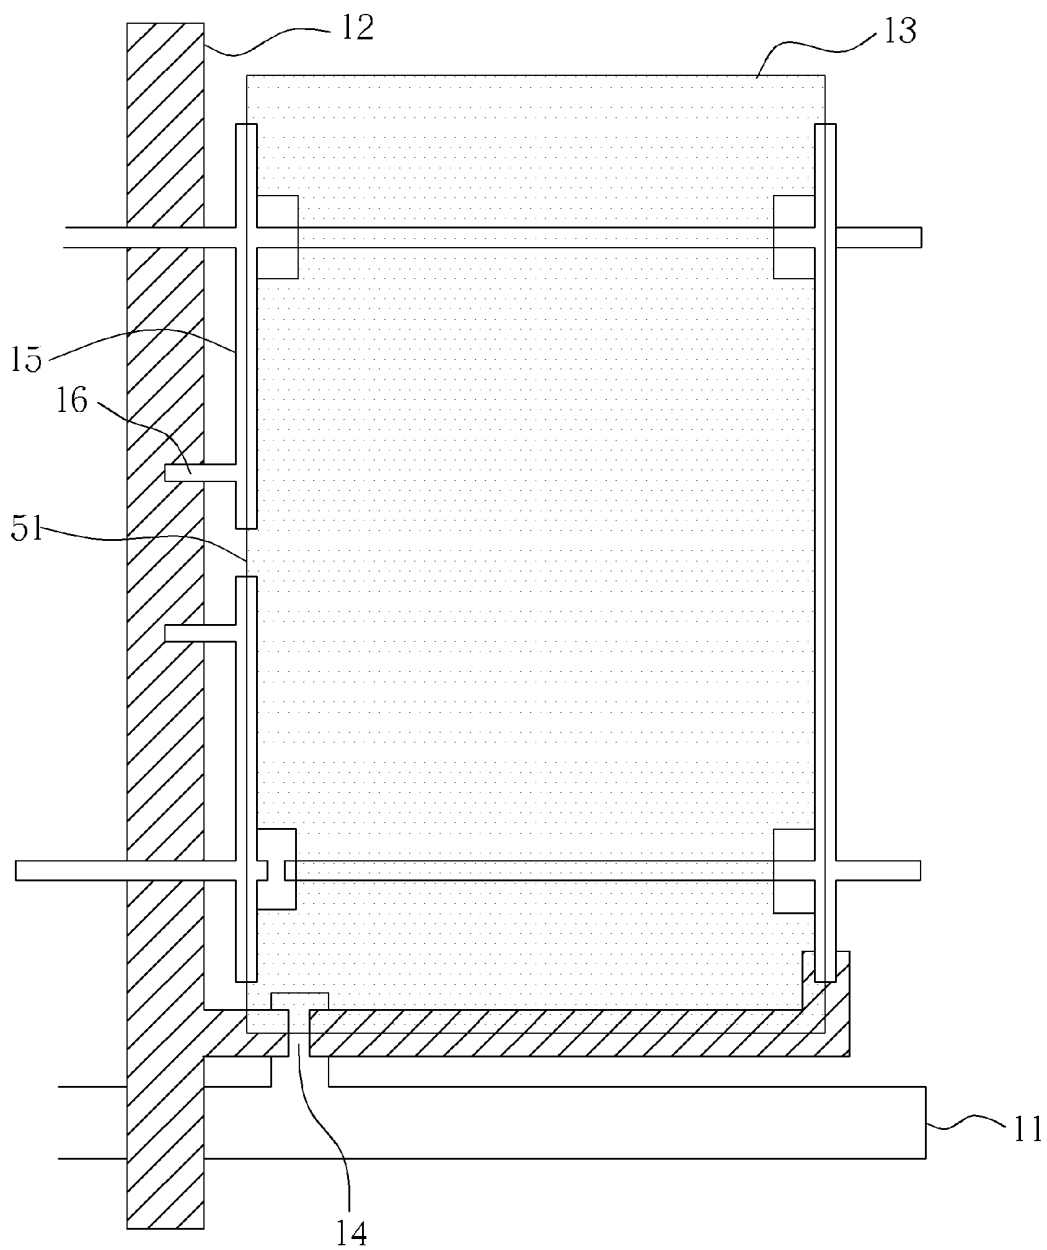
FIG. 2 PRIOR ART

FIG. 2 is a schematic diagram illustrating a repair of a data line in accordance with another conventional laser repair method. As illustrated in FIG. 2, a scan line 11 and a data line 12 are perpendicularly intersected with each other to define a pixel region. A pixel electrode 13, which is made of ITO, is disposed in the pixel region, and the pixel electrode 13 is electrically connected to the scan line 11 and the data line 12 respectively via a thin film transistor 14. A common line 15 is disposed in the peripheral region of the pixel electrode 13, and the common line 15 is disposed parallel to the scan line 11 or the data line 12, wherein a portion of the common line 15 disposed parallel to the data line 12 includes an opening part 51. The opening part 51 divides the common line 15 into two sections, and an extension part 16 of the common line 15 partially overlaps the data line 12. When a line defect occurs at the data line 12, the overlapping region between the extension part 16 and the data line 12 are connected by a laser repair method, so that the data signals can bypass the broken data line 12 and complete the transmission via the common line 15, improving the yield of the panel. Although such method is less complicated, the extension part 16 would generate a parasitic capacitance, which adversely affects the display quality.

FIG. 2 is a schematic diagram illustrating a repair of a data line in accordance with another conventional laser repair method.

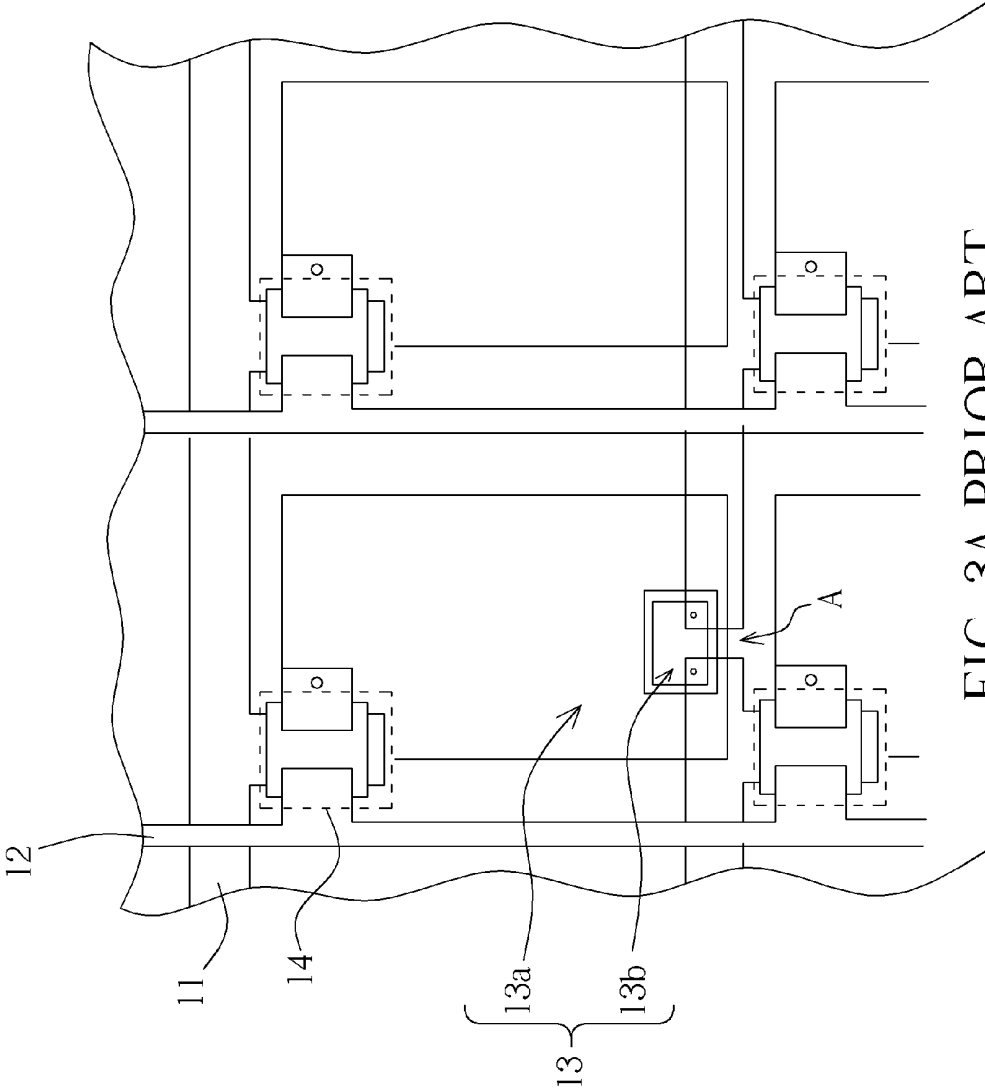
FIG. 3A PRIOR ART

FIG. 3A is a schematic diagram illustrating a repair of a scan line in accordance with another conventional laser repair method. As illustrated in FIG. 3A, a scan line 11 and a data line 12 are perpendicularly intersected to define a pixel region. A pixel electrode 13, which is made of ITO, is disposed in the pixel region, and the pixel electrode 13 is electrically connected to the scan line 11 and the data line 12 respectively via a thin film transistor 14. When a line defect A occurs at the scan line 11 between two adjacent data lines 12, the repair method includes: first, dividing the pixel electrode 13 above the line defect A into a display portion 13a and a repair portion 13b surrounded by the display portion 13a so that the display portion 13a and the repair portion 13b are electrically insulated from each other; and then electrically connecting the repair portion 13b and the two ends of the broken scan line 11 with the line defect A via a laser repair method. Although such method can repair the scan line with the line defect, the aperture ratio of the display region is reduced, and therefore the display quality is adversely affected. Furthermore, since there are two layers existing between the pixel electrode and the scan line, the level of difficulties when connecting the pixel electrode with the scan line is increased. Consequently, the success rate of the repair is reduced.

FIG. 3A is a schematic diagram illustrating a repair of a scan line in accordance with another conventional laser repair method.

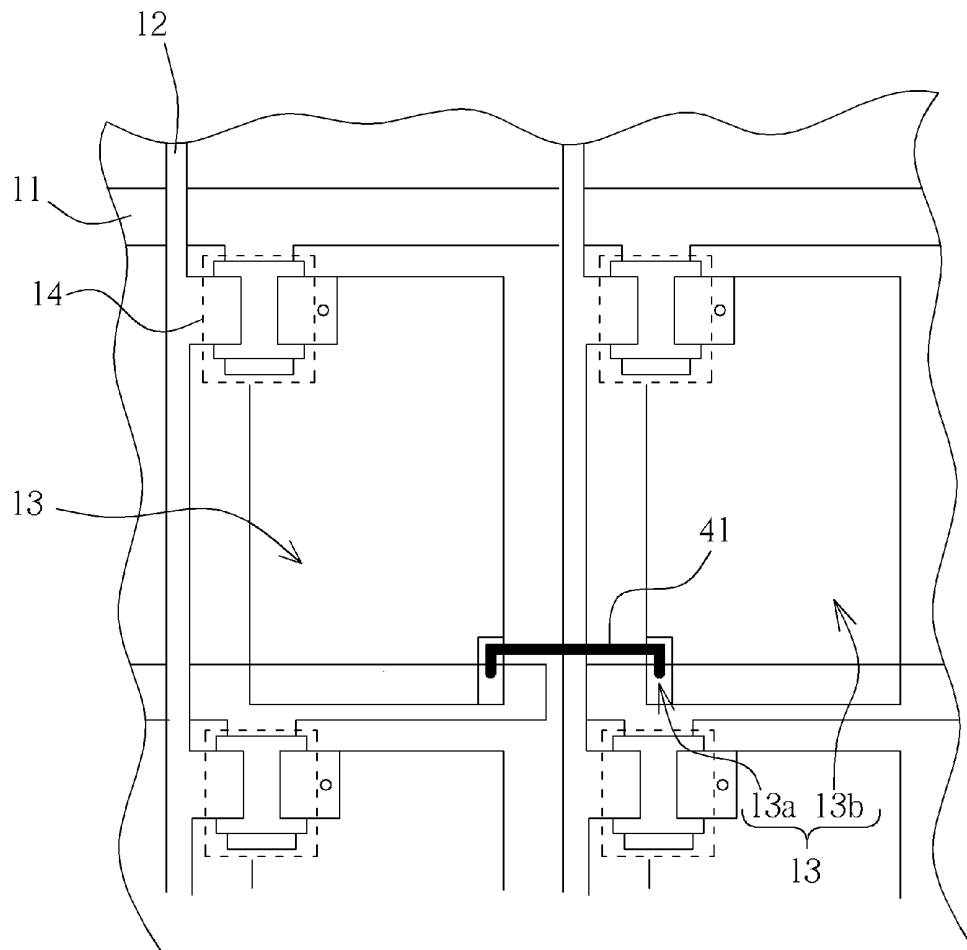
FIG. 3B PRIOR ART

FIG. 3B is a schematic diagram illustrating a repair of a scan line in accordance with another conventional laser repair method. As illustrated in FIG. 3B, a scan line 11 and a data line 12 are perpendicularly intersected to define a pixel region. A pixel electrode 13, which is made of ITO, is disposed in the pixel region, and the pixel electrode 13 is electrically connected to the scan line 11 and the data line 12 respectively via a thin film transistor 14. When a line defect occurs at the scan line 11 below the data line 12, the repair method includes: first, dividing the pixel electrodes 13 adjacent to the line defect into a display portion 13b and a repair portion 13a, which are electrically insulated with each other; and then depositing a metal film 41 on the repair portions 13a between the two adjacent pixel electrodes 13 so that two ends of the broken scan line 11 are electrically connected via the metal film 41. Although such method can repair the line defects, the procedures of the repair are more complicated.

Also, when depositing the metal film 41, the deposition could be very time consuming and the results of the deposition cannot be guaranteed. Furthermore, the pixel electrode may be contaminated during the deposition process, which adversely affects the display quality.

FIG. 3B is a schematic diagram illustrating a repair of a scan line in accordance with another conventional laser repair method.

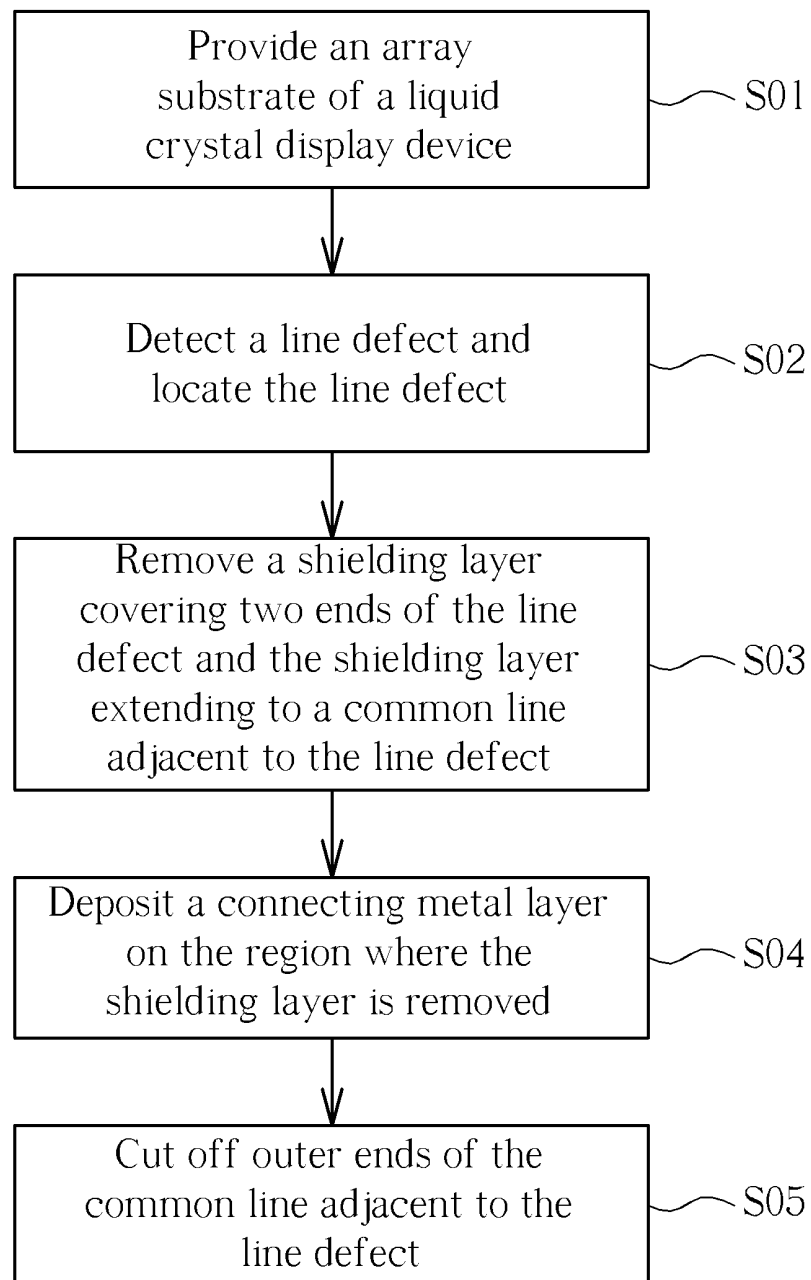
FIG. 4 is a schematic line defect repair process flow diagram in accordance with the present invention. As illustrated in FIG. 4, the repair process includes the following steps. First, provide an array substrate of a liquid crystal display device (S01); then, detect a line defect and locate the line defect (S02). The detections may be executed by AOI machine or other methods/machines, e.g. a TESTER machine could detect, for detecting any line defect of the signal transmitting wires. The signal transmitting wires described above include a data line and a scan line. Then, locate the positions of the line defects at the data line or the scan line and remove a shielding layer covering two ends of the line defect and the shielding layer extending to a common line adjacent to the line defect (S03). The shielding layer located on the two ends of the signal transmitting wire adjacent to the line defect, and the shielding layer extending horizontally from the two ends to the space (line section) of the common line is removed by a laser light beam.

Then a connecting metal layer is deposited on the regions where the shielding layer is removed (S04). A laser chemical vapor deposition (L-CVD) repairing apparatus is used using a tungsten-carbon compound as its target material to deposit the connecting metal layer on the regions where the data line and the common line are exposed in order to repair the line defect of the data line. Or, the connecting metal layer may also be formed on regions where the scan line and the common line are exposed in order to repair the line defect of the scan line. Typically, the thickness of the connecting metal layer is between 2000 Å and 4000 Å, wherein the exposed regions of the scan line or the data line and the common line are the regions where the shielding layer is removed. When the shielding layer includes only the shielding layer for metal, the connecting metal layer would be slightly larger than the exposed regions of the data line and the common line, so that the electrical connection can be further improved. When the shielding layer includes the insulation layer and the transparent electrode layer, two different methods can be employed. In method 1, the connecting metal layer is slightly smaller than the regions where the data line and common line is exposed, so that the transparent electrode layer is not electrically connected to the connecting metal layer. In method 2, in order to improve the electrical connection of the connecting metal layer, the connecting metal layer is slightly larger than the regions where the data line and the common line are exposed. The process of disconnecting the electrical connection between the connecting metal layer and the transparent electrode layer will be performed after all of the repair processes have completed. Method 2 will be discussed in more details in the following passages.

Then the repair process includes performing a cutting process to disconnect outer ends of the common line adjacent to the line defect to form a common line section (S05). The laser light beam is used to cut off the electrical connection of the common line adjacent to the outer ends of the connecting metal layer, so that the common line is by passed without being affected by the signal of the data line or the signal of the scan line. Also, the signal transmission of the data line or the scan line is completed via the common line section between the connecting metal layers. When the shielding layer mentioned above includes the insulation layer and the transparent electrode layer, method 2 is employed to form a thin channel in the pixel electrode around the common line after the common line disposed in the external ends of the shielding layer is cut off, so that the pixel electrode is not electrically connected to the common line between the connecting metal layers. Typically a width of the thin channel is between 2 micrometers (um) and 6 um.

FIG. 4 is a schematic line defect repair process flow diagram in accordance with the present invention.

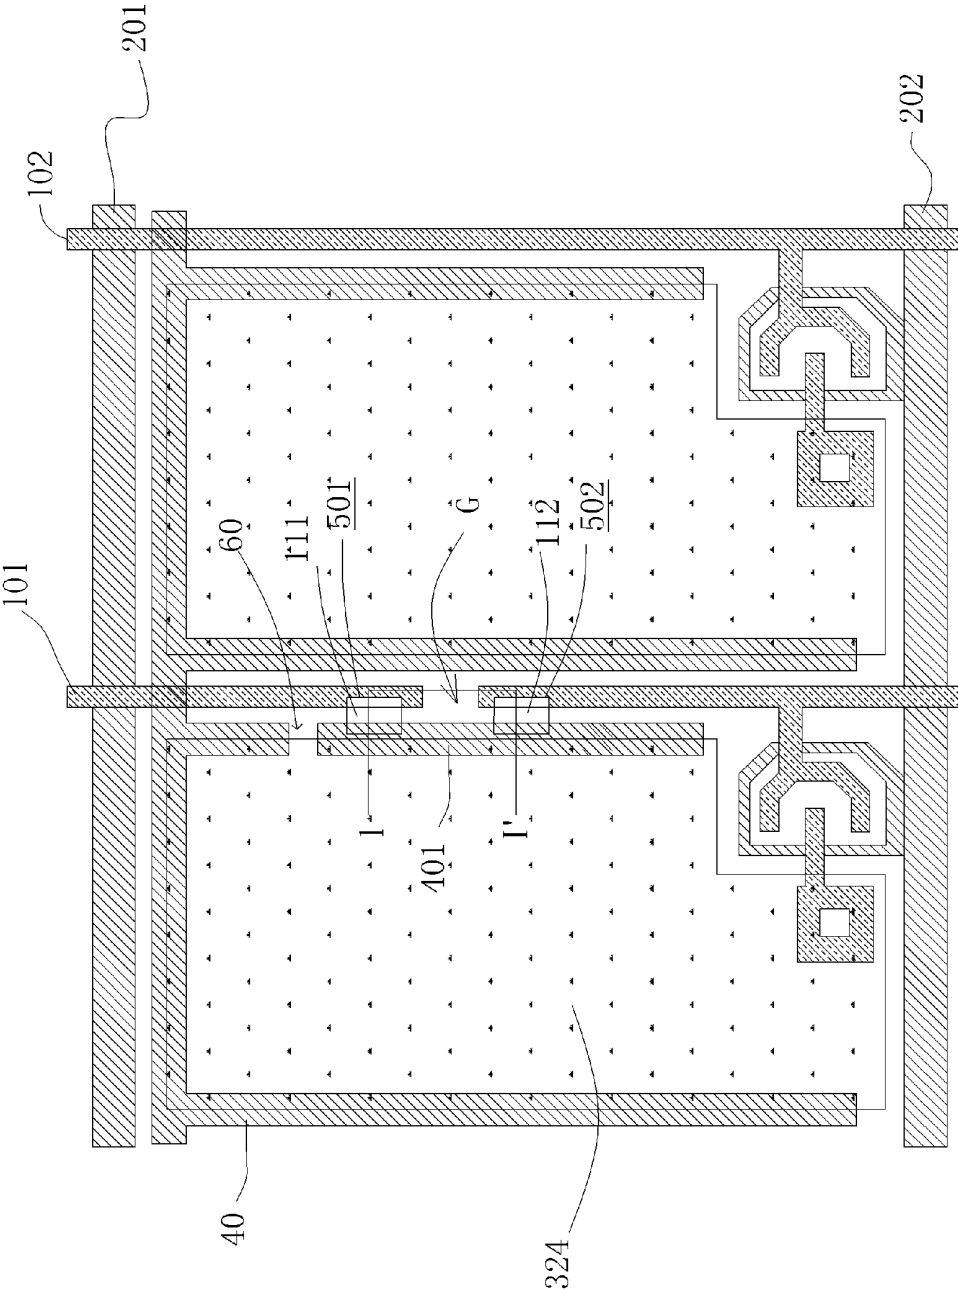
Referring to FIG. 5, FIG. 5 is a schematic diagram illustrating a line defect in a "C" shaped common line in accordance with the present invention. A first data line 101 is

disposed perpendicular to a first scan line **201**, the first data line **101** is disposed parallel to a second data line **102**, the first scan line **201** is disposed parallel to a second scan line **202**, the second scan line **202** is disposed perpendicular to the first data line **101**, the second scan line **202** is disposed perpendicular to the second data line **102**, and the second data line **102** is disposed perpendicular to the first scan line **201**. The intersected data lines and the scan lines define a plurality of pixel units, wherein a common line **40** serving as a bottom electrode of a storage capacitor is disposed on top of the data lines and the scan lines, and the common line **40** forms the storage capacitor with the pixel electrode **324** in the pixel unit. The shape of the common line **40** in the pixel unit affects the magnitude of the storage capacitor directly. In the present embodiment, the common line **40** serving as the bottom electrode of the storage capacitor has a "C" shape, wherein a "C" shaped common line section **401** is the line section of the common line **40** after the cutting process and is not electrically connected to the original common line **40**, i.e. the common line section **401** above the connecting metal layer **111** is cut off. The previously described cut off region is the opening **60**, and the "C" shaped common line section **401** is partially coupled with the pixel electrode **324** and partially contacts the connecting metal layers **111** and **112**. In addition, the connecting metal layers **111** and **112** are also partially connected to the first data line **101** having the line defect G. The connecting metal layers **111** and **112** are disposed adjacent to the two ends of the line defect G, but do not overlap the line defect G. Therefore, the repaired circuit described above allows the first data line **101** having the line defect G to complete the transmission via the common line section **401**.

FIG. 5 is a schematic diagram illustrating a line defect in a "C" shaped common line in accordance with the present invention.

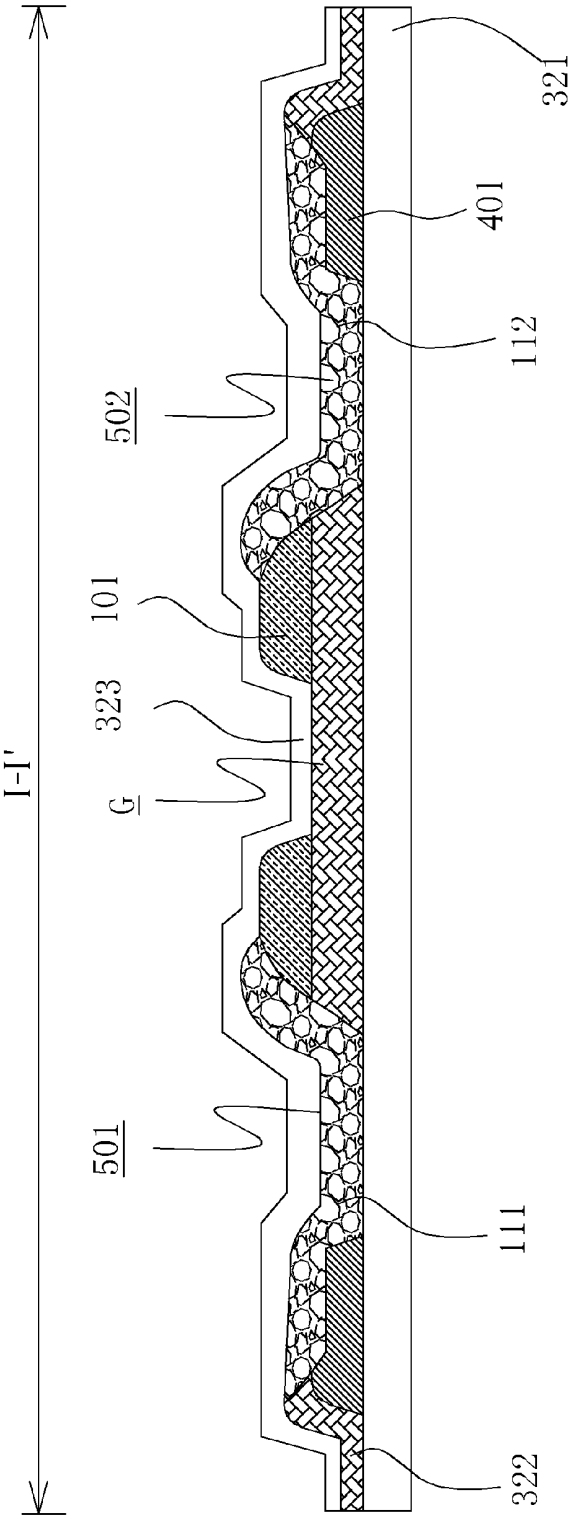
FIG. 6A is a schematic cross-sectional diagram illustrating the line section across line I-I' of FIG. 5. Referring to FIG. 5 and FIG. 6A, when the shielding layer includes only the shielding layer for metal (i.e. the third process without the deposition of the transparent electrode layer of the five processes in fabricating a TFT-LCD, and the line defect is detected and repaired), the common line section **401**, the shielding layer for metal **322** and the connecting metal layers **111** and **112** are disposed on a glass substrate **321**. A portion of the shielding layer for metal **322** previously described is disposed on a portion of the common line section **401**, and the first data line section **401** is disposed on the other portion of the shielding layer for metal **322**. During the third process without the deposition of a passivation layer **323** of the five processes in fabricating a TFT-LCD, the detection detects the line defects and proceeds to the repairing immediately. The IR with a wavelength between 1000 nm and 1500 nm or the green light with a wavelength between 450 nm and 600 nm removes the shielding layer for metal **322**, and the regions of removal are positions of connection holes **501** and **502** as illustrated in the figure (the regions of removal also includes the shielding layer described above located adjacent to the two ends of the line defect, and the space (line sections) extending horizontally from these two ends to the common line section). Also, the positions of the connection holes **501** and **502** are covered by the connecting metal layers **111** and **112**. Therefore, the laser chemical vapor deposition (L-CVD) repairing apparatus is used using a tungsten-carbon compound as its target material to deposit the connecting metal layer **111** and **112** on the regions where the first data line **101** and the common line section **401** are exposed, i.e. to deposit the connecting metal layers **111** and **112** on the connection holes **501** and **502** in order to repair the line defect G of the first data line **101**. Typically, the connecting metal layers **111** and **112** are slightly larger than the exposed regions of the first data line **101** and the common line section **401**, i.e. the con-

nection holes **501** and **502**, so that the connecting metal layers **111** and **112** cover a portion of the first data line **101** and a portion of the common line section **401**. Then the laser light beam is used to disconnect the common line section **401** located above the connecting metal layer **111**, so that the common line **40** is not affected by the signal of the first data line **101** having the line defect G, and the signal of the first data line **101** may also complete the transmission via the common line section **401** between the connecting metal layers **111** and **112** in order to complete the signal transmission. Then the following manufacturing process of the array substrate is continued to form the passivation layer **323** and the transparent electrode layer (not illustrated in the figure).

FIG. 6A and FIG. 6B are a schematic cross-sectional diagrams illustrating the line section across line I-I' of FIG. 5.

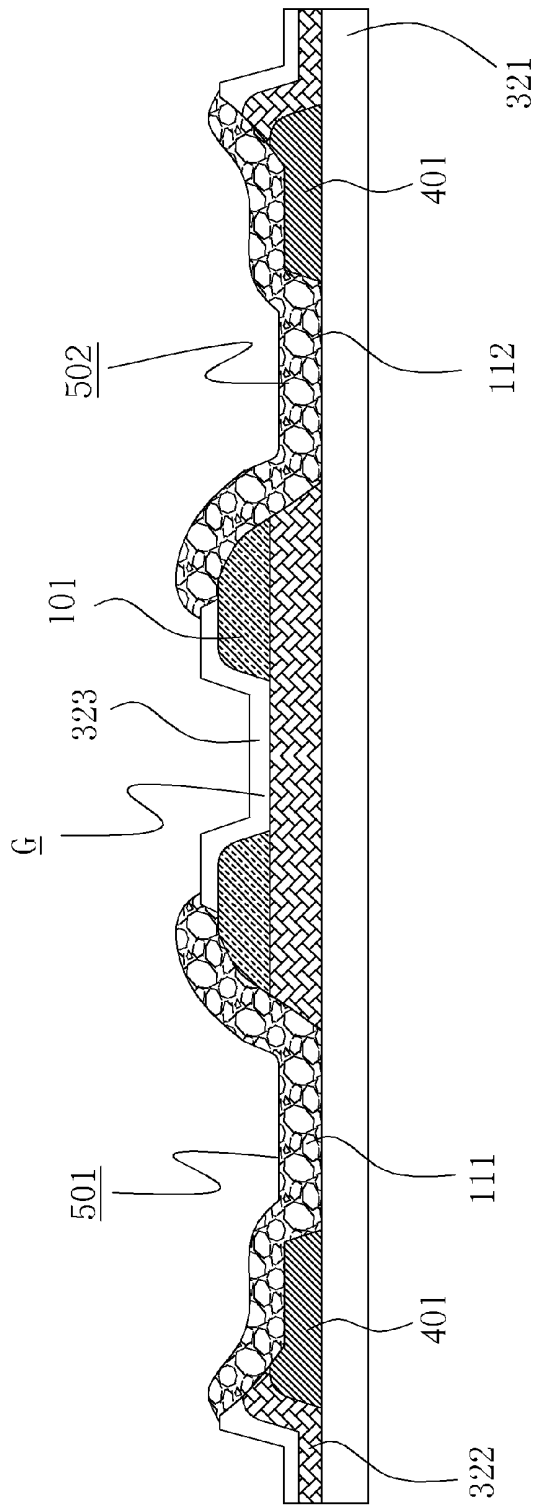
FIG. 6B

FIG. 6-B illustrates when the shielding layer includes the insulation layer and the transparent electrode layer (i.e. the five processes in fabricating a TFT-LCD are completed, and the line defect is detected and repaired). Referring to FIG. 5 and FIG. 6B, the common line section **401**, the shielding layer for metal **322** and the connecting metal layers **111** and **112** are disposed on the glass substrate **321**, and the passivation layer **323** is further disposed thereon. In addition, a portion of the shielding layer for metal **322** mentioned above is disposed on a portion of the common line section **401**, the passivation layer **323** is further covered on the metal shielding layer **322**, the first data line section **401** is disposed on another portion of the shielding layer for metal **322**, and the passivation layer **323** is further partially covered on the first data line section **401**. After completing the five processes of manufacturing the TFT, the line defect is detected and repaired. The IR with a wavelength between 1000 nm and 1500 nm or the green light with a wavelength between 450 nm and 600 nm removes the shielding layer for metal **322** and the passivation layer **323**, and the regions of removal are positions of the connection holes **501** and **502** as illustrated in the figure (the regions of removal also includes the shielding layer described above located adjacent to the two ends of the line defect, and the space (line sections) extending horizontally from the two ends to the common line section). Also, the positions of the connection holes **501** and **502** are covered by the connecting metal layers **111** and **112**. Thereafter, the laser chemical vapor deposition (L-CVD) repairing apparatus is used using a tungsten-carbon compound as its target material to deposit the connecting metal layer **111** and **112** on the regions where the first data line **101** and the common line section **401** are exposed, i.e. the connection holes **501** and **502**, to repair the line defect G of the first data line **101**. Typically, the connecting metal layers **111** and **112** are slightly larger than the exposed regions of the first data line **101** and the common line section **401**, i.e. the connection holes **501** and **502**, so that the connecting metal layers **111** and **112** cover a portion of the first data line **101** and a portion of the common line section **401**. Then the laser light beam is used to disconnect the common line section **401** located above the connecting metal layer **111**, so that the common line **40** is not affected by the signal of the first data line having the line defect G, and the signal of the first data line **101** may also complete the transmission via the common line section **401** between the connecting metal layers **111** and **112**.

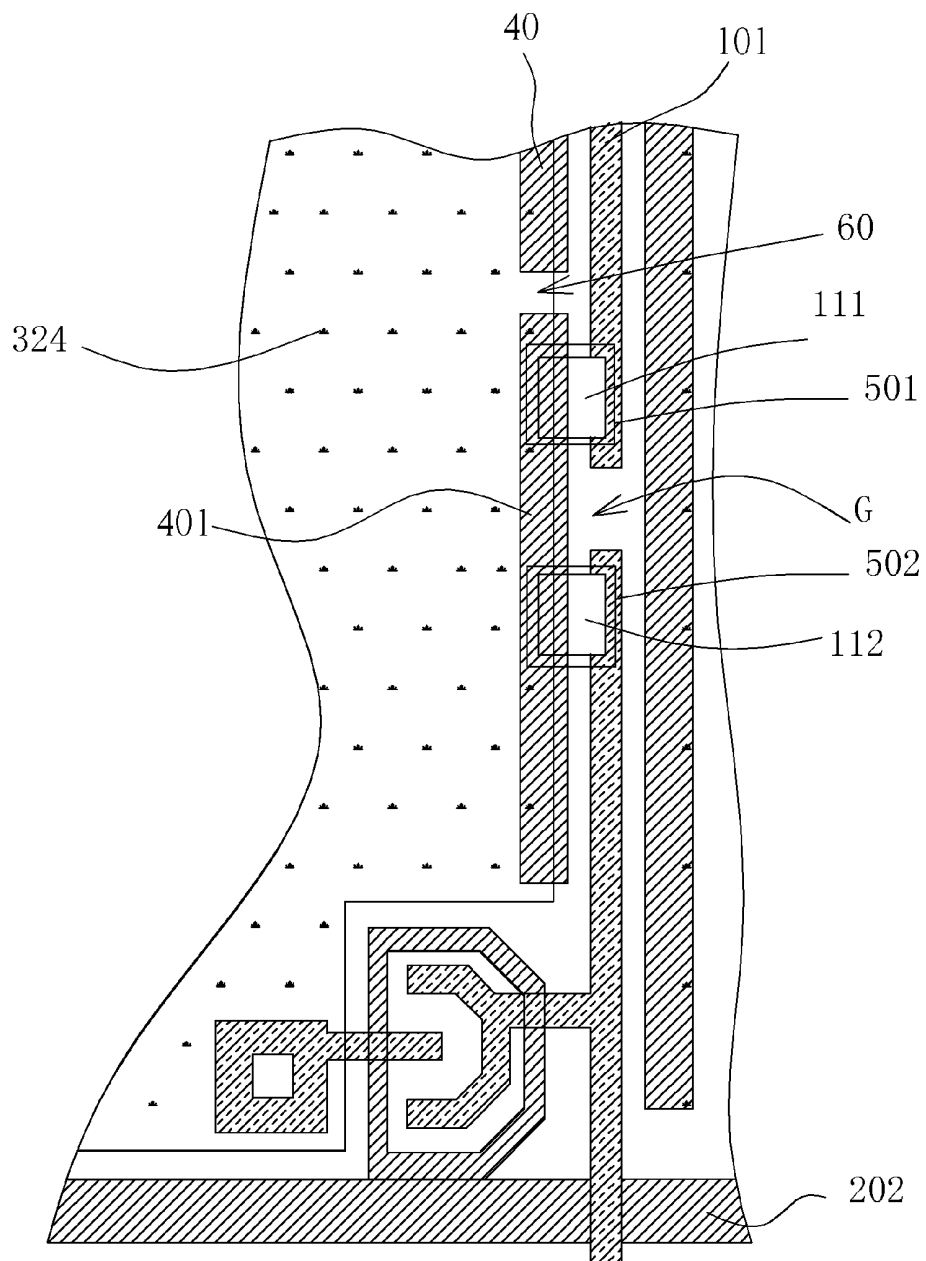
FIG. 7 is a sectional zoomed-in diagram of FIG. 5. Referring to FIG. 5 and FIG. 7, in the present embodiment, the common line **40** serving as the bottom electrode of the storage capacitor has a "C" shape, wherein the "C" shaped common line section **401** is the line section of the common line **40** after the cutting process and is not electrically connected to the original common line **40**, i.e. the common line section **401** above the connecting metal layer **111** is cut off. The previously described cut off region is the opening **60**, and the "C"

shaped common line section 401 is partially coupled with the pixel electrode 324 and partially contacts the connecting metal layers 111 and 112. The pixel electrode 324 on the overlapping region of the common line section 401 and the pixel electrode 324 electrically connected to the connecting metal layers 111 and 112 is removed, and the removed portion is slightly larger than the connecting metal layers 111 and 112, so that the first data line 101 and the pixel electrode 324 are not electrically connected. In addition, the connecting metal layers 111 and 112 are also partially overlapping the first data line 101 having the line defect G, wherein the connecting metal layers 111 and 112 are disposed adjacent to the two ends of the line defect G, but do not overlap the line defect G. Therefore, the repaired circuit described above allows the first data line 101 having the line defect G to complete the transmission via the common line section 401. However, when the shielding layer includes the insulation layer and the transparent electrode layer, method 1 is employed. When a higher energy laser light beam is used to remove the shielding layer, the laser chemical vapor deposition (L-CVD) repairing apparatus is used using a tungsten-carbon compound as its target material to deposit the connecting metal layer 111 and 112 on the regions where the first data line 101 and the common line section 401 are exposed, i.e. the connection holes 501 and 502, for repairing the line defect G of the first data line 101. Here, the connecting metal layers 111 and 112 are respectively smaller than the exposed regions of the first data line 101 and the common line section 401, i.e. the positions of the connection holes 501 and 502. Then the laser light beam is used to cut off the common line section 401 above the connecting metal layer 111 to form the opening 60. Meanwhile, the first data line 101 signal passes through the common line section 401 between the connecting metal layers 111 and 112 to complete the signal transmission.

FIG. 7 is a sectional zoomed-in diagram of FIG. 5.

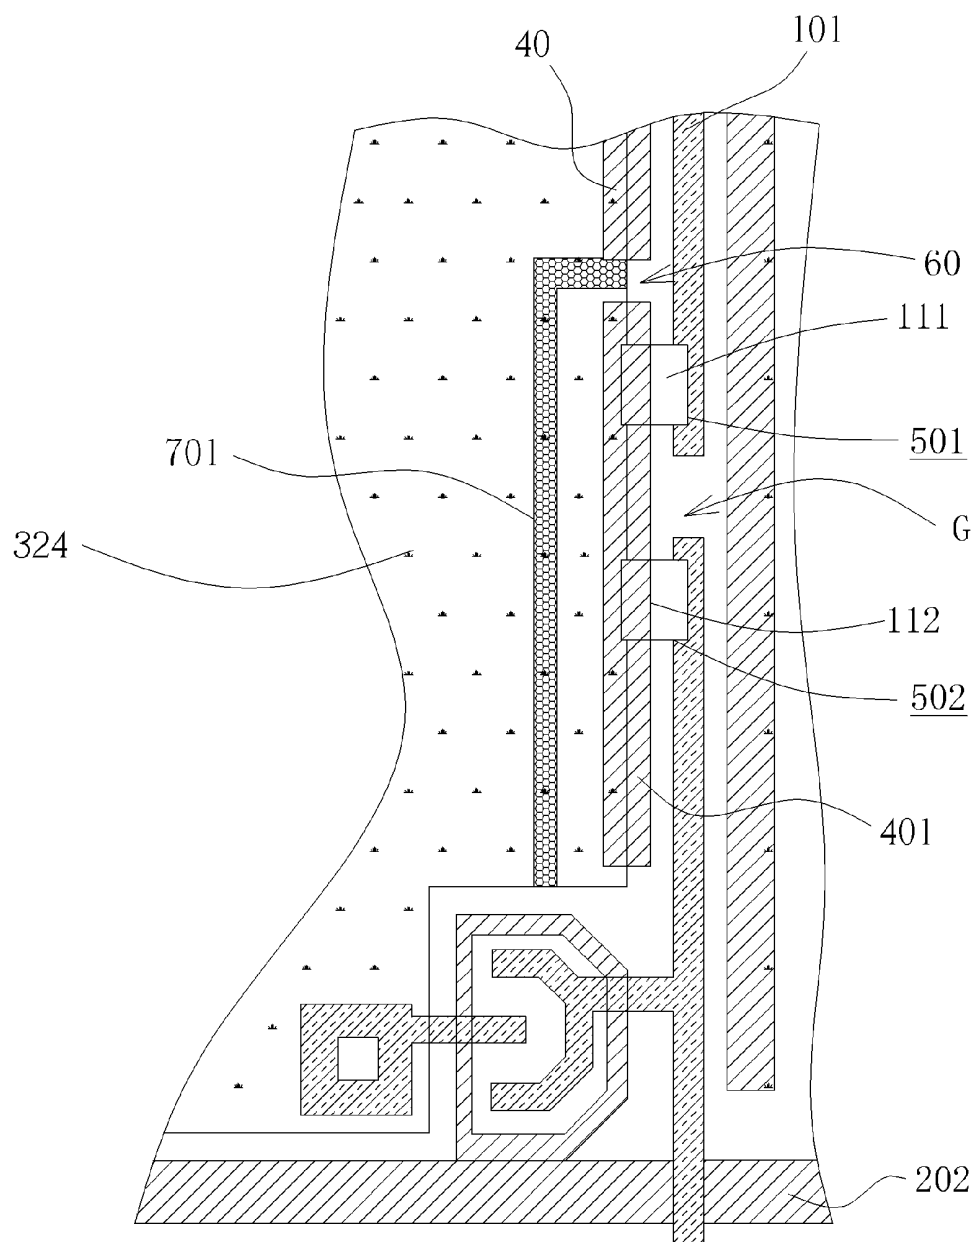
FIG. 8 is another sectional zoomed-in diagram of FIG. 5. Referring to FIG. 5 and FIG. 8, when the shielding layer includes the shielding layer for metal, the passivation layer and the pixel electrode, method 2 is employed. First the shielding layer for metal, the passivation layer and the pixel electrode are removed as mentioned above, to form the connection holes 501 and 502; then the laser chemical vapor deposition (L-CVD) repairing apparatus is used using a tungsten-carbon compound as its target material to deposit the connecting metal layer 111 and 112 on the regions where the first data line 101 and the common line section 401 are exposed, i.e. the connection holes 501 and 502, to repair the line defect G of the first data line 101. Typically, the connecting metal layers 111 and 112 are slightly larger than the exposed regions of the first data line 101 and the common line section 401, i.e. the connection holes 501 and 502, so that the connecting metal layers 111 and 112 cover a portion of the first data line 101 and a portion of the common line section 401. Then the laser light beam is used to disconnect the common line section 401 located above the connecting metal layer 111, to form the opening 60. Finally, a thin channel 701 is formed in the pixel electrode 324 around the common line section 401 by the laser light beam, so that the common line section 401 between the connecting metal layers 111 and 112 is not electrically connected to the pixel electrode 324. Meanwhile, the signal of the first data line 101 passes through the common line section 401 between the connecting metal layers 111 and 112 to complete the signal transmission.

FIG. 8 is another sectional zoomed-in diagram of FIG. 5.

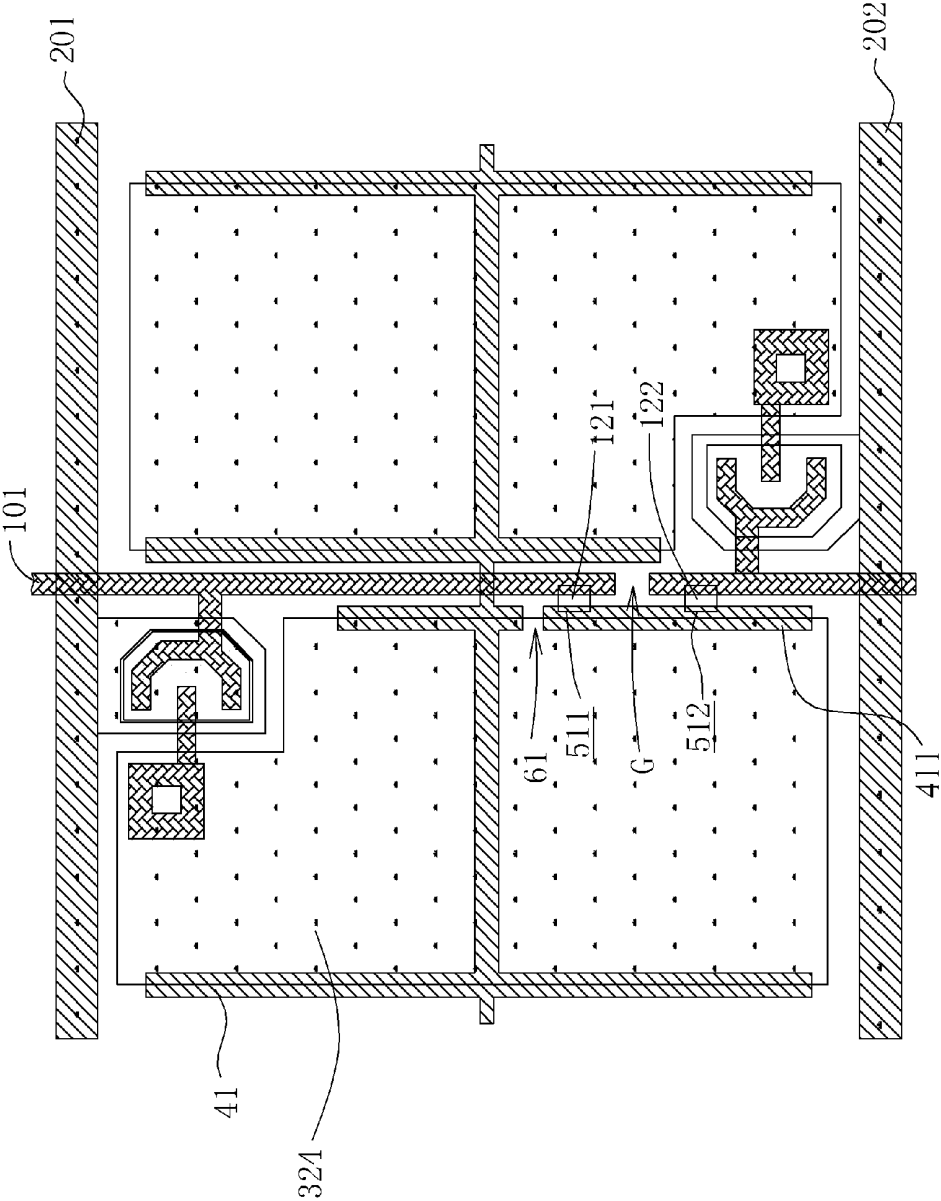
FIG. 9 is a schematic diagram illustrating a line defect in an "H" shaped common line in accordance with the present invention. In the present embodiment, the common line serving as the bottom electrode of the storage capacitor, has an "H" shape. A first data line 101 and a first scan line 201 are disposed perpendicularly, the first scan line 201 is disposed parallel to a second scan line 202, and the second scan line 202 is disposed perpendicular to the first data line 101. The intersected data lines and the scan lines define a plurality of pixel units, wherein a common line 41 serving as a bottom electrode of the storage capacitor is disposed on top of the data lines and the scan lines, and the common line 41 forms the storage capacitor with the pixel electrode 324 in the pixel unit. The shape of the common line 41 on the pixel unit affects the magnitude of the storage capacitor directly. In the present embodiment, the common line 41 serving as the bottom electrode of the storage capacitor has an "H" shape, wherein an "H" shaped common line section 411 is the line section of the common line 41 after the cutting process and is not electrically connected to the original common line 41, i.e. the common line section 411 above the connecting metal layer 121 is cut off. The previously described cut off region is an opening 61, and the "H" shaped common line section 411 is partially coupled with the pixel electrode 324 and partially contacts connecting metal layers 121 and 122. In addition, the connecting metal layers 121 and 122 are also partially connected with the first data line 101 having the line defect G. The connecting metal layers 121 and 122 are disposed adjacent to the two ends of the line defect G, but do not overlap with the line defect G. Therefore, the repaired circuit described above allows the first data line 101 having the line defect G to complete the transmission via the common line section 411.

FIG. 9 is a schematic diagram illustrating a line defect in an "H" shaped common line in accordance with the present invention.

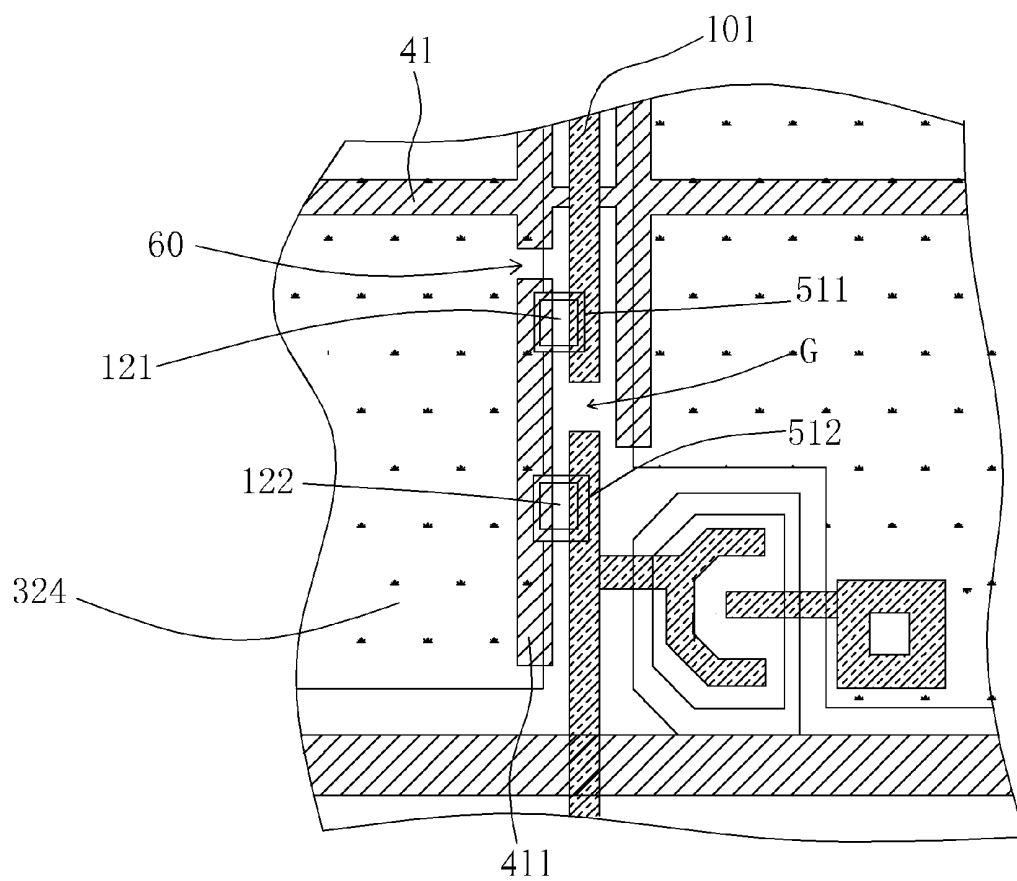
When the shielding layer includes a shielding layer for metal, or a combination of a shielding layer for metal, a passivation and a pixel electrode, a higher energy laser light beam is used to remove the shielding layer for metal, the passivation layer and the pixel electrode. Then the laser chemical vapor deposition (L-CVD) repairing apparatus is used using a tungsten-carbon compound as its target material to deposit the connecting metal layers 121 and 122 on the regions where the first data line 101 and the common line section 411 are exposed, i.e. the connection holes 511 and 512, to repair the line defect G of the first data line 101. Typically, the thickness of the connecting metal layers 121 and 122 is between 2000 Å and 4000 Å, and here the connecting metal layers 121 and 122 are respectively larger than the exposed regions of the first data line 101 and the common line section 411, i.e. the connection holes 511 and 512. Then the laser light beam is used to cut off the common line section 411 above the connecting metal layer 121 to form the opening 61. Meanwhile, the signal of the first data line 101 passes through the common line section 411 between the connecting metal layers 121 and 122 to complete the signal transmission. The laser light beam mentioned above can be IR (far-infrared light), UV (far-ultraviolet light), Green light (Green), or laser light beam and is used for removing the shielding layer above. Typically, the wavelength of the IR is between 1000 nm and 1500 nm, the wavelength of the green light is between 450 nm and 600 nm, and through adjusting the energy of the light beams, the objective of removing the shielding layer can be achieved.

When the shielding layer includes only the shielding layer for metal, the connecting metal layer is slightly larger than the exposed region of the data line and the common line, so that the electrical connection can be improved. When the shielding layer mentioned above includes the insulation layer and the transparent electrode layer, two different methods can be

applied. In method 1, the connecting metal layer is slightly smaller than the exposed regions of the data line and common line, so that the transparent electrode layer is not electrically connected to the connecting metal layer, as illustrated in FIG. 10 where FIG. 10 is a schematic sectional zoomed-in diagram of FIG. 9. In the present embodiment, the common line 41 serving as the bottom electrode of the storage capacitor has an "H" shape, wherein an "H" shaped common line section 411 is the line section of the common line 41 after the cutting process and is not electrically connected to the original common line 41, i.e. the common line section 411 above the connecting metal layer 121 is cut off. The previously described cut off region is the opening 61, and the "H" shaped common line section 411 is partially coupled with the pixel electrode 324 and partially contacts the connecting metal layer 121 and 122. The pixel electrode 324 on the overlapping region of the common line section 411 and the connecting metal layers 121 and 122 is removed, and the removed portion is slightly larger than the connecting metal layers 121 and 122, so that the first data line 101 and the pixel electrode 324 are not electrically connected. In addition, the connecting metal layers 121 and 122 also partially overlap the first data line 101 having the line defect G, wherein the connecting metal layers 121 and 122 are disposed adjacent to the two ends of the line defect G, but do not overlap the line defect G. Therefore, the repaired circuit described above allows the first data line 101 having the line defect G to complete the transmission via the common line section 411. However, when the shielding layer includes the insulation layer and the transparent electrode layer, method 1 is employed. When a higher energy laser light beam is used to remove the shielding layer, the laser chemical vapor deposition (L-CVD) repairing apparatus is used using a tungsten-carbon compound as its target material to deposit the connecting metal layers 121 and 122 on the regions where the first data line 101 and the common line section 411 are exposed, i.e. the connection holes 511 and 512, for repairing the line defect G of the first data line 101. Here, the connecting metal layers 121 and 122 are respectively smaller than the exposed regions of the first data line 101 and the common line section 411, i.e. the positions of the connection holes 511 and 512. Then the laser light beam is used to cut off the common line section 411 above the connecting metal layer 121 to form the opening 60. Meanwhile, the signal of the first data line 101 passes through the common line section 411 between the connecting metal layers 121 and 122 to complete the signal transmission.

In method 2, in order to improve the electrical connection of the connecting metal layers, the connecting metal layers are slightly larger than the exposed regions of the data line and the common line. The step that disconnects the electrical connection between the connecting metal layers and the transparent electrode layer will be performed after all of the repair steps are completed. Specifically, a thin channel will be formed in the pixel electrode 324 around the common line after the common line disposed in the external ends of the shielding layer is cut off, so that the pixel electrode is not electrically connected to the common line between the connecting metal layers.

FIG. 10 is a schematic sectional zoomed-in diagram of FIG. 9.
