(10) **Patent No.:** US 8,384,837 B2  
(45) **Date of Patent:** Feb. 26, 2013

- (57) **ABSTRACT**

# ARRAY SUBSTRATE OF LIQUID CRYSTAL DISPLAY DEVICE AND REPAIR METHOD THEREOF

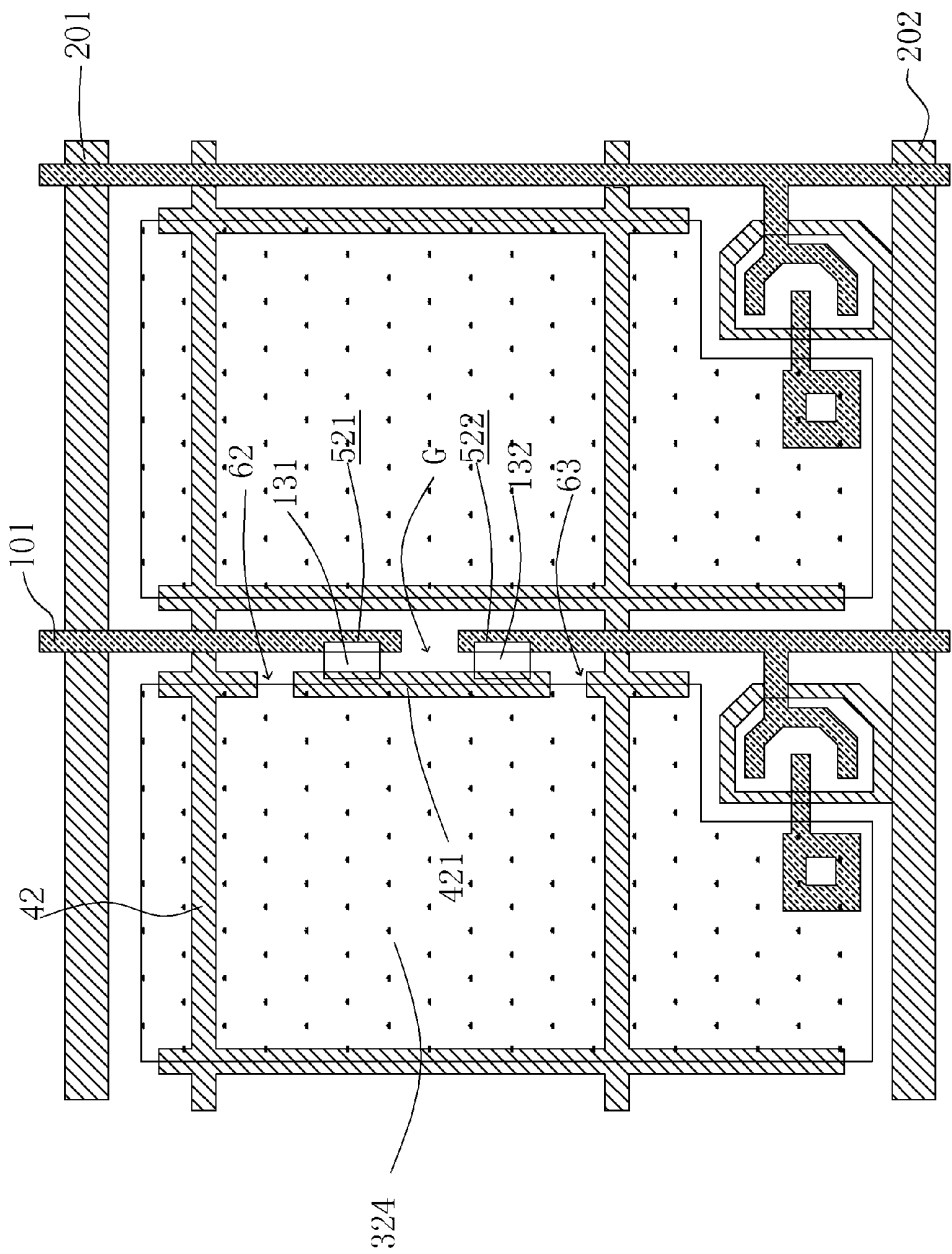
FIG. 11 is a schematic diagram illustrating a line defect in a hollow square shaped common line of the present invention. In the present embodiment, the common line 42 serving as the bottom electrode of the storage capacitor has a hollow square

shape. A first data line 101 is disposed perpendicular to a first scan line 201, the first scan line 201 is disposed parallel to a second scan line 202, and the second scan line 202 is disposed perpendicular to the first data line 101. The intersected data lines and the scan lines define a plurality of pixel units, wherein a common line 42 serving as a bottom electrode of the storage capacitor is disposed on top of the data lines and the scan lines, and the common line 42 forms the storage capacitor with the pixel electrode 324 in the pixel unit. The shape of the common line 42 on the pixel unit affects the magnitude of the storage capacitor directly.

In the present embodiment, the common line 42 serving as the bottom electrode of the storage capacitor has a hollow square shape, wherein the common line section 421 is the line section of the common line 42 after the cutting process and is not electrically connected to the original common line 42, i.e. the common line section 421 above the connecting metal layer 131 is cut. The previously described cut off region is the openings 62 and 63, and the common line section 421 is partially coupled with the pixel electrode 324 and partially contacts the connecting metal layers 131 and 132. In addition, the connecting metal layers 131 and 132 are also partially connected to the first data line 101 having the line defect G. The connecting metal layers 131 and 132 are disposed adjacent to the two ends of the line defect G, but do not overlap the line defect G. Therefore, the repaired circuit described above allows the first data line 101 having the line defect G to complete the transmission via the common line section 421.

FIG. 11 is a schematic diagram illustrating a line defect in a hollow square shaped common line of the present invention.

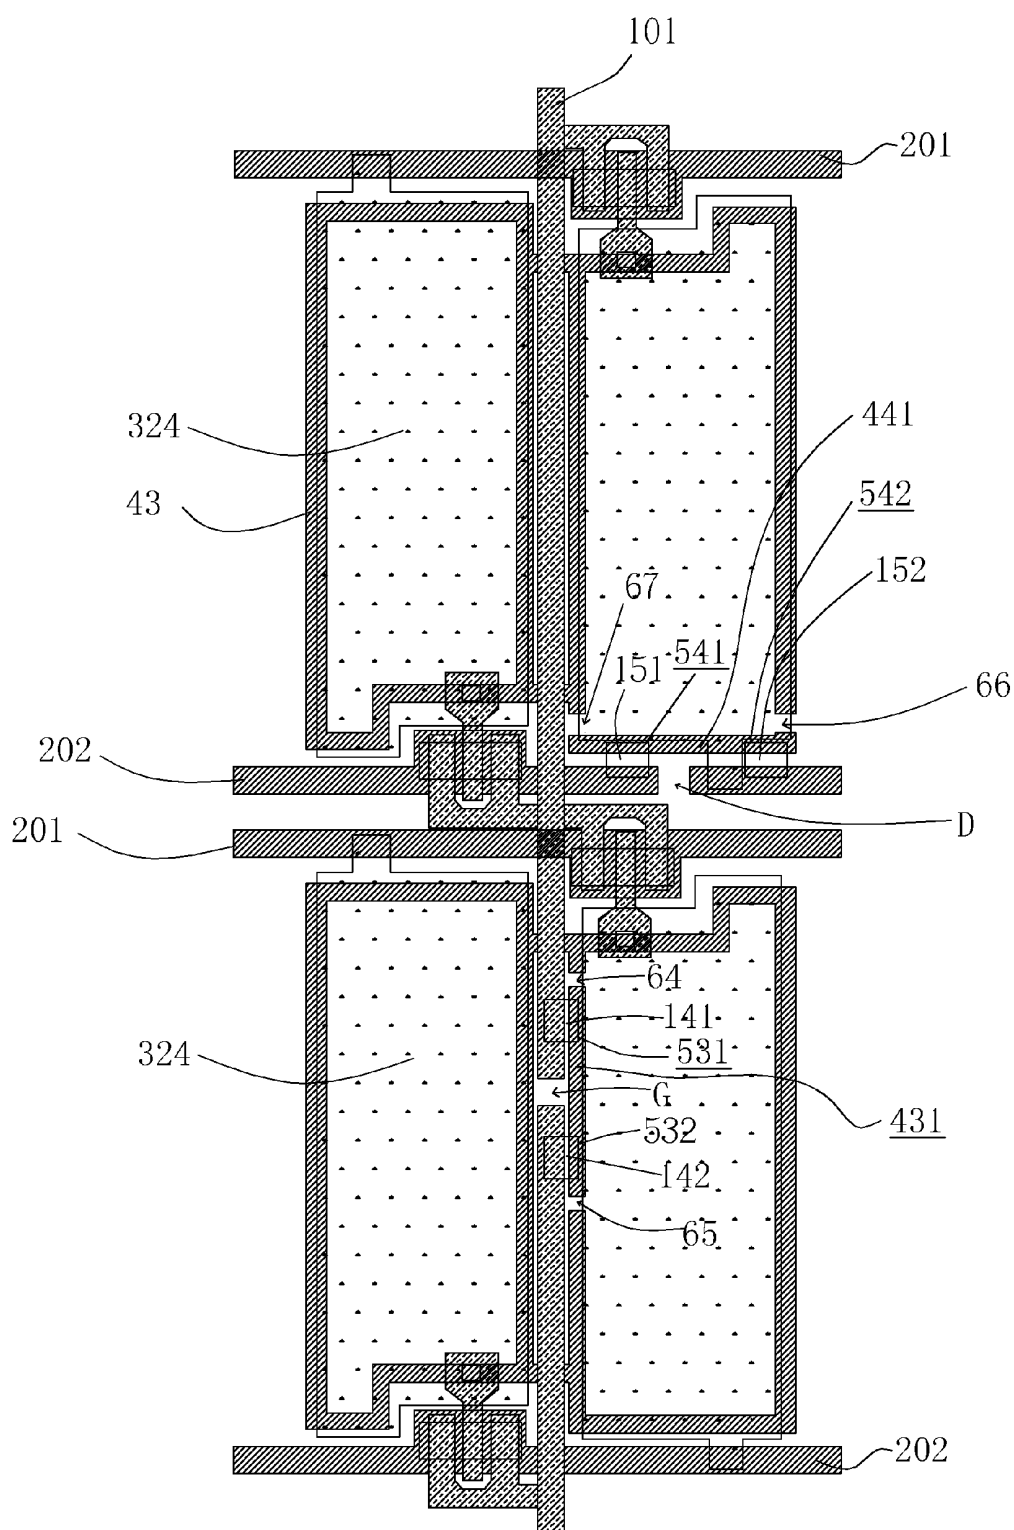
FIG. 12 is a schematic diagram illustrating a line defect in another hollow square shaped common line of the present invention. Referring to bottom portion of FIG. 12, in the present embodiment, the common line serving as the bottom electrode of the storage capacitor has a hollow square shape. A first data line 101 is disposed perpendicular to a first scan line 201, the first scan line 201 is disposed parallel to a second scan line 202, and the second scan line 202 is disposed perpendicular to the first data line 101. The intersected data lines and the scan lines define a plurality of pixel units, wherein a common line 43 serving as a bottom electrode of the storage capacitor is disposed on top of the data lines and the scan lines, and the common line 43 forms the storage capacitor with a pixel electrode 324 in the pixel unit. The shape of the common line 43 on the pixel unit affects the magnitude of the storage capacitor directly. In the present embodiment, the common line 43 serving as the bottom electrode of the storage capacitor has the hollow square shape, wherein the common line section 431 is the line section of the common line 43 after the cutting process and is not electrically connected to the original common line 43, i.e. the common line section 431 above the connecting metal layers 141 and 142 is cut. The previously described cut off region is the openings 64 and 65, and the common line section 431 is partially coupled with the pixel electrode 324 and partially contacts the connecting metal layers 141 and 142. In addition, the connecting metal layers 141 and 142 are also partially connected with the first data line 101 having the line defect G. The connecting metal layers 141 and 142 are disposed adjacent to the two ends of the line defect G, but do not overlap the line defect G. Therefore, the repaired circuit described above allows the first data line 101 having the line defect G to complete the transmission via the common line section 431.

FIG. 12 is a schematic diagram illustrating a line defect in another hollow square shaped common line of the present invention.

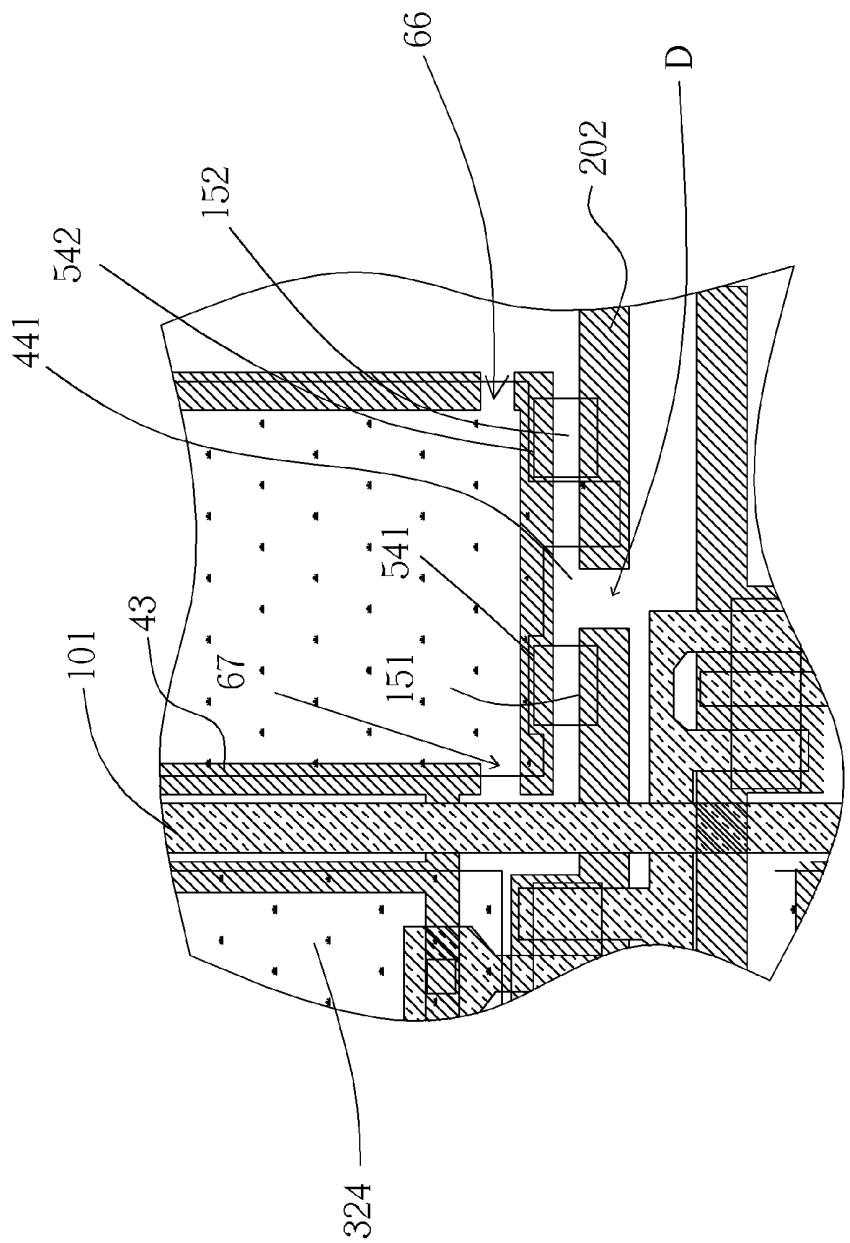
When the shielding layer includes a shielding layer for metal, or a combination of a shielding layer for metal, a passivation and a pixel electrode, a higher energy laser light beam is used to remove the shielding layer for metal, the passivation layer and the pixel electrode. Then the laser chemical vapor deposition (L-CVD) repairing apparatus is used using a tungsten-carbon compound as its target material to deposit the connecting metal layer on the regions where the first data line 101 or the second scan line 202, and the common line section are exposed, i.e. the connection holes, to repair the line defect D of the first data line 101 or the second scan line 202. Typically, the thickness of the connecting metal layers 151 and 152 is between 2000 Å to 4000 Å, and here the connecting metal layers 151 and 152 are respectively larger than the exposed region of the first data line 101 and the common line section 441, i.e. the connection holes. Then the laser light beam is used to cut off the common line section 441 above the connecting metal layers 151 and 152 to form the openings 66 and 67. Meanwhile, the signal of the first data line 101 or the signal of the second scan line 202 passes through the common line section 441 between the connecting metal layers 151 and 152 to complete the signal transmission. The laser light beam mentioned above can be IR (far-infrared light), UV (far-ultraviolet light), Green light (Green), or laser light beam and is used for removing the shielding layer above. Typically the wavelength of the IR is between 1000 nm and 1500 nm, the wavelength of the green light is between 450 nm and 600 nm, and through adjusting the energy of the light beam, the objective of removing the shielding layer can be achieved.

FIG. 13 is a sectional zoomed-in diagram of FIG. 12.
