(12) **Patent Application Publication**
Chung et al.

(10) **Pub. No.: US 2009/0167976 A1**
(43) **Pub. Date: Jul. 2, 2009**

(54) **ARRAY SUBSTRATE OF LIQUID CRYSTAL DISPLAY, METHOD OF REPAIRING SAME, AND LIQUID CRYSTAL DISPLAY**

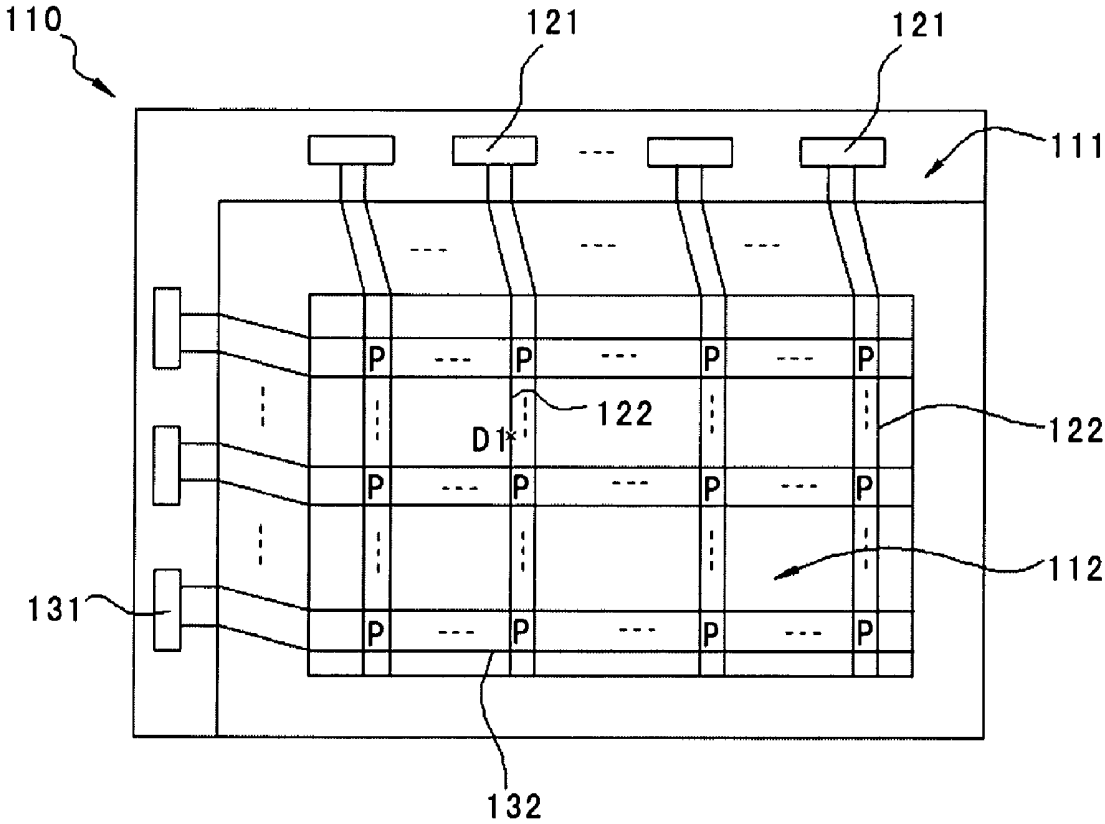
FIG. 1
(Prior Art)

[0003] FIG. 1 shows an array substrate of a conventional liquid crystal display. The LCD array substrate 110 comprises a signal introducing region 111 and a display region 112. Data line pads 121 and scanning line pads 131 are formed in the signal introducing region 111. A plurality of data lines 122 and scanning lines 132 are respectively connected to the data line pads 121 and the scanning line pads 131. A plurality of pixels P is defined in regions where the data lines and the scanning lines cross. External data signals and scanning signals are inputted via the data line pads 121 and the scanning line pads 131, and then transmitted to the respective pixels P in the display region 112 through the data lines 122 and the scanning lines 132.

[0010] FIG. 1 is a view showing an array substrate of a conventional liquid crystal display.

[0004] In a conventional process for fabricating LCD array substrates, defects such as breakage and the like may occur in the data lines. As shown in FIG. 1, the data line 122 breaks at point D1 in the display region 112. In this case, data signals cannot be transmitted to the portion of data line below the break point D1, thereby causing a line defect.

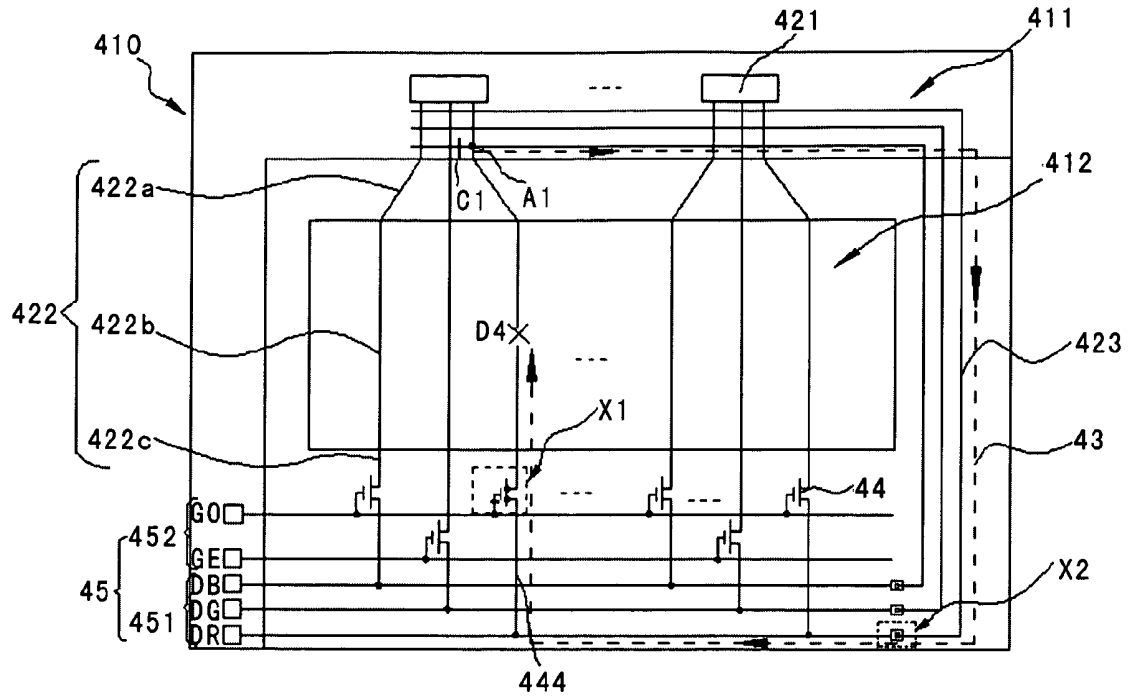
[0011] FIG. 2A is a view showing a repair line structure of an array substrate of a liquid crystal display in accordance with a first embodiment of the invention.

[0019] FIG. 2A is a plan view showing a repair line structure of an array substrate of a liquid crystal display (LCD) in accordance with a first embodiment of the invention. The LCD array substrate 410 comprises a display region 412 and a signal introducing region 411 outside the display region 412. A plurality of data line pads 421 is formed in the signal introducing region 411 and electrically connected with corresponding data lines 422 respectively. Each of the data lines 422 comprises three portions, that is, a front data line portion 422a outside the display region 412 and electrically connected with a corresponding data line pad 421, a display region data line portion 422b in the display region 412, and an end data line portion 422c outside the display region 412 and at the side away from the data line pad 421. Data signals inputted from the data line pad 421 are transmitted on the whole data line 422 in an order of the front data line portion 422a, the display region data line portion 422b and the end

[0020] A repair line 423 is positioned outside the display region 412. As shown in FIG. 2A, the repair line 423 is positioned on the upper and right sides of the display region 412, but does not fully extend to the lower side of the display region. As shown in the plan view of FIG. 2A, the repair line 423 crosses with the front data line portion 422a at a location A1 when viewed along a direction perpendicular to the surface of the array substrate 410. Along the direction perpendicular to the surface of the array substrate 410, the repair line 423 and the front data line portion 422a are positioned in different layers separated by an insulating layer therebetween. Hence the repair line 423 and the front data line portion 422a are normally not in an electrical connection. Although in the plan view of FIG. 2A, the repair line 423 and the front data line portion 422a are arranged perpendicularly, the invention is by no means limited to such a perpendicularly arranged manner. It is sufficient as long as there is a crossing point between them in the plan view.

[0021] As shown in FIG. 2A, test lines 45 are also provided outside the display region 412, and in the embodiment are positioned below the display region 412. The test lines 45 comprise test data lines 451 and test scanning lines 452. The test data lines 451 for transmitting test data signals comprise three test data lines DB, DG and DR for transmitting test data signals with respect to blue (B), green (G) and red (R) respectively. The test scanning lines 452 for transmitting test scanning signals comprise two test scanning lines GO and GE for transmitting test scanning signals with respect to the odd and even columns respectively. The test lines 45 transmit test signals to the data lines 422 via TFTs 44.

[0022] In the embodiment shown in FIG. 2A, the test lines 45 and the TFTs 44 are connected in the following manner. Gate electrodes of TFTs 44 in the odd and even columns counted from the left are respectively connected to the GO and GE lines of the test scanning lines 452, and source electrodes of TFTs 44 in the $3n-2$, $3n-1$ and $3n$ ($n=1, 2, 3 \dots$) columns counted from the left are respectively connected to the DB, DG and DR lines of the test data lines 451. It is noted that the connecting technique of FIG. 2A is merely an example, and it is possible to have other techniques, for example, providing only one test scanning line, or providing more test data lines, etc. In an embodiment, the test lines 45 and the repair line 423 may be arranged partly or entirely in a perimeter seal region so as to reduce the non-display area in the liquid crystal display panel. Here, the perimeter seal region is such a region in the array substrate that will be adhered to a color filter substrate so as to form a liquid crystal display.

[0025] With reference to FIGS. 4A-4C, a method for repairing a defective data line of the array substrate 410 of the liquid crystal display in accordance with the first embodiment of the invention will be described as follows. For example, in case of a break defect occurring at a point D4 of the defective data line 422 as shown in FIG. 2A, the method may comprise:

[0029] With the above repairing technique, data signals on the defective data line 422 can be transmitted, along a path shown by the dashed line 43 of FIG. 2A, to the portion of this data line 422 below the break point D4. The specific transmitting path is: from the front data line portion 422a to the repair line 423 via the crossing point A1, then to the test data line 451 (in particular, the DR line) via the crossing point A4, then to the source electrode 442 of the TFT 44 via the test data line branch 444 connected with the test data line 451, then to the gate electrode 443 via the overlapping region A2, then to the drain electrode 441 via the overlapping region A3 and to the end data line portion 422c connected with the drain electrode 441 via the drain electrode 441, and finally to the portion of the display region data line portion 442b below the break point D4.

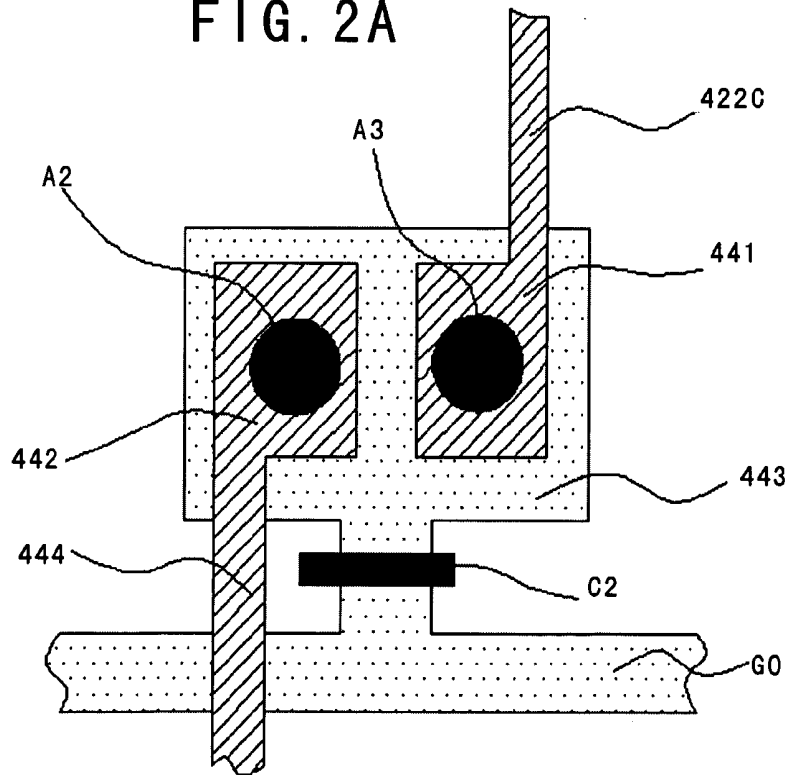
[0012] FIG. 2B is a detailed view of TFT in the region X1 of FIG. 2A.

[0023] FIG. 2B shows a detailed view showing the TFT 44 in the region X1 of FIG. 2A. The TFT 44 has a source electrode 442, a drain electrode 441 and a gate electrode 443. The source electrode 442 is connected to a test data line branch 444, the drain electrode 441 is connected to the end data line portion 422c of corresponding data line 422, and the gate electrode 443 is connected to one of the test scanning lines 452 (in particular, to the GO line of the test scanning lines 452 in FIG. 2A). The test data line branch 444 is connected to one of the test data lines 451 (in particular, to the DR line of the test data lines 451 in FIG. 2A).

[0028] (3) Processing the TFT 44 to electrically connect the source electrodes 442 and the drain electrodes 441 and cut off the electrical connection between the gate line 443 and the test scanning line 452. For example, for the TFT 44 in the region X1 of FIG. 2A, as shown in FIG. 2B, the source electrode 442 and the drain electrode 441 are electrically connected with the gate electrode 443 at the respective crossing points A2 and A3 by laser melting, and the electrical connection between the gate electrode 443 and the test scanning line 452 is cut off at the point C2 by, for example, laser. Thus the gate electrode 443 becomes an isolated island structure and is no longer electrically connected with the test scanning line 452. As a result, data signals transmitted from the test data line branch 444 to the gate electrode 443 (repaired data signal) will not be transmitted to the test scanning line 452 to affect normal operation of the display.

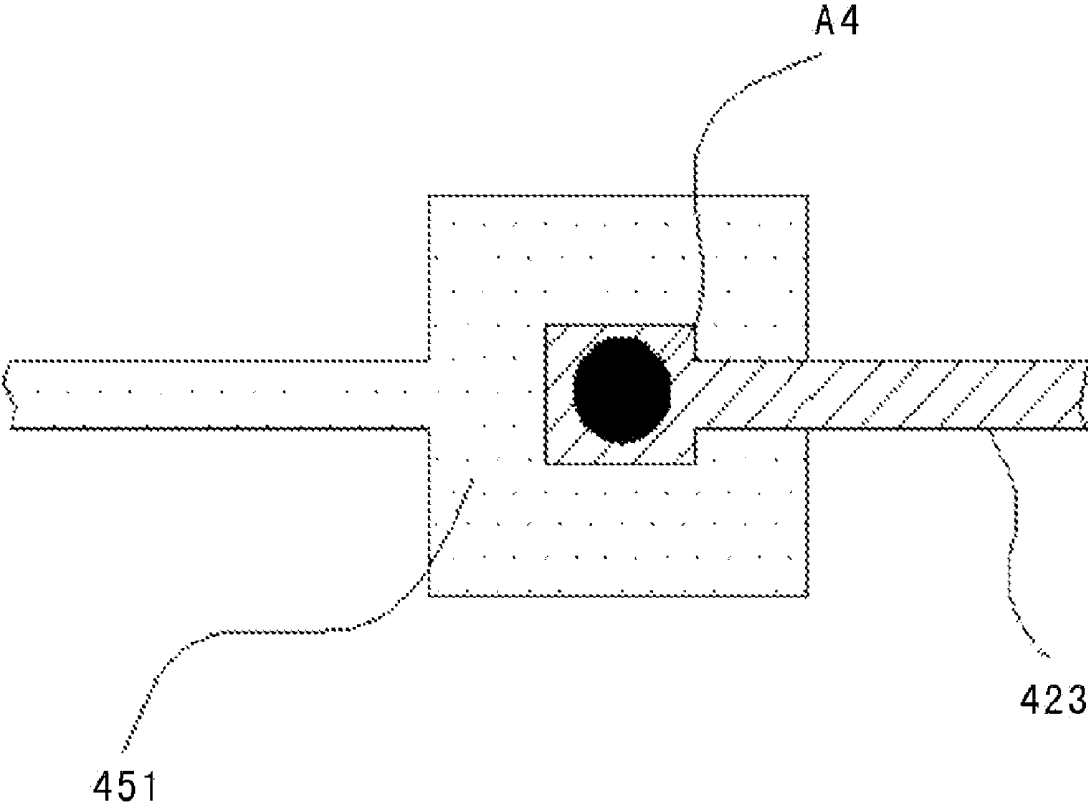
FIG. 20

[0013] FIG. 2C is a detailed view of the region X2 of FIG. 2A.

[0024] FIG. 2C is a detailed view showing the test data line 451 and the repair line 423 in the region X2 of FIG. 2A. When

viewed along a direction perpendicular to the surface of the array substrate, as shown in FIG. 2C, the test data line 451 (in particular, the DR line of the test data lines 451 in FIG. 2A) at least partly overlaps with an end of the repair line 423; that is, an overlapping region exists between them. However, in the direction perpendicular to the surface of the array substrate, the test data line 451 and the repair line 423 are positioned in different layers which are separated by an insulating layer therebetween. Therefore, the test data line 451 and the repair line 423 are in an insulated state when repair is not carried out.

[0027] (2) Electrically connecting the test data line 451 with the repair line 423. For example, an end of the test data line 451 (in particular, the DR line of the test data line 451 in FIG. 2A) may be electrically connected with an end of the repair line 423 at the crossing point A4 by laser melting, as shown in FIG. 2C.

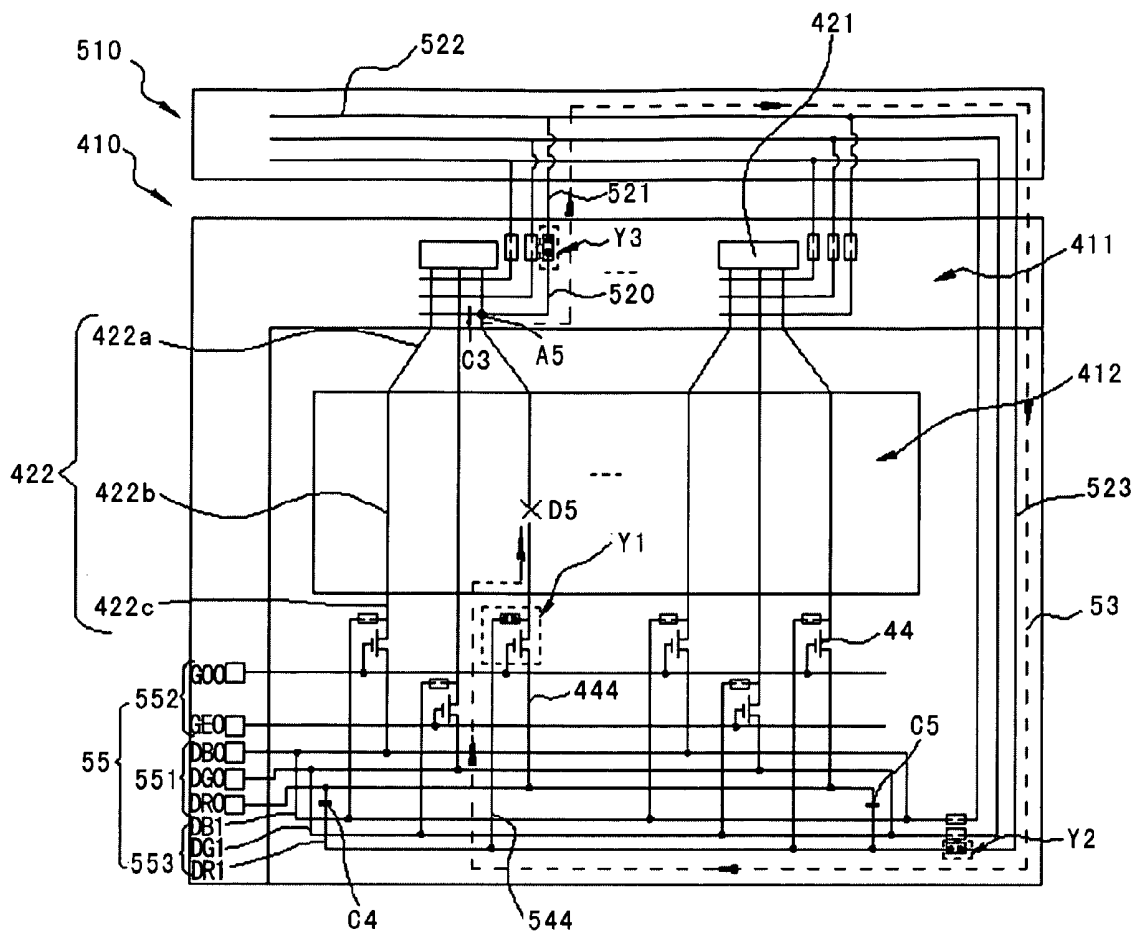
[0014] FIG. 3A is a view showing a repair line structure of an array substrate of a liquid crystal display in accordance with a second embodiment of the invention.

[0034] FIG. 3A is a plan view showing a repair line structure of an array substrate of liquid crystal display in accordance with a second embodiment of the invention. Similar to FIG. 2A, the array substrate 410 of the liquid crystal display comprises a display region 412 and a signal introducing region 411 outside the display region 412. A plurality of data line pads 421 are formed in the signal introducing region 411 and electrically connected with the data lines 422. Each data line 422 comprises three portions, that is, a front data line portion 422a outside the display region 412 and connected with a corresponding data line pad 421, a display region data line portion 422b, and an end data line portion 422c outside the display region 412 and at the side away from the data line pad 421. Data signals inputted from the data line pad 421 are transmitted on the whole data line 422 in an order of the front data line portion 422a, the display region data line portion 422b and the end data line portion 422c. For the sake of clarity, scanning lines crossing with the data lines 422, and scanning line pads are not shown in FIG. 3A.

[0035] The repair line comprises a data connection line 520, a connection element 547 (see FIG. 3D), a repair connection line 521, a common repair line 522 on a printed circuit board (PCB) 510, and a data repair line 523 outside the display region 412. The data repair line 523 extends at the right side of the display region 412 and does not fully extend to the lower side of the display region 412. In order to facilitate the description, the connecting technique between the common repair line 522 on the PCB 510 and the data repair line 523 on the array substrate 410 will not be described in detail. However, it is apparent to those skilled in the art that

[0036] As shown in FIG. 3A, test lines 55 are provided outside the display region 412, and comprise test data lines 551, test scanning lines 552 and auxiliary test data lines 553. The test data lines 551 are used to transmit test data signals and include three test data lines DB₀, DG₀ and DR₀. The test scanning lines 552 are used to transmit test scanning signals and include two test scanning lines GO₀ and GE₀. The auxiliary test data lines 553 include three lines DB₁, DG₁ and DR₁. As shown in FIG. 3A, the two ends of the test data line DB₀ and the two ends of the auxiliary test data line DB₁ are connected respectively. Similarly, the two ends of the test data line DG₀ and the two ends of the auxiliary test data line DG₁, and the two ends of the test data line DR₀ and the two ends of the auxiliary test data line DR₁, are also connected respectively. That is, the auxiliary test data lines DB₁, DG₁ and DR₁ are in parallel with the corresponding test data lines DB₀, DG₀ and DR₀ respectively. Data test signals are transmitted to the data lines 422 via the TFTs 44 from the test lines 55.

[0037] As shown in FIG. 3A, in order to carry out tests more effectively, the test lines 55 and the TFTs 44 are connected such that the gate electrodes of the TFTs in the odd and even columns counted from the left are respectively connected to the GO₀ and GE₀ lines of the test scanning lines 552, and the source electrodes of TFTs in the 3n-2, 3n-1 and 3n (n=1, 2, 3, ...) columns counted from the left are respectively connected to the DB₀, DG₀ and DR₀ lines of the test data lines 551. It is noted that that the connecting technique in FIG. 3A is merely an example, and it is possible to use other techniques, for example, providing only one test scanning line, or providing more test data lines, etc. In an embodiment, the test lines 55 and the data repair line 523 may be arranged partly or entirely in a perimeter seal region so as to reduce the non-display area in the liquid crystal display panel.

[0041] With reference to FIGS. 5A-5D, a method for repairing a defective data line of the array substrate 410 of the liquid crystal display in accordance with the second embodiment of the invention will be described as follows. For example, in case of a break defect occurring at a point D5 of the defective data line 422 as shown in FIG. 3A, the method may comprise:

[0046] With the above repair technique, data signals on the defective data line 422 can be transmitted, along a path shown by the dashed line 53, to the portion of this data line 422 below the break point D5. The specific transmitting path is: from the front data line portion 422a to the data connection line 520 via the crossing point A5, then to the connection element 547 via the crossing point A11, then to the repair connection line 521 via the crossing point A10, then to the data repair line 523 via the common repair line 522 on the PCB, then to the connection element 546 via the crossing point A9, then to the DR₁ line of the auxiliary test data lines 553 and to the auxiliary test data line branch 544 via the crossing point A8, and to the connection element 545 via the crossing point A6, to the end data line portion 422c via the crossing point A7, and finally to the portion of the display region data line portion 442b below the break point D5.

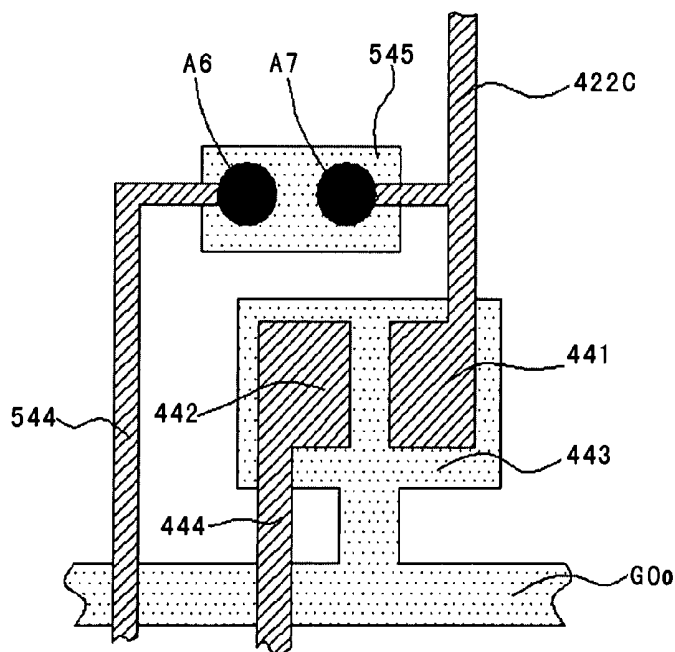
[0015] FIG. 3B is a detailed view of TFT in the region Y1 of FIG. 3A.

[0038] FIG. 3B shows a detailed view of the region Y1 of FIG. 3A, which mainly discloses a TFT 44 and a connecting element 545 made of conductor. The TFT 44 has a source electrode 442, a drain electrode 441 and a gate electrode 443. The source electrode 442 is connected to the test data line branch 444, the drain electrode 441 is connected to the end data line portion 422c of the corresponding data line 422, and the gate electrode 443 is connected to the test scanning line 552 (in particular, to the GO₀ line of the test scanning line 552 in FIG. 3A). The test data line branch 444 is connected to one of the test data lines 551 (in particular, to the DR₀ line of the test data lines 551 in FIG. 3A). In addition, when viewed along a direction perpendicular to the surface of the array substrate, an overlapping region exists at a point A6 between a auxiliary test data line branch 544 and the connecting ele-

ment 545 which are positioned in different layers in the direction and are separated by an insulating layer therebetween; an overlapping region exists at a point A7 between the end data line portion 422c and the connecting element 545 which are positioned in different layers in the direction and are separated by an insulating layer therebetween. The auxiliary test data line branch 544 is connected to one of the auxiliary test data lines 553 (in particular to the line DR₁ of the auxiliary test data lines 553). When repair is not carried out using the repair line, any two among the auxiliary test data line branch 544, the connecting element 545 and the end data line portion 422c are not electrically connected.

[0045] (4) electrically connecting the auxiliary test data line branch 544 corresponding to the defective data line 422 with the end data line portion 422c of the data line 422, and cutting off the connection between the test data auxiliary line 553 (in particular, the DR₁ line in FIG. 3A) used for repair and the corresponding test data line 551 (in particular, the DR₀ line in FIG. 3A). As shown in FIG. 3A, when the DR₁ line of the auxiliary test data lines 553 is used as a repair line, the auxiliary test data line branch 544 may be electrically connected with the connection element 545 at the crossing point A6 and the end data line portion 422c may be electrically connected with the connection element 545 at the crossing point A7, for example, by laser melting (see FIG. 3B), while the connection between the DR₁ line and the DR₀ line may be cut off at points C4 and C5, for example, by laser.

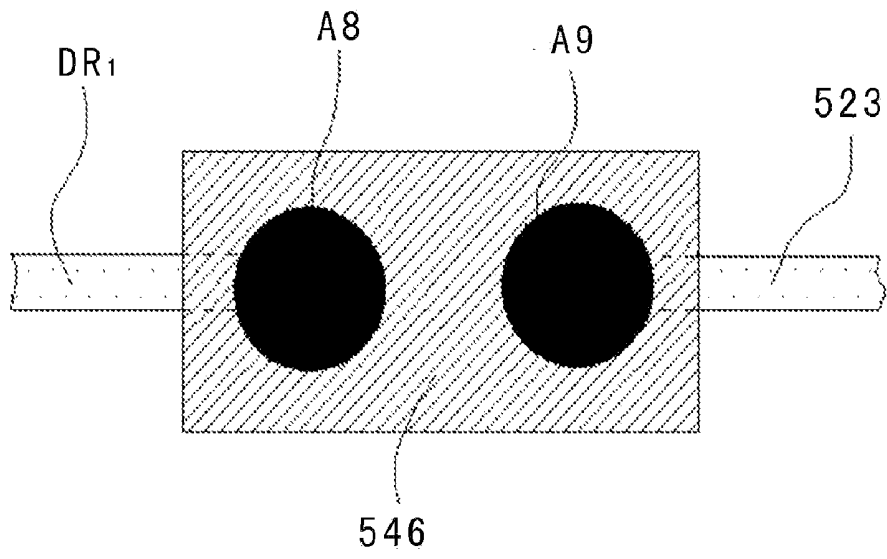
[0016] FIG. 3C is a detailed view of the region Y2 of FIG. 3A.

[0039] FIG. 3C is a detailed view showing the region Y2 of FIG. 3A. When viewed along a direction perpendicular to the surface of the array substrate 410, as shown in FIG. 3C, an overlapping region exists at a point A8 between the test data auxiliary line 553 (in particular, the DR₁ line in the test data auxiliary lines 553 in FIG. 3A) and a connecting element 546 made of conductor which are positioned in different layers in the direction and are separated by an insulating layer therebetween. Also, when viewed along a direction perpendicular to the surface of the array substrate 410, an overlapping region exists at a point A9 between the data repair line 523 and the connecting element 546 which are positioned in different layers in the direction and are separated by an insulating layer therebetween. Therefore, when repair is not carried out using the repair line, any two among the auxiliary test data line 553, the connecting element 546 and the data repair line 523 are not electrically connected.

[0044] (3) Electrically connecting the test data line 551 with the data repair line 523. For example, the auxiliary test data line 553 (in particular, the DR₁ line in FIG. 3A) may be electrically connected with the connection element 546 at the crossing point A8 and the data repair line 523 may be electrically connected with the connection element 546 at the crossing point A9 by laser melting, as shown in FIG. 3C.

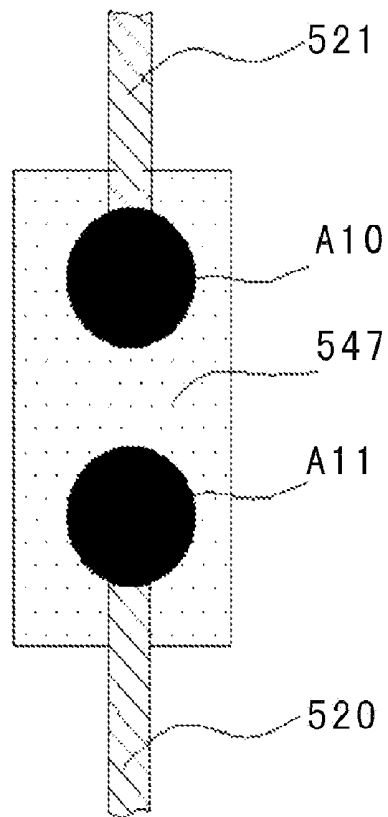
[0017] FIG. 3D is a detailed view of the region Y3 of FIG. 3A.

[0040] FIG. 3D is an enlarged view of the region Y3 of FIG. 3A. When viewed along a direction perpendicular to the surface of the array substrate 410, as shown in FIG. 3D, an overlapping region exists at a point A11 between the data connection line 520 and a connecting element 547 made of conductor which are positioned in different layers in the direction and are separated by an insulating layer therebetween. Also, when viewed along a direction perpendicular to the surface of the array substrate 410, an overlapping region exists at a point A10 between the repair connection line 521 and the connecting element 547 which are positioned in different layers in the direction and are separated by an insulating layer therebetween. Therefore, when repair is not carried out using the repair line, any two among the data connection line 520, the connecting element 547 and the repair connection line 521 are not electrically connected.

[0043] (2) Electrically connecting the data connection line 520 with the repair connection line 521. For example, the data connection line 520 may be electrically connected with the connection element 547 at the crossing point A11 and the repair connection line 521 may be electrically connected with the connection element 547 at the crossing point A10 by laser melting, as shown in FIG. 3D.
