(10) **Patent No.:** **US 8,023,059 B2**  
(45) **Date of Patent:** **Sep. 20, 2011**

(54) **ARRAY SUBSTRATE OF LIQUID CRYSTAL DISPLAY, METHOD OF REPAIRING SAME, AND LIQUID CRYSTAL DISPLAY**

(73) Assignee: **Infovision Optoelectronics (Kunshan) Co., Ltd.**, Kunshan (CN)

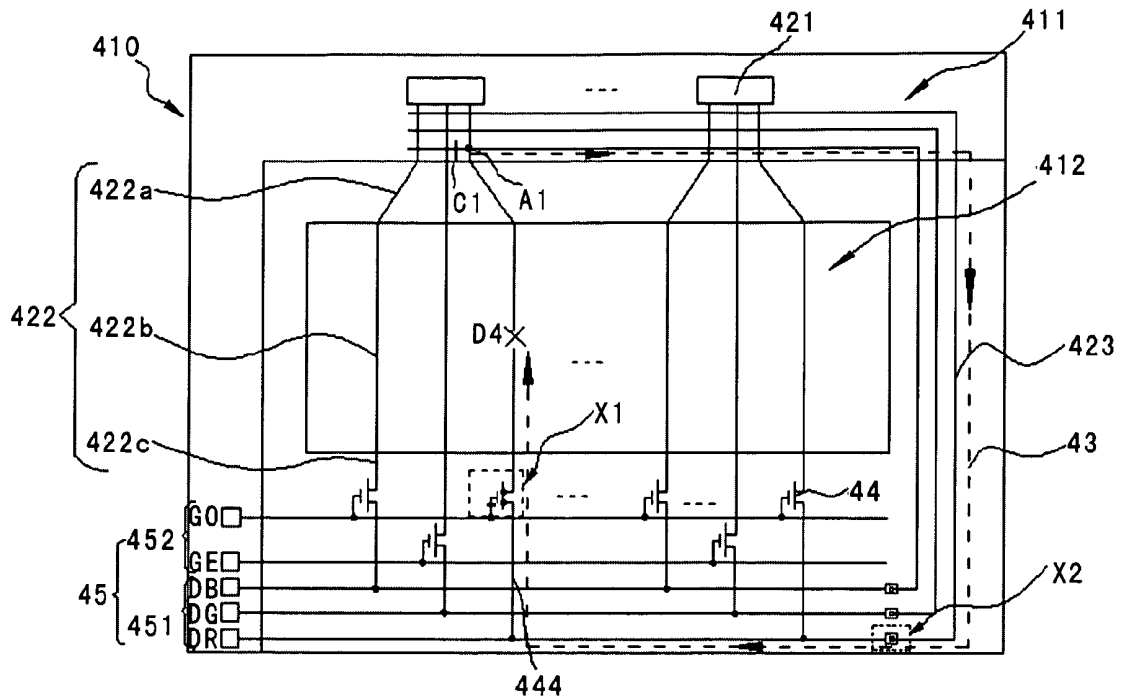
FIG. 2A is a view showing a repair line structure of an array substrate of a liquid crystal display in accordance with a first embodiment of the invention.

FIG. 2A is a plan view showing a repair line structure of an array substrate of a liquid crystal display (LCD) in accordance with a first embodiment of the invention. The LCD array substrate **410** comprises a display region **412** and a signal introducing region **411** outside the display region **412**. A plurality of data line pads **421** is formed in the signal introducing region **411** and electrically connected with corresponding data lines **422** respectively. Each of the data lines **422** comprises three portions, that is, a front data line portion **422a** outside the display region **412** and electrically connected with a corresponding data line pad **421**, a display region data line portion **422b** in the display region **412**, and an end data line portion **422c** outside the display region **412** and at the side away from the data line pad **421**. Data signals inputted from the data line pad **421** are transmitted on the whole data line **422** in an order of the front data line portion **422a**, the display region data line portion **422b** and the end data line portion **422c**. For the sake of clarity, scanning lines, which are provided crossing with the data lines **422**, and scanning line pads are not shown in FIG. 2A.

A repair line **423** is positioned outside the display region **412**. As shown in FIG. 2A, the repair line **423** is positioned on the upper and right sides of the display region **412**, but does not fully extend to the lower side of the display region. As

shown in the plan view of FIG. 2A, the repair line 423 crosses with the front data line portion 422a at a location A1 when viewed along a direction perpendicular to the surface of the array substrate 410. Along the direction perpendicular to the surface of the array substrate 410, the repair line 423 and the front data line portion 422a are positioned in different layers separated by an insulating layer therebetween. Hence the repair line 423 and the front data line portion 422a are normally not in an electrical connection. Although in the plan view of FIG. 2A, the repair line 423 and the front data line portion 422a are arranged perpendicularly, the invention is by no means limited to such a perpendicularly arranged manner. It is sufficient as long as there is a crossing point between them in the plan view.

As shown in FIG. 2A, test lines 45 are also provided outside the display region 412, and in the embodiment are positioned below the display region 412. The test lines 45 comprise test data lines 451 and test scanning lines 452. The test data lines 451 for transmitting test data signals comprise three test data lines DB, DG and DR for transmitting test data signals with respect to blue (B), green (G) and red (R) respectively. The test scanning lines 452 for transmitting test scanning signals comprise two test scanning lines GO and GE for transmitting test scanning signals with respect to the odd and even columns respectively. The test lines 45 transmit test signals to the data lines 422 via TFTs 44.

In the embodiment shown in FIG. 2A, the test lines 45 and the TFTs 44 are connected in the following manner. Gate electrodes of TFTs 44 in the odd and even columns counted from the left are respectively connected to the GO and GE lines of the test scanning lines 452, and source electrodes of TFTs 44 in the 3n-2, 3n-1 and 3n (n=1, 2, 3 . . . ) columns counted from the left are respectively connected to the DB, DG and DR lines of the test data lines 451. It is noted that the connecting technique of FIG. 2A is merely an example, and it is possible to have other techniques, for example, providing only one test scanning line, or providing more test data lines, etc. In an embodiment, the test lines 45 and the repair line 423 may be arranged partly or entirely in a perimeter seal region so as to reduce the non-display area in the liquid crystal display panel. Here, the perimeter seal region is such a region in the array substrate that will be adhered to a color filter substrate so as to form a liquid crystal display.

With the above repairing technique, data signals on the defective data line 422 can be transmitted, along a path shown by the dashed line 43 of FIG. 2A, to the portion of this data line 422 below the break point D4. The specific transmitting path is: from the front data line portion 422a to the repair line 423 via the crossing point A1, then to the test data line 451 (in particular, the DR line) via the crossing point A4, then to the source electrode 442 of the TFT 44 via the test data line branch 444 connected with the test data line 451, then to the gate electrode 443 via the overlapping region A2, then to the drain electrode 441 via the overlapping region A3 and to the end data line portion 442c connected with the drain electrode 441 via the drain electrode 441, and finally to the portion of the display region data line portion 442b below the break point D4.

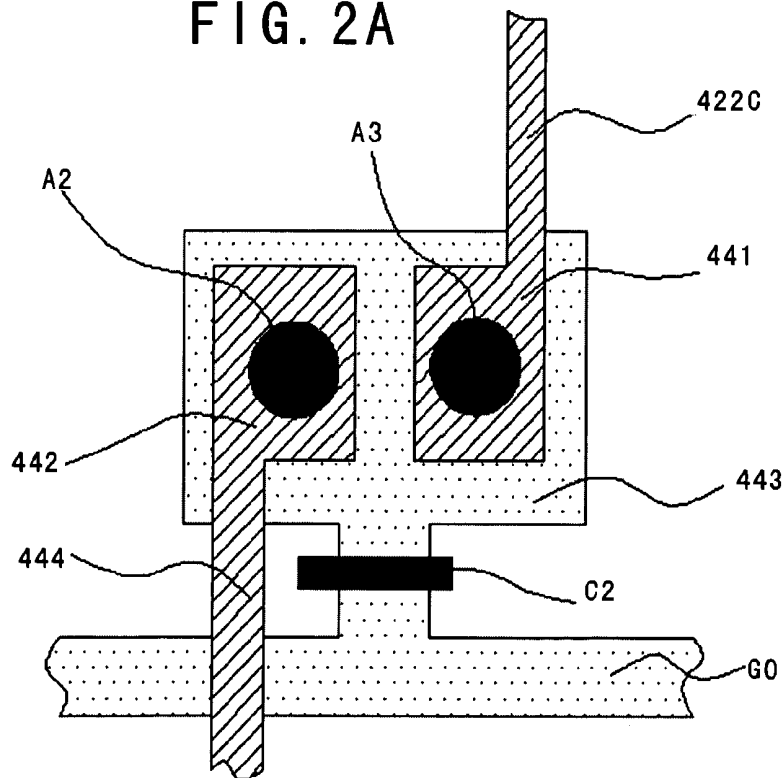
FIG. 2B is a detailed view of TFT in the region X1 of FIG. 2A.

FIG. 2B shows a detailed view showing the TFT 44 in the region X1 of FIG. 2A. The TFT 44 has a source electrode 442, a drain electrode 441 and a gate electrode 443. The source electrode 442 is connected to a test data line branch 444, the drain electrode 441 is connected to the end data line portion 422c of corresponding data line 422, and the gate electrode 443 is connected to one of the test scanning lines 452 (in particular, to the GO line of the test scanning lines 452 in FIG. 2A). The test data line branch 444 is connected to one of the test data lines 451 (in particular, to the DR line of the test data lines 451 in FIG. 2A).

(3) Processing the TFT 44 to electrically connect the source electrodes 442 and the drain electrodes 441 and cut off the electrical connection between the gate line 443 and the test scanning line 452. For example, for the TFT 44 in the region X1 of FIG. 2A, as shown in FIG. 2B, the source electrode 442 and the drain electrode 441 are electrically connected with the gate electrode 443 at the respective crossing points A2 and A3 by laser melting, and the electrical connection between the gate electrode 443 and the test scanning line 452 is cut off at the point C2 by, for example, laser. Thus the gate electrode 443 becomes an isolated island structure and is no longer electrically connected with the test scanning line 452. As a result, data signals transmitted from the test data line branch 444 to the gate electrode 443 (repaired data signal) will not be transmitted to the test scanning line 452 to affect normal operation of the display.

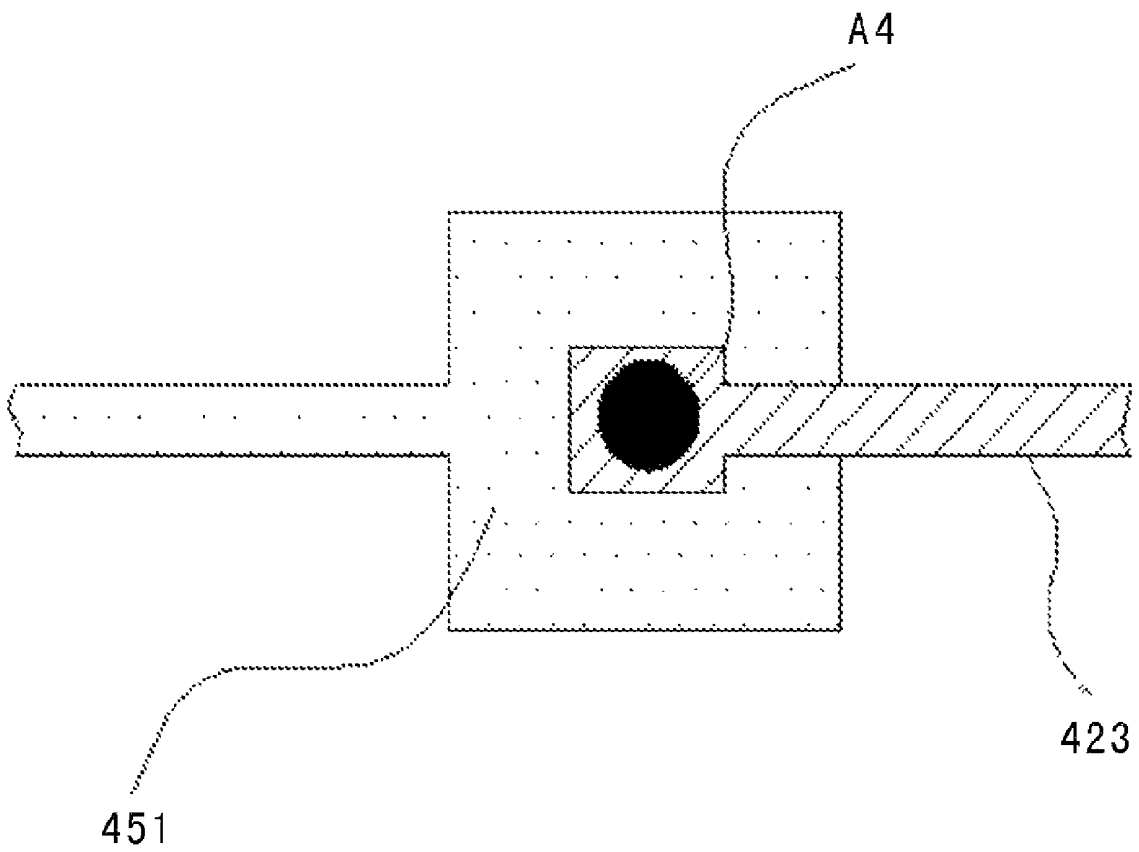
FIG. 20

FIG. 2C is a detailed view of the region X2 of FIG. 2A.

FIG. 2C is a detailed view showing the test data line 451 and the repair line 423 in the region X2 of FIG. 2A. When viewed along a direction perpendicular to the surface of the array substrate, as shown in FIG. 2C, the test data line 451 (in particular, the DR line of the test data lines 451 in FIG. 2A) at least partly overlaps with an end of the repair line 423; that is, an overlapping region exists between them. However, in the direction perpendicular to the surface of the array substrate, the test data line 451 and the repair line 423 are positioned in different layers which are separated by an insulating layer therebetween. Therefore, the test data line 451 and the repair line 423 are in an insulated state when repair is not carried out.

(2) Electrically connecting the test data line 451 with the repair line 423. For example, an end of the test data line 451 (in particular, the DR line of the test data line 451 in FIG. 2A) may be electrically connected with an end of the repair line 423 at the crossing point A4 by laser melting, as shown in FIG. 2C.

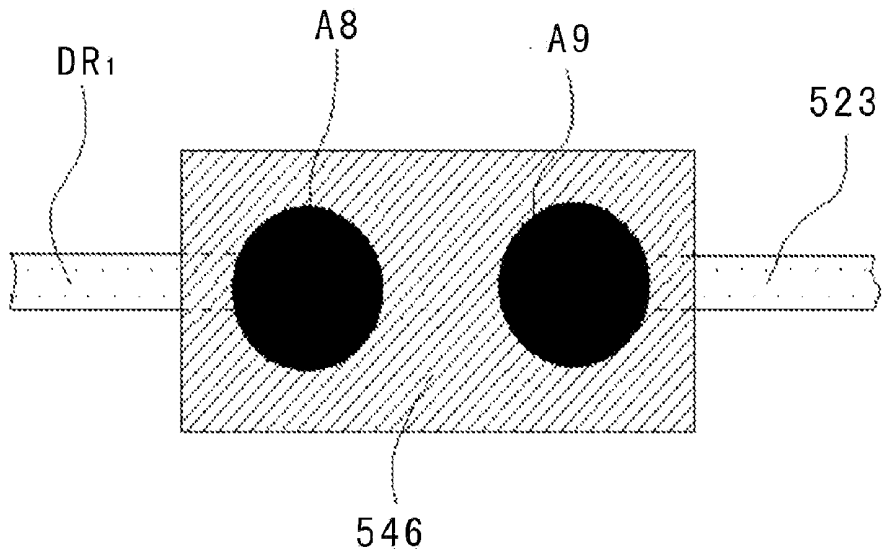
FIG. 3C is a detailed view of the region Y2 of FIG. 3A.

the direction and are separated by an insulating layer therebetween. Also, when viewed along a direction perpendicular to the surface of the array substrate **410**, an overlapping region exists at a point **A9** between the data repair line **523** and the connecting element **546** which are positioned in different layers in the direction and are separated by an insulating layer therebetween. Therefore, when repair is not carried out using the repair line, any two among the auxiliary test data line **553**, the connecting element **546** and the data repair line **523** are not electrically connected.

(3) Electrically connecting the test data line **551** with the data repair line **523**. For example, the auxiliary test data line **553** (in particular, the  $DR_1$  line in FIG. 3A) may be electrically connected with the connection element **546** at the crossing point **A8** and the data repair line **523** may be electrically connected with the connection element **546** at the crossing point **A9** by laser melting, as shown in FIG. 3C.

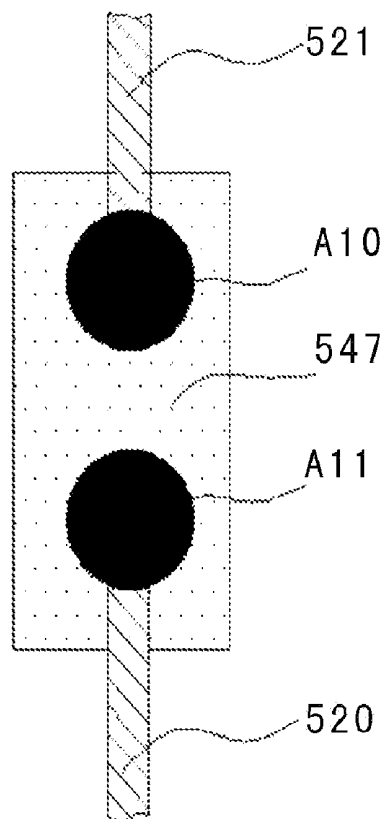
FIG. 3D is a detailed view of the region Y3 of FIG. 3A.

FIG. 3D is an enlarged view of the region **Y3** of FIG. 3A. When viewed along a direction perpendicular to the surface of the array substrate **410**, as shown in FIG. 3D, an overlapping region exists at a point **A11** between the data connection line **520** and a connecting element **547** made of conductor which are positioned in different layers in the direction and are separated by an insulating layer therebetween. Also, when viewed along a direction perpendicular to the surface of the array substrate **410**, an overlapping region exists at a point **A10** between the repair connection line **521** and the connecting element **547** which are positioned in different layers in the direction and are separated by an insulating layer therebetween. Therefore, when repair is not carried out using the repair line, any two among the data connection line **520**, the connecting element **547** and the repair connection line **521** are not electrically connected.

(2) Electrically connecting the data connection line **520** with the repair connection line **521**. For example, the data connection line **520** may be electrically connected with the connection element **547** at the crossing point **A11** and the repair connection line **521** may be electrically connected with the connection element **547** at the crossing point **A10** by laser melting, as shown in FIG. 3D.
