(10) **Pub. No.: US 2001/0028418 A1**

(54) **LIQUID CRYSTAL DISPLAY DEVICE AND
FAULT REPAIRING METHOD FOR THE
LIQUID CRYSTAL DISPLAY DEVICE**

There is provided a fault repairing method for a liquid crystal display device capable of repairing simply a disconnected portion when a disconnection fault occurs in a display panel. For example, it is on the assumption that the disconnected portion is present in a data bus line. Disconnection repairing contact holes that have a width larger than that of the data bus line are formed in a protection insulating film on the data bus line on both sides of the disconnected portion respectively. Then, a laser CVD film (metal film) for covering inner surfaces of the disconnection repairing contact holes is formed by the laser CVD method, and then respective laser CVD films are connected electrically.

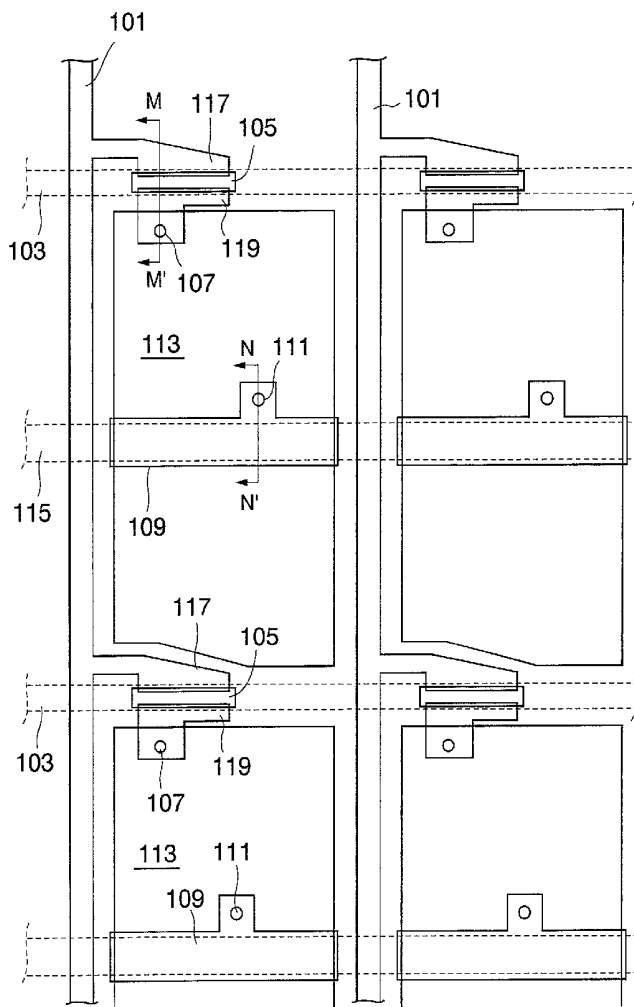
FIG. 1 (PRIOR ART)

[0012] FIG. 1 is a top view showing a configuration of the liquid crystal display device. In this liquid crystal display device, the liquid crystal is sealed between the TFT substrate 18 and the CF substrate 40 and the area in which the liquid crystal is sealed acts as the display area 38. At the end portion of the TFT substrate 18, the gate bus lines and the data bus lines (called also as the drain bus lines) are collected as a plurality of gate bus line groups 48 and a plurality of data bus line groups 50, and connected to the TAB substrates 44, 46 respectively. The TAB substrates 44, 46 are connected to the printed-wiring board 42.

[0013] FIG. 2 is an enlarged view showing the portion encircled by a broken line in FIG. 1. The gate bus lines 10 are connected to the gates of the TFTs 30 formed in the display area respectively. End portions of the gate bus lines 10 are connected to the gate terminal (TAB terminal). A plurality of pixels are arranged in a matrix fashion in the display area. Each pixel is surrounded by the gate bus line 10 and the data bus line 34, and the TFT 30 and the pixel electrode 32 are formed every pixel. The source electrode of the TFT 30 is connected to the pixel electrode 32, and the drain electrode is connected to the data bus line 34. The storage capacitance bus lines 22 that are formed in parallel with the gate bus lines 10 by the same steps as the gate bus lines 10 are formed in the central portion of the pixel area. Also, in order to prevent the destruction of the TFT by the static electricity, the gate bus lines 10 are connected to the guard ring 26 via the protection elements 28.

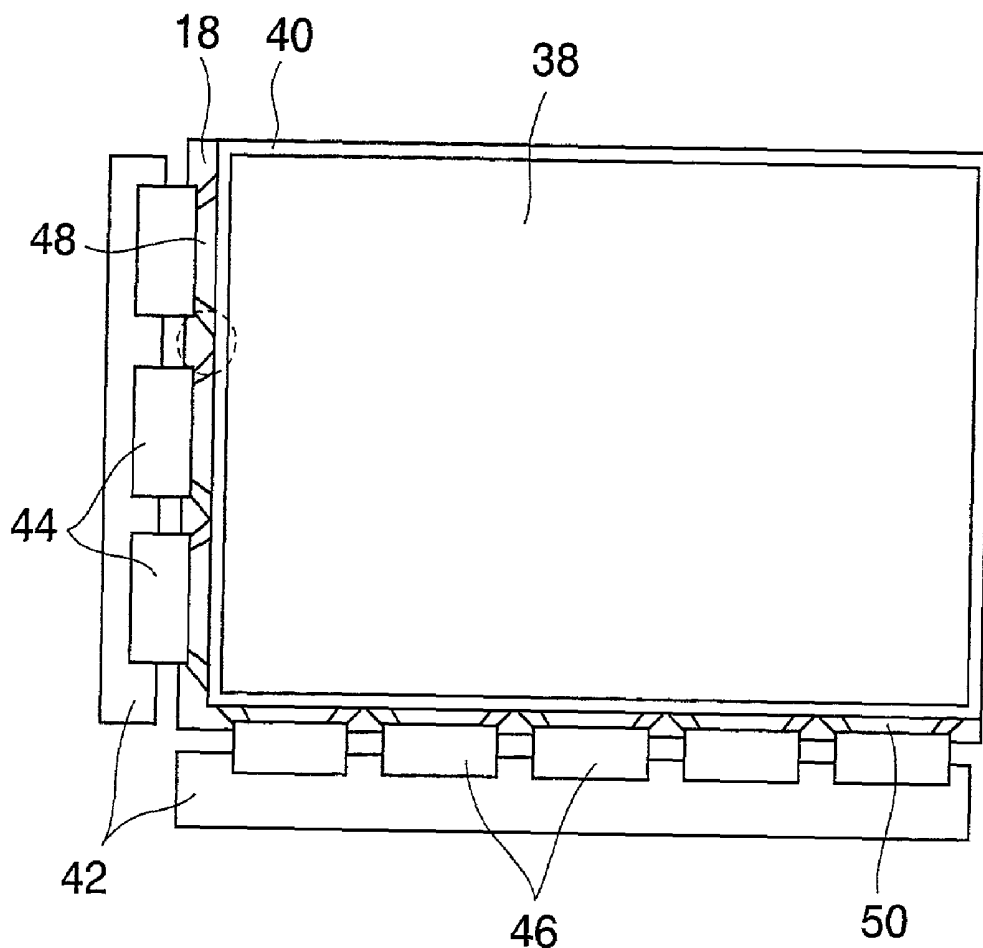
FIG.2 (PRIOR ART)

[0068] FIG. 2 is a view (#1) showing a configuration of the liquid crystal display device in the prior art, i.e., an enlarged view showing a portion encircled by a broken line in FIG. 1;

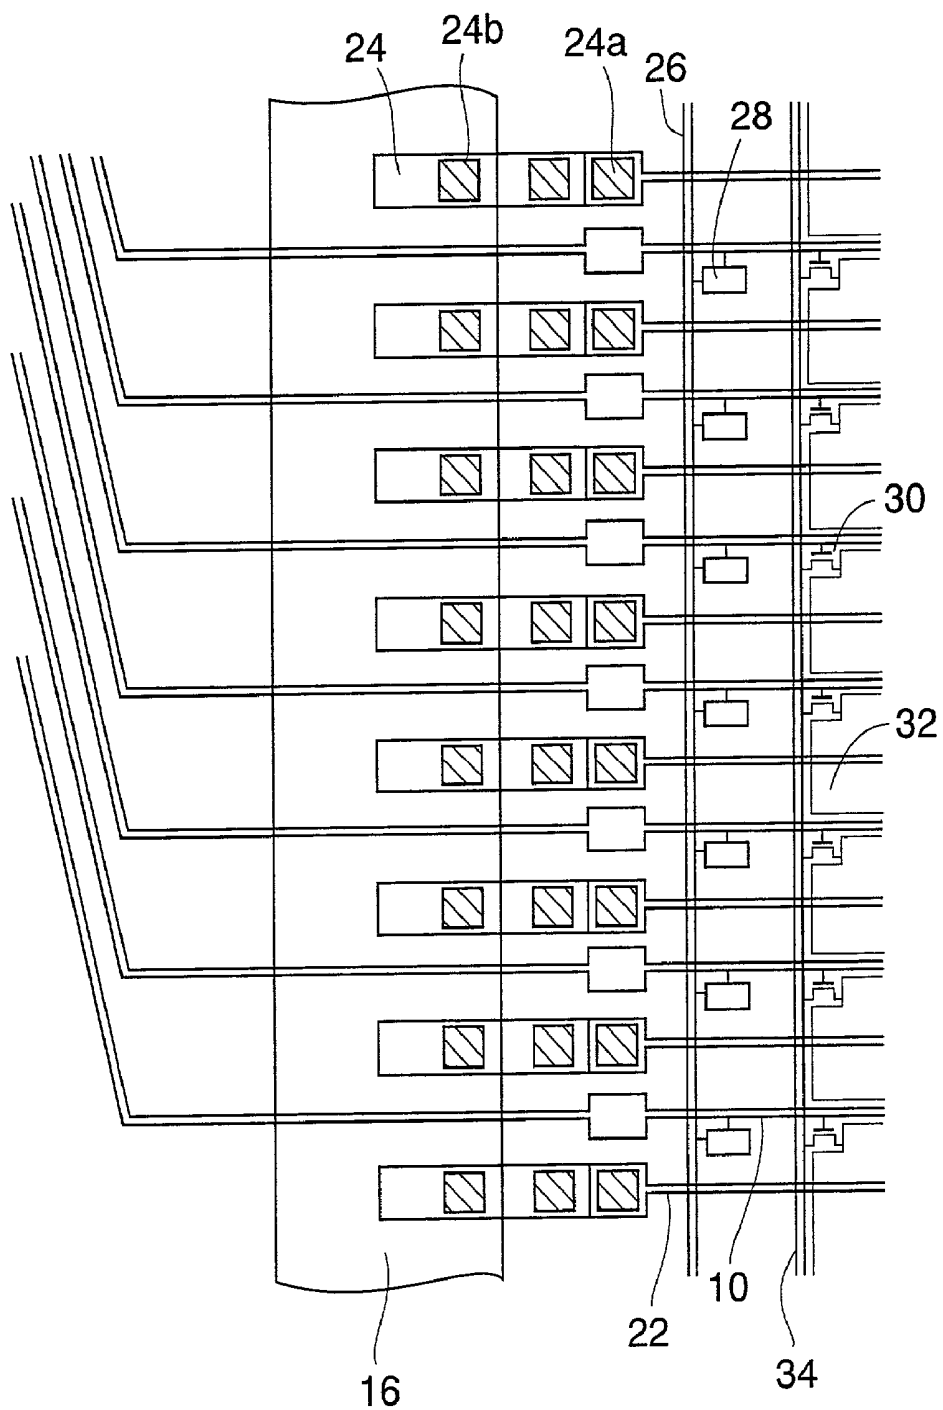
FIG.3 (PRIOR ART)

[0015] In the meanwhile, the gate bus lines **10** are provided to intersect with the storage capacitance bus line general electrode **16** via the insulating film. FIG. 3 shows the intersecting portion of the gate bus line **10** and the storage capacitance bus line general electrode **16**. If the short circuit occurs in this intersecting portion due to the static electricity, etc. during manufacturing steps, the line fault is brought about in the direction along the gate bus lines.

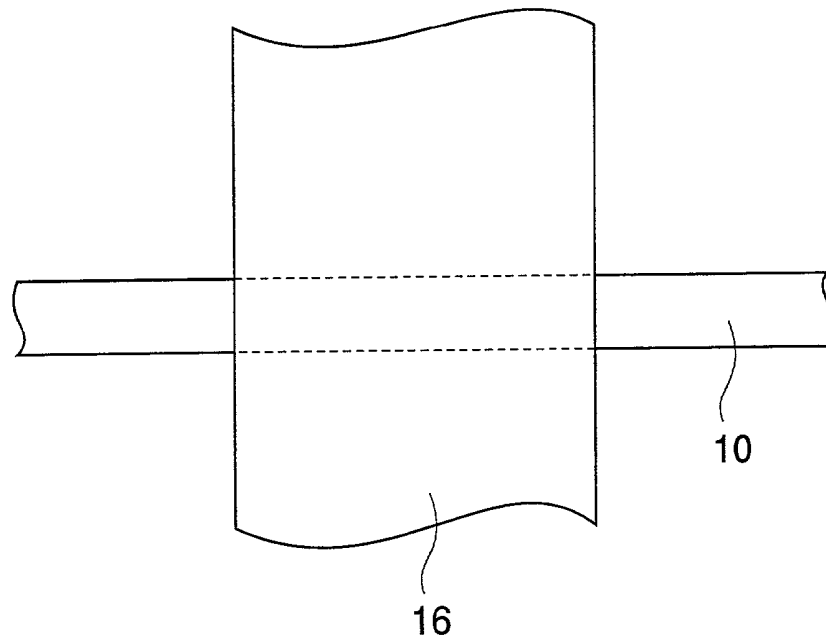
FIG.4 (PRIOR ART)

[0016] FIG. 4 is a view showing another configuration of the intersecting portion in the prior art. In the configuration in FIG. 4, the gate bus line **10** is separated into two branch portions **10d**, **10e** in the portion at which the gate bus line **10** intersects with the storage capacitance bus line general electrode **16**. In case the short circuit occurs in the intersecting portion due to the static electricity, etc. during manufacturing steps, the short-circuited portion is electrically separated by cutting off the short-circuited branch portion by the laser beam, etc. after the short-circuited position is checked by the inspection using the pattern recognition. Thus, the gate bus line **10** is restored to the normal gate bus line.

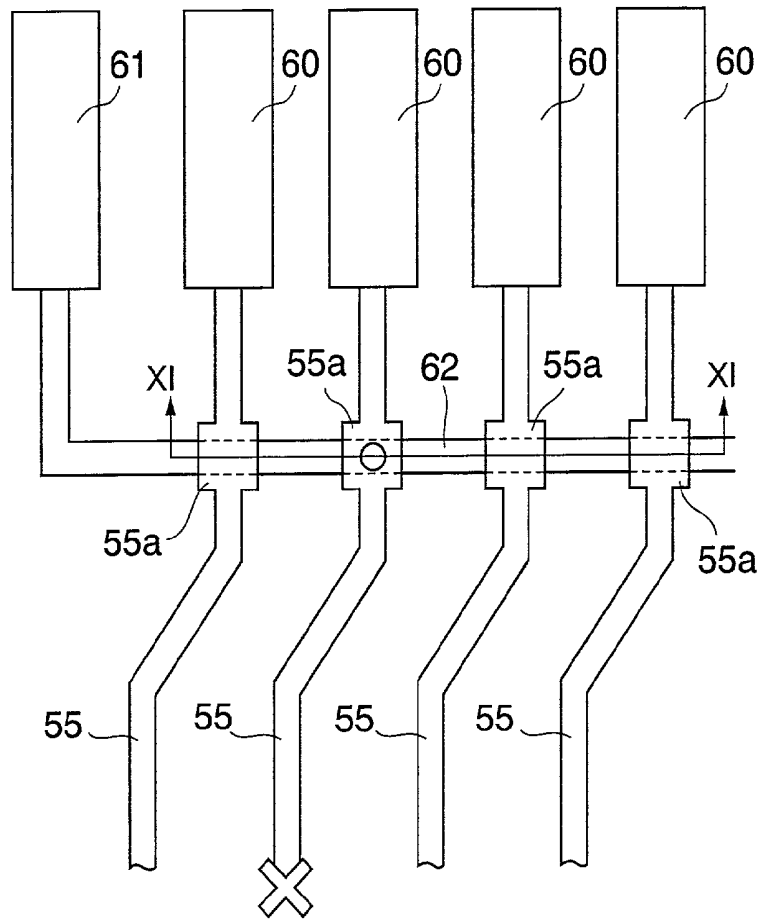
FIG.7B (PRIOR ART)

[0037] The second repair wiring 63, that passes through the repair terminals 55b provided to the end portions of the data bus lines 55, and a plurality of (two in FIG. 7B) third repair wirings 64 are provided to other end side of the data

bus lines 55. The top end of the second repair wiring 63 is bended like the L-shape, and this top end portion intersects with the third repair wirings 64. The third repair wirings 64 are connected to the spare TAB terminals 65.

[0073] FIGS. 7A and 7B are schematic plan views showing a method of repairing disconnection of a gate bus line in the prior art respectively;

[0040] Also, as shown in FIG. 7B and FIG. 8B, the intersecting portions of the second repair wiring 63 and the repair terminals 55a of the data bus lines 55 are electrically connected by the laser welding, and also the intersecting portions of the second repair wiring 63 and the third repair wirings 64 are electrically connected by the laser welding.

[0042] However, according to the method shown in FIGS. 7A and 7B and FIGS. 8A and 8B, since the first repair wiring 62 and the second repair wiring 63 intersect with the data bus lines 55, capacitances are generated at the intersecting portions. With the progress of the larger size and higher definition of the liquid crystal display device in recent years, the wiring resistance of the repair wiring is increased and also the capacitance of the intersecting portion is increased. Therefore, sometimes the signal delay is increased and the thin line fault or spot fault occurs after the fault portion is repaired. As a result, there is the problem that the number of the repair wirings is limited.

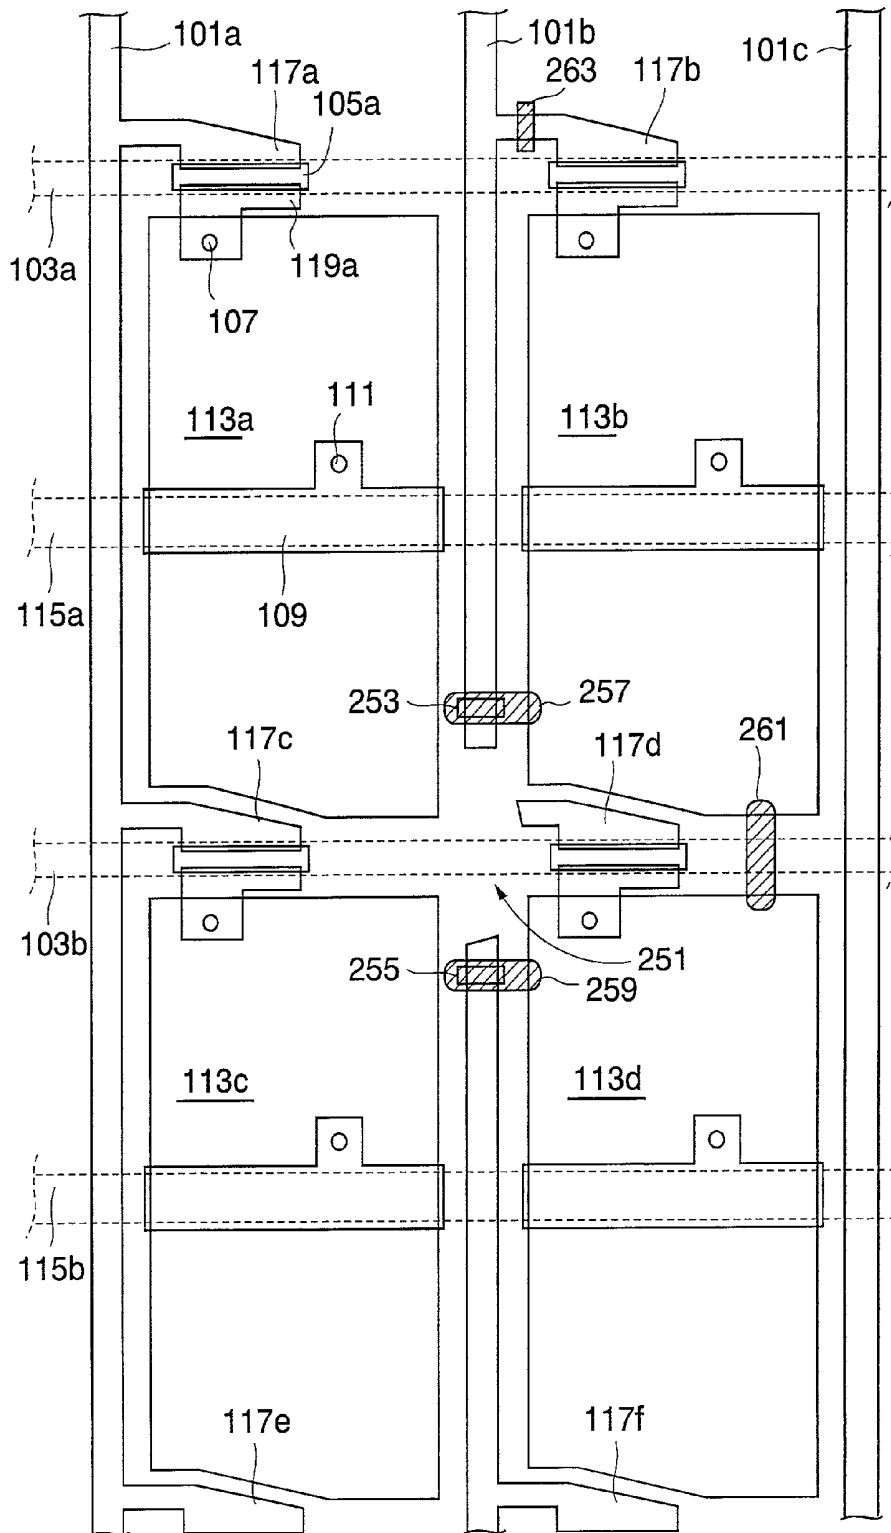
FIG.21

[0082] FIG. 21 is a plan view showing an outline of an example 4 of a fault repairing method for a liquid crystal display device according to the first embodiment of the present invention;

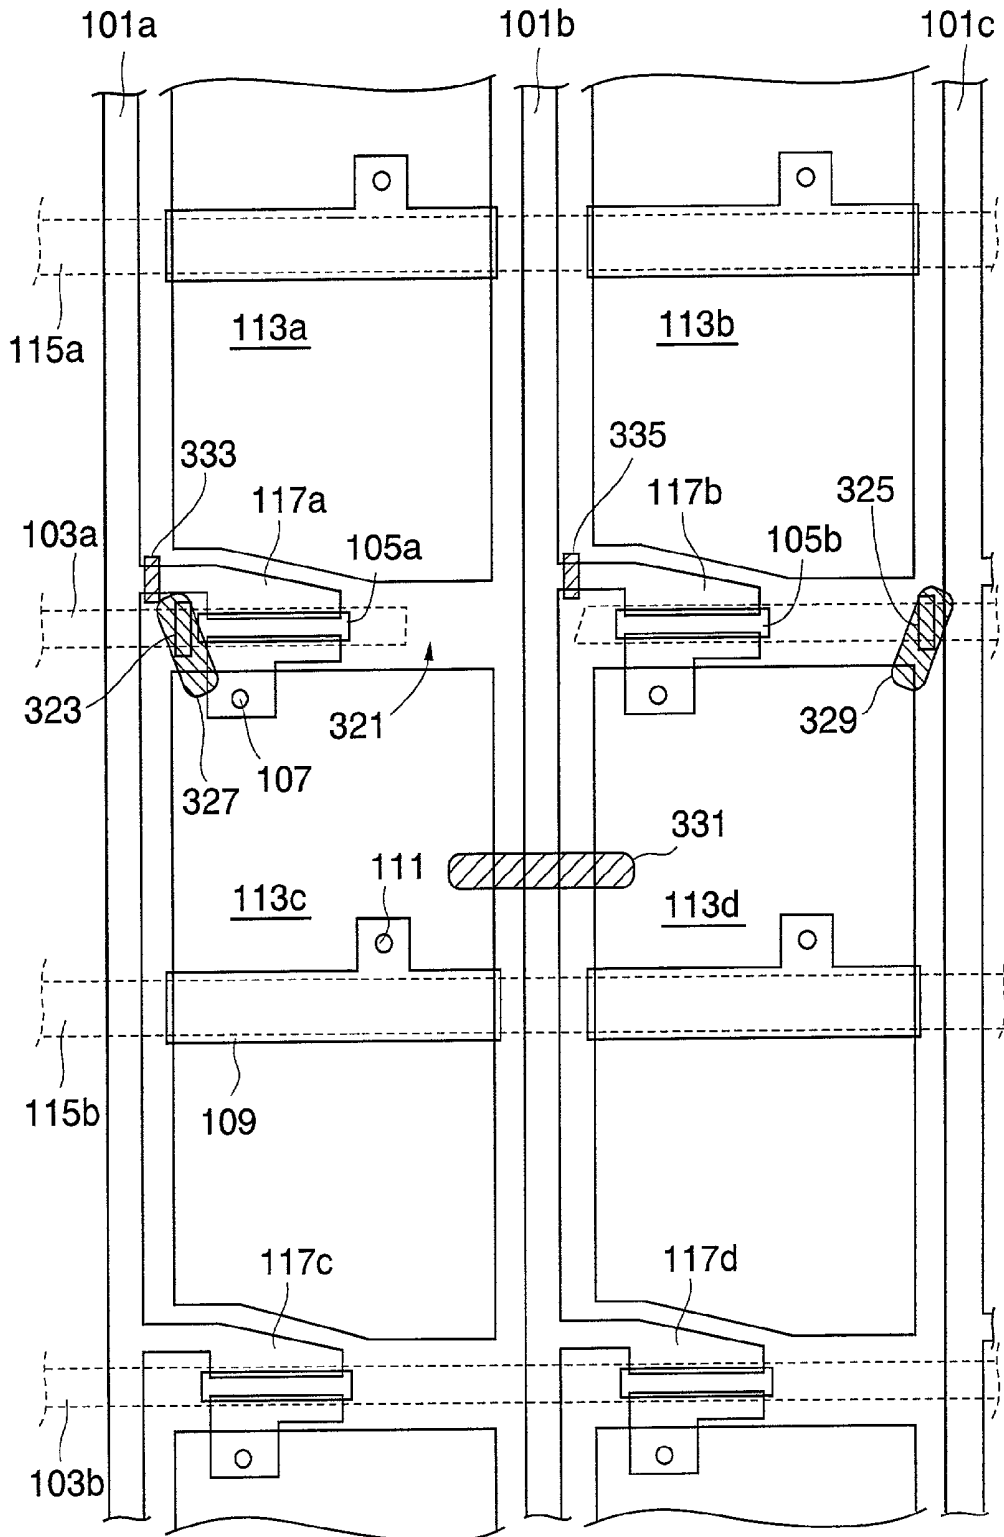
FIG.26

[0087] FIG. 26 is a plan view showing an outline of an example 7 of a fault repairing method for a liquid crystal display device according to the first embodiment of the present invention;

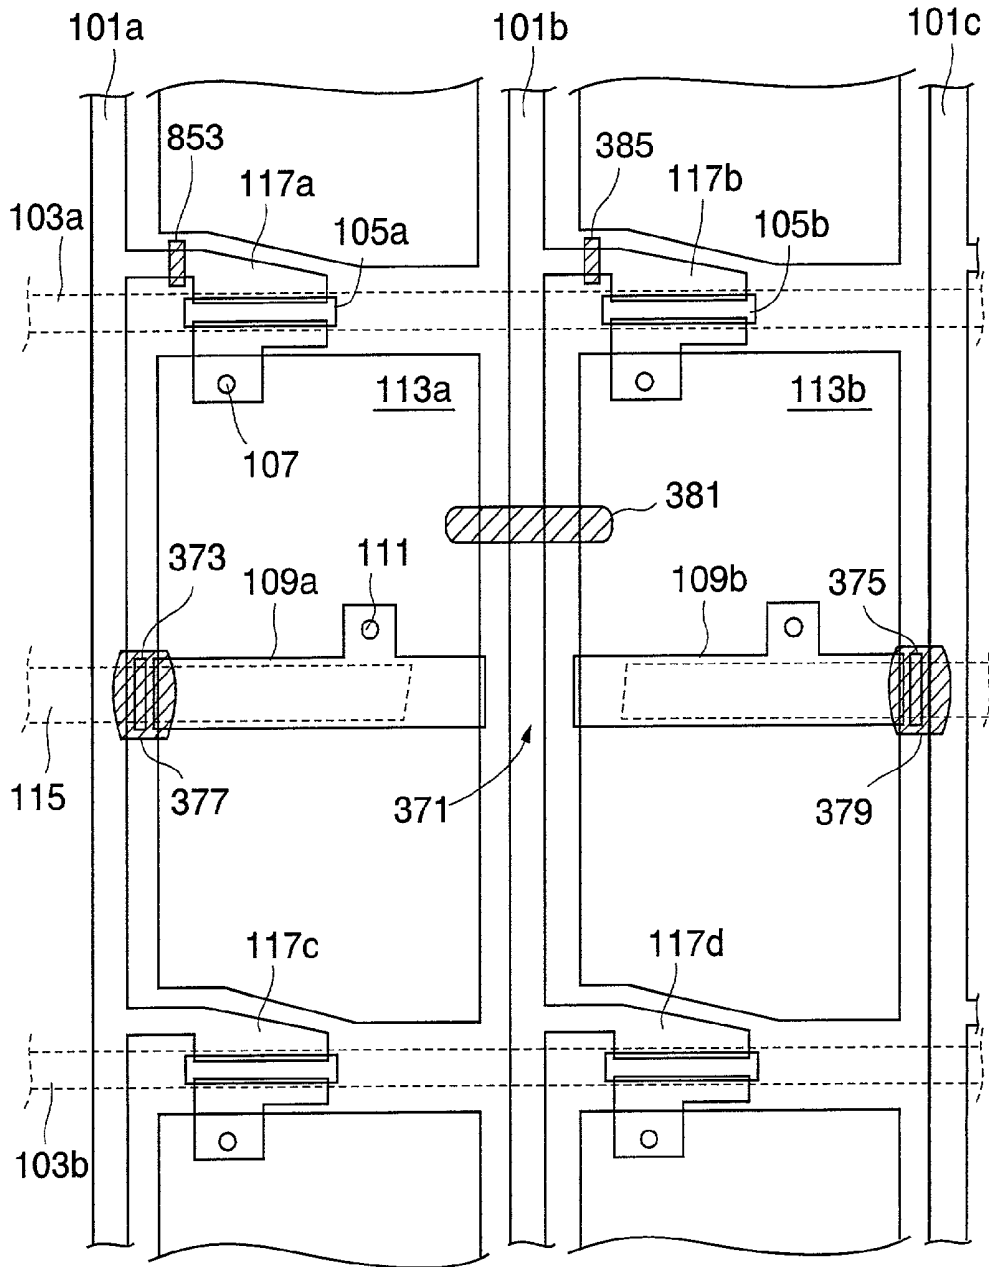
FIG.29

[0090] FIG. 29 is a plan view showing an outline of an example 9 of a fault repairing method for a liquid crystal display device according to the first embodiment of the present invention;

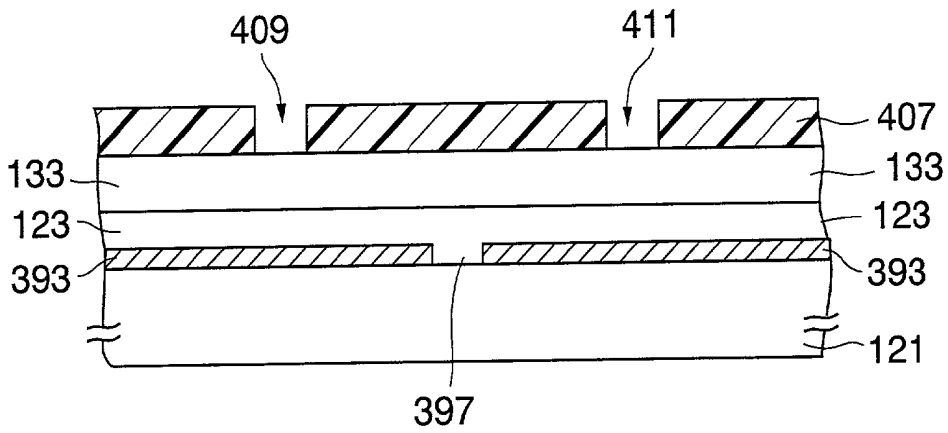
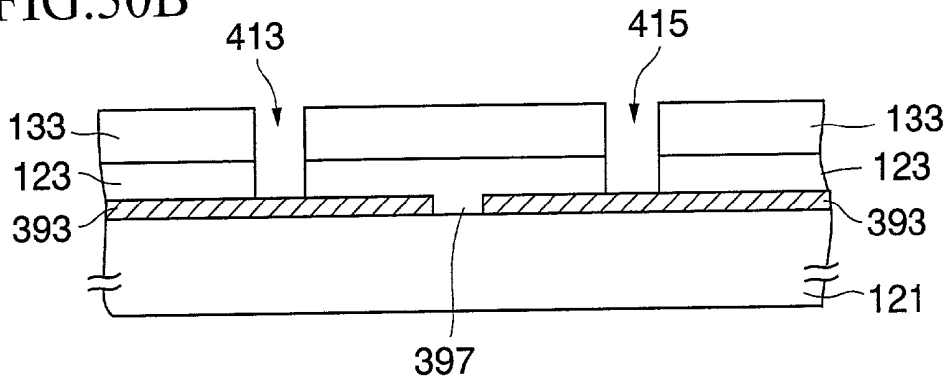
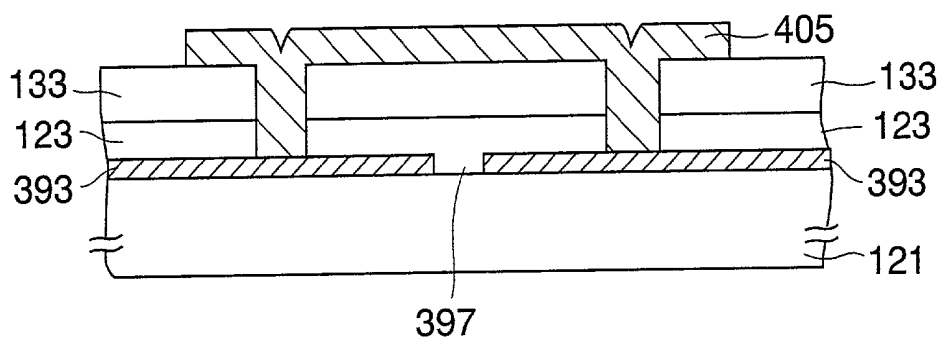
[0091] FIGS. 30A to 30C are sectional views showing the example 9 of the fault repairing method according to the first embodiment of the present invention;

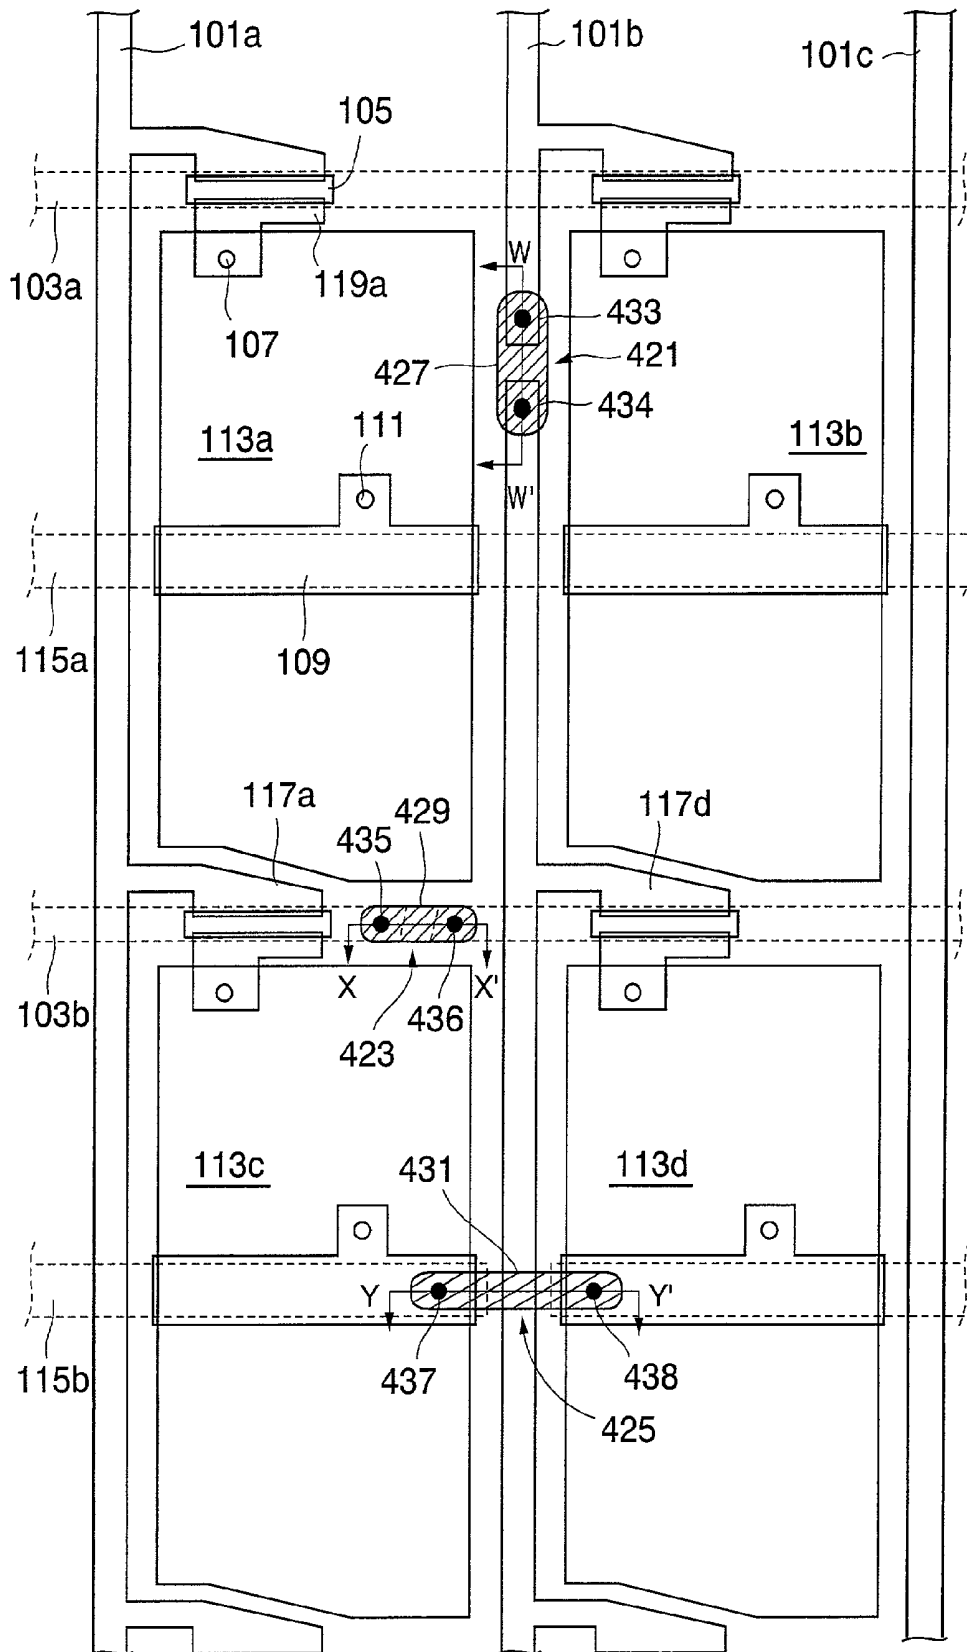
FIG.31

[0092] FIG. 31 is a plan view showing an outline of an example 10 of a fault repairing method for a liquid crystal display device according to the first embodiment of the present invention;

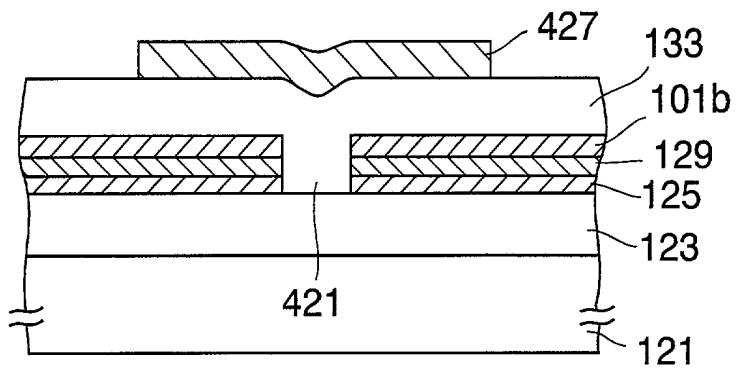
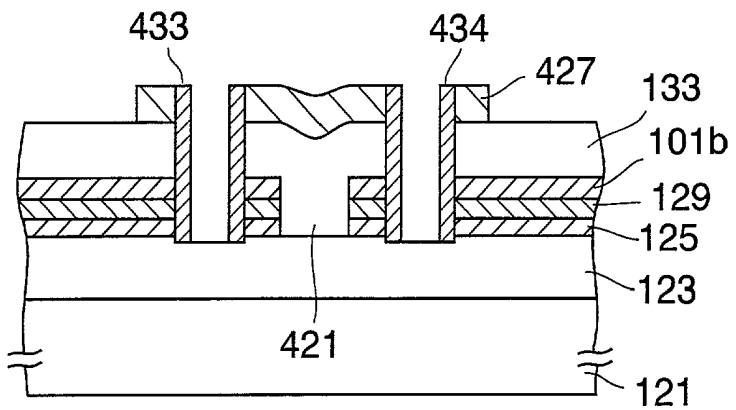
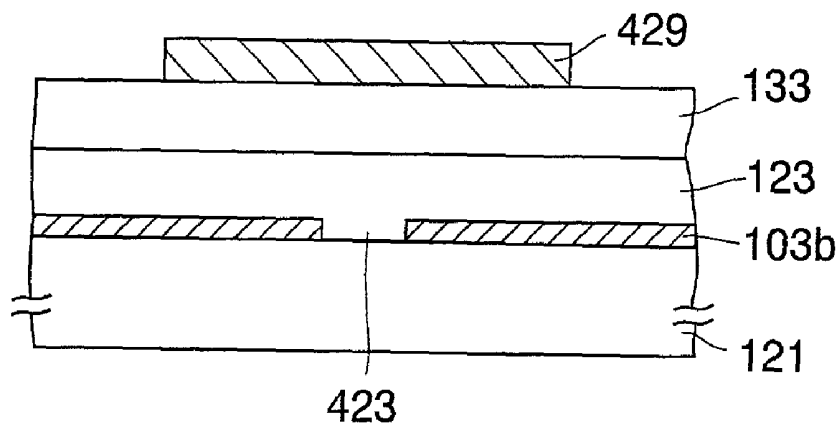
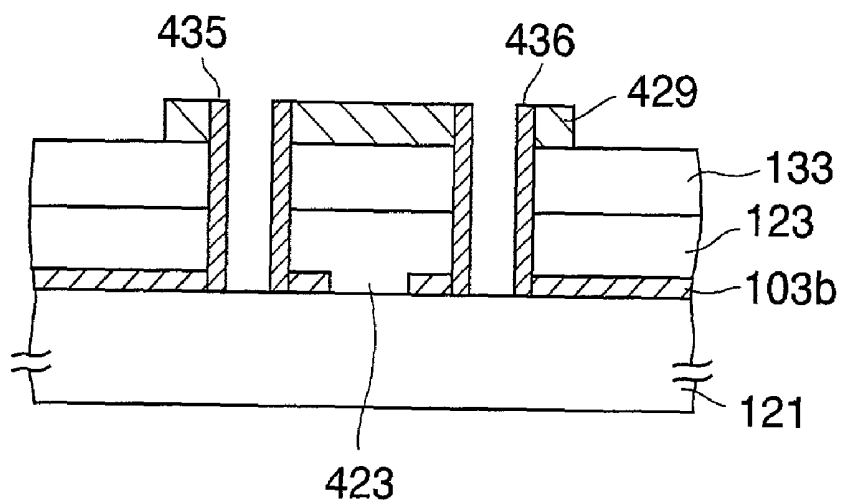
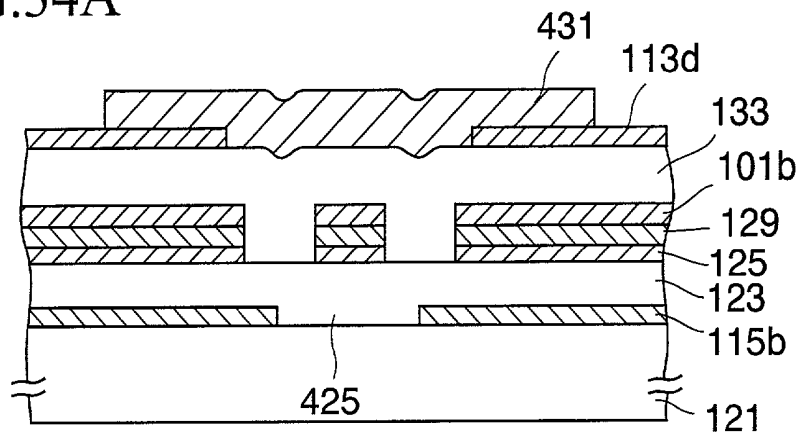
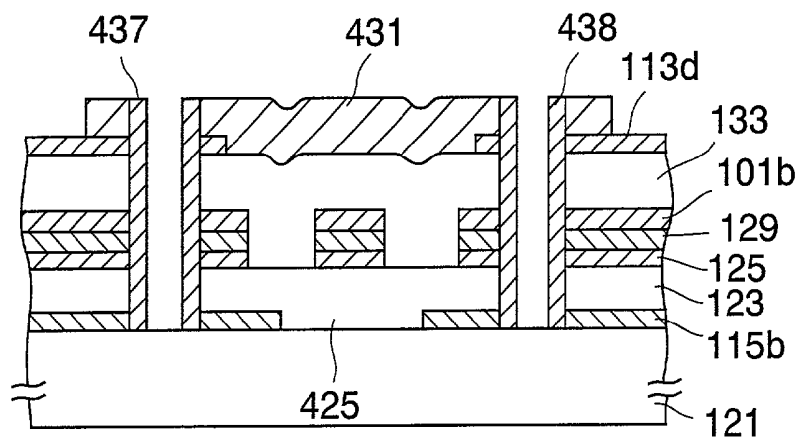
[0093] FIGS. 32A and 32B, FIGS. 33A and 33B, and FIGS. 34A and 34B are sectional views showing the example 10 of the fault repairing method according to the first embodiment of the present invention;

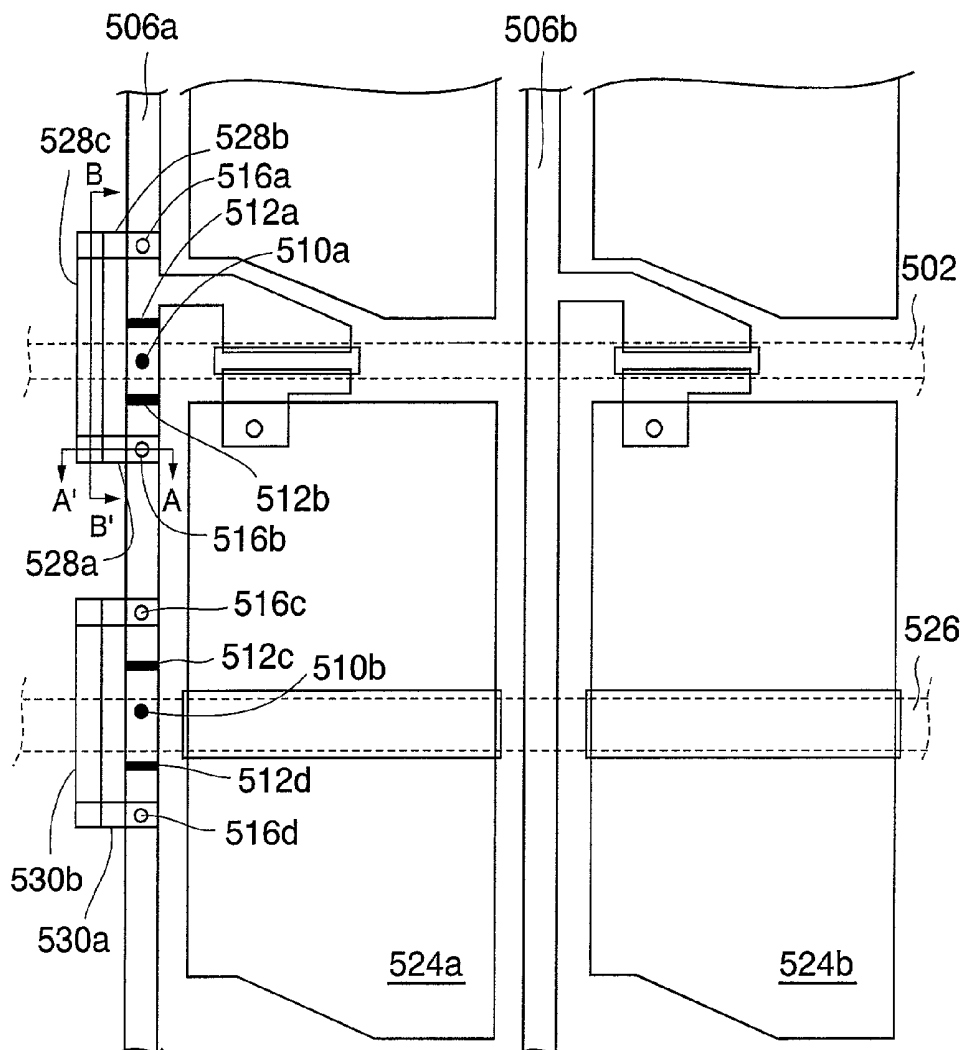
FIG.37

[0096] FIG. 37 is a schematic sectional view (#1) showing the example 1 of the fault repairing method according to the second embodiment of the present invention;

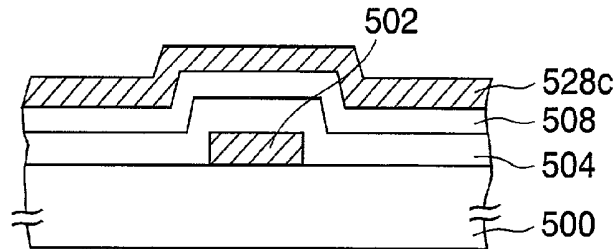
FIG.38

[0097] FIG. 38 is a schematic sectional view (#2) showing the example 1 of the fault repairing method according to the second embodiment of the present invention;

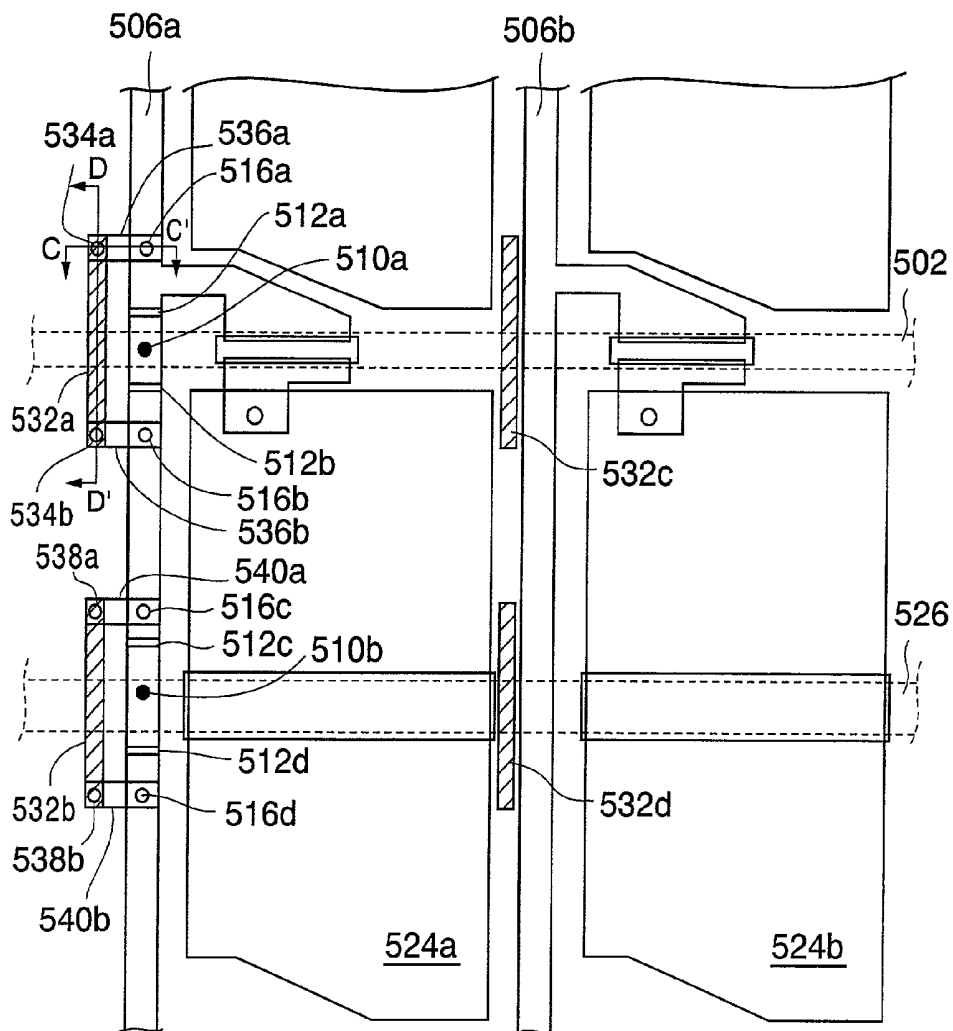
FIG.40

[0099] FIG. 40 is a schematic sectional view (#1) showing the example 2 of the fault repairing method according to the second embodiment of the present invention;

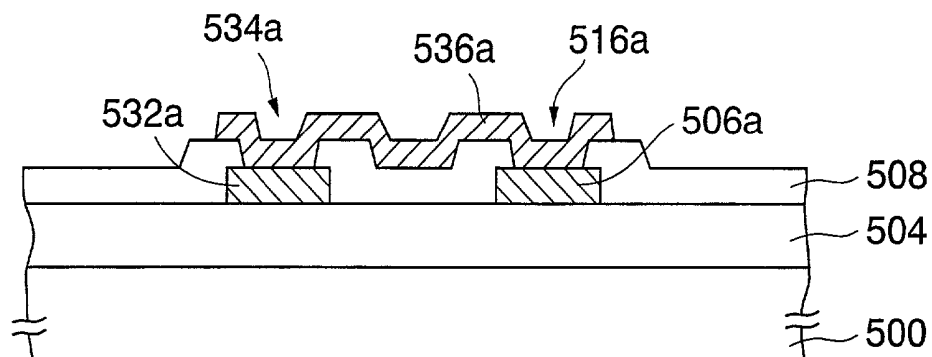
FIG.41

[0100] FIG. 41 is a schematic sectional view (#2) showing the example 2 of the fault repairing method according to the second embodiment of the present invention;

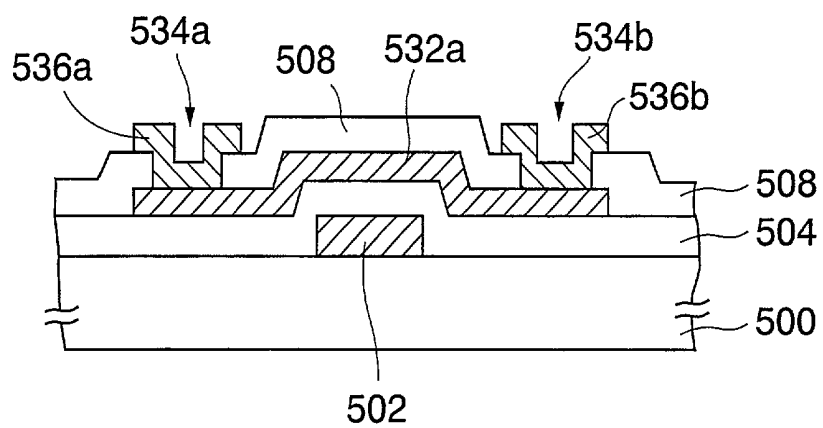
FIG.42

[0101] FIG. 42 is a plan view showing an outline of an example 3 of the liquid crystal display device and its fault repairing method according to the second embodiment of the present invention;

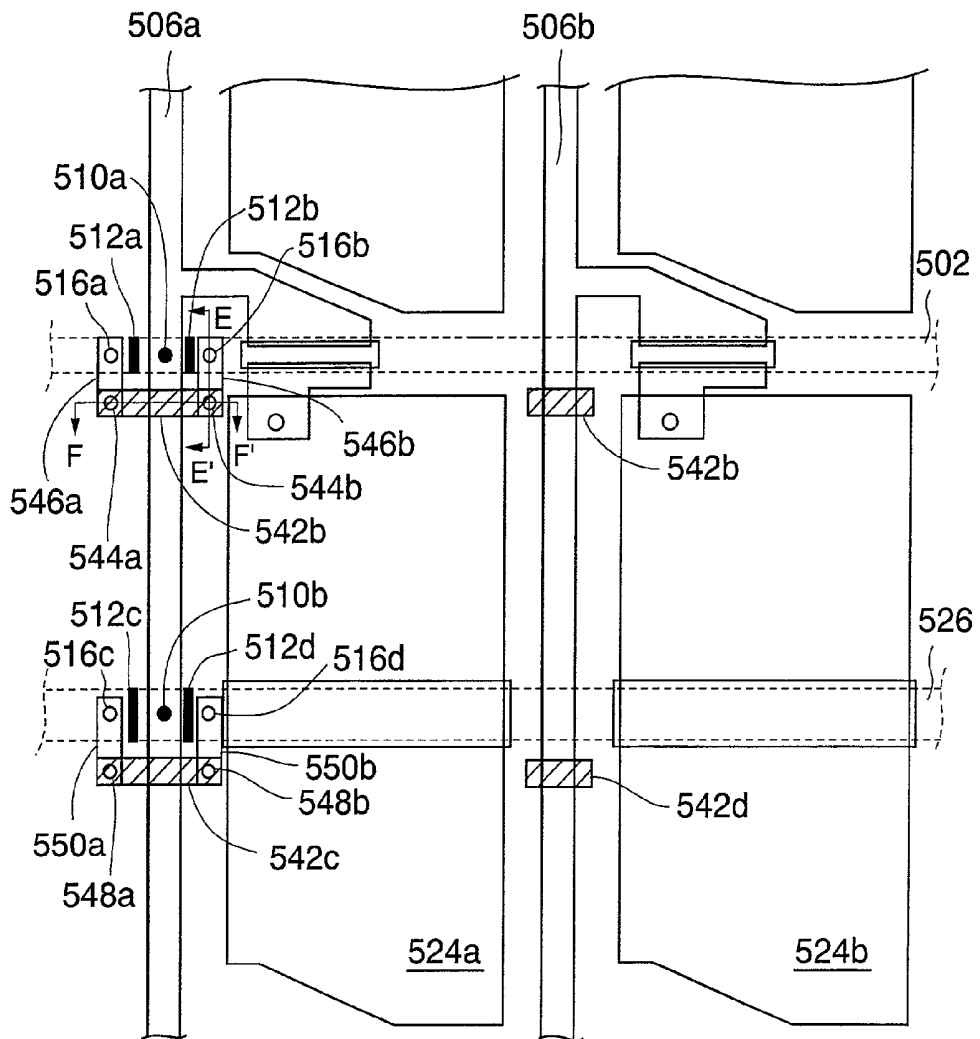
FIG.43

[0102] FIG. 43 is a schematic sectional view (#1) showing the example 3 of the fault repairing method according to the second embodiment of the present invention;

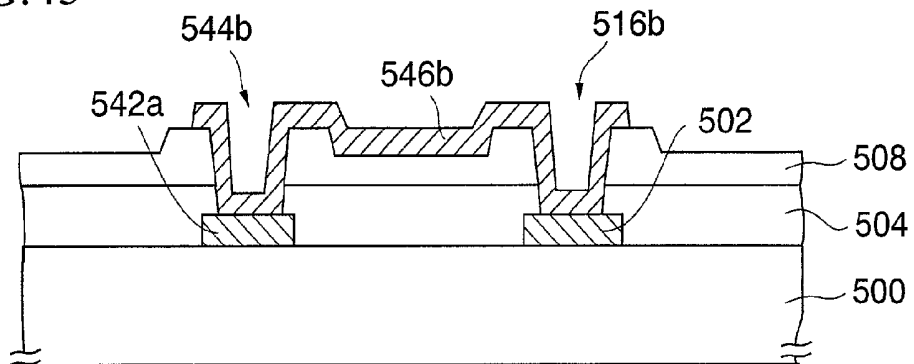
[0103] FIG. 44 is a schematic sectional view (#2) showing the example 3 of the fault repairing method according to the second embodiment of the present invention;

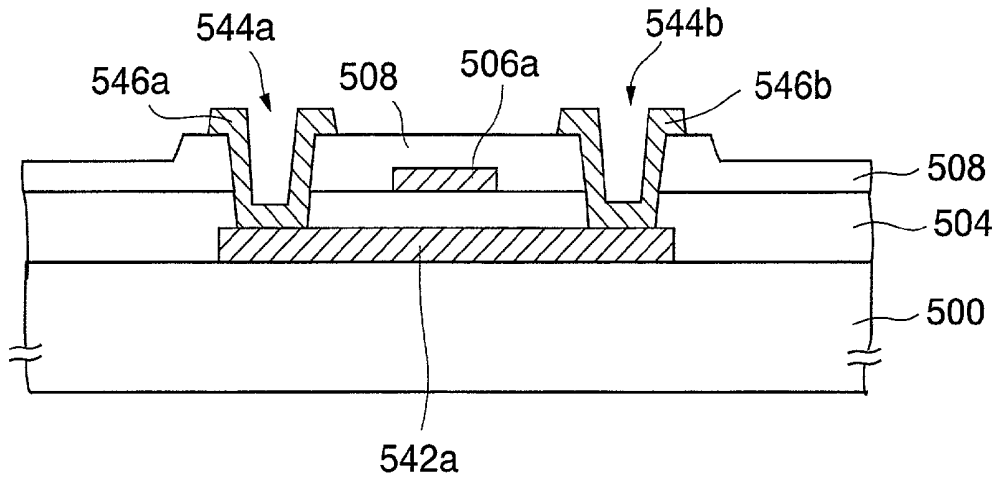
[0104] FIG. 45 is a plan view showing an outline of an example 4 of the liquid crystal display device and its fault repairing method according to the second embodiment of the present invention;

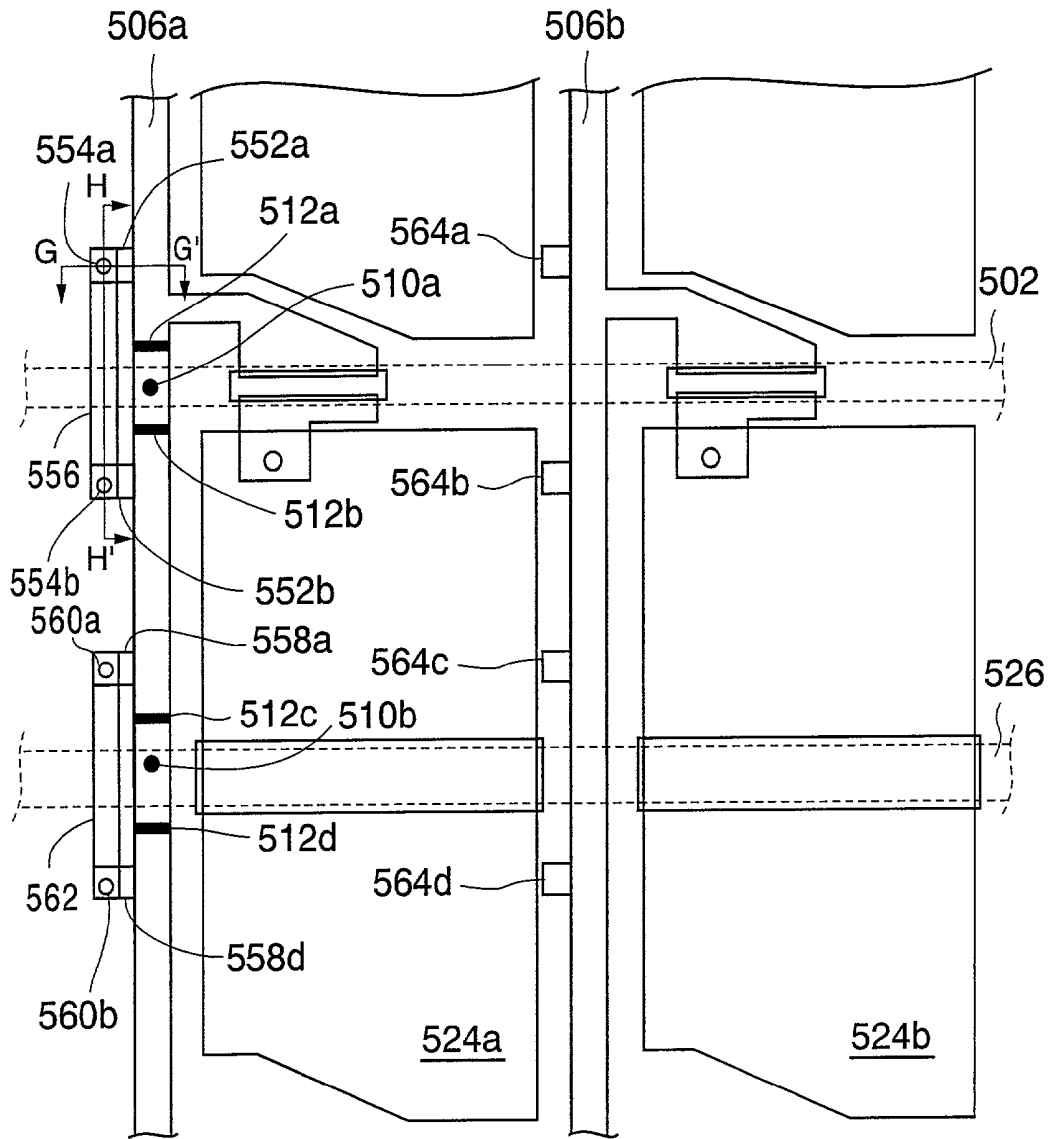
FIG.46

[0105] FIG. 46 is a schematic sectional view (#1) showing the example 4 of the fault repairing method according to the second embodiment of the present invention;

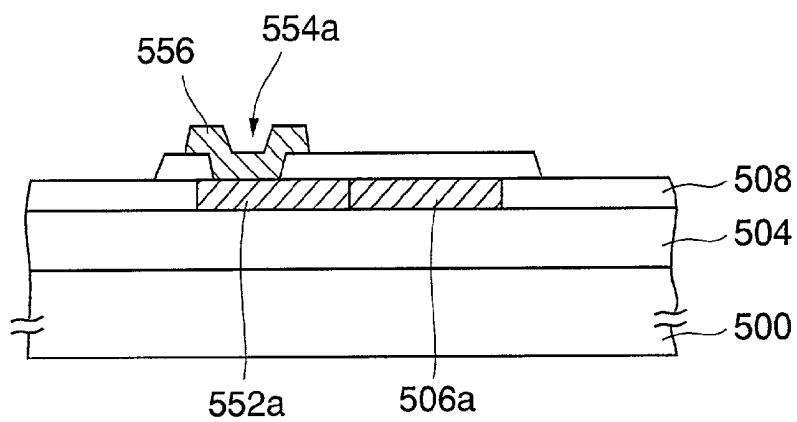
FIG.47

[0106] FIG. 47 is a schematic sectional view (#2) showing the example 4 of the fault repairing method according to the second embodiment of the present invention;

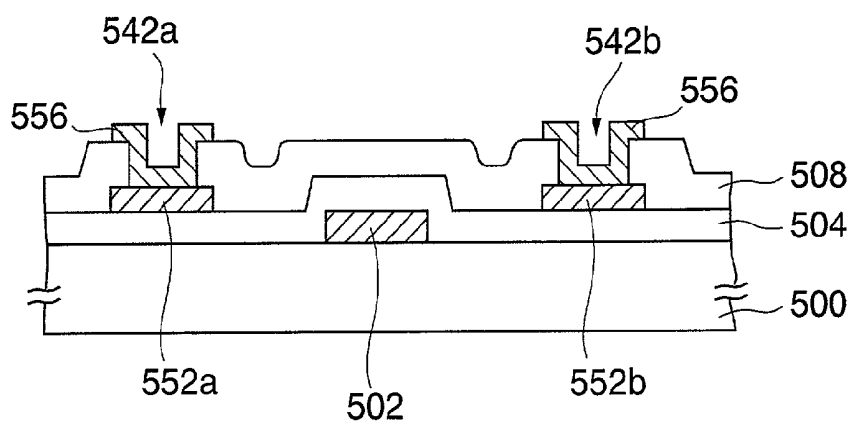
FIG.48

[0107] FIG. 48 is a plan view showing an outline of an example 5 of the liquid crystal display device and its fault repairing method according to the second embodiment of the present invention;

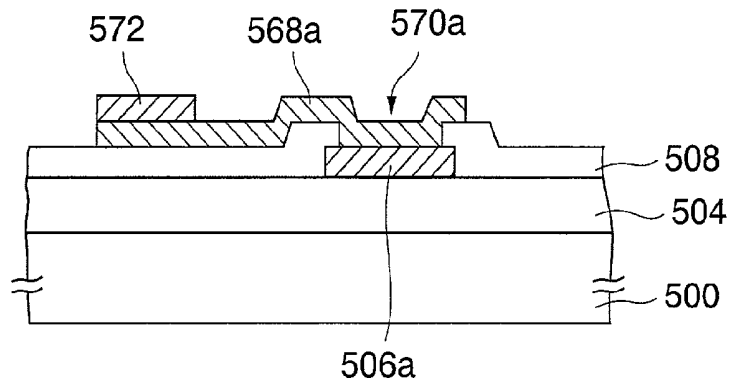
FIG.49

[0108] FIG. 49 is a schematic sectional view showing the example 5 of the fault repairing method according to the second embodiment of the present invention;
