(10) **Pub. No.: US 2001/0028418 A1**

(54) **LIQUID CRYSTAL DISPLAY DEVICE AND
FAULT REPAIRING METHOD FOR THE
LIQUID CRYSTAL DISPLAY DEVICE**

There is provided a fault repairing method for a liquid crystal display device capable of repairing simply a disconnected portion when a disconnection fault occurs in a display panel. For example, it is on the assumption that the disconnected portion is present in a data bus line. Disconnection repairing contact holes that have a width larger than that of the data bus line are formed in a protection insulating film on the data bus line on both sides of the disconnected portion respectively. Then, a laser CVD film (metal film) for covering inner surfaces of the disconnection repairing contact holes is formed by the laser CVD method, and then respective laser CVD films are connected electrically.

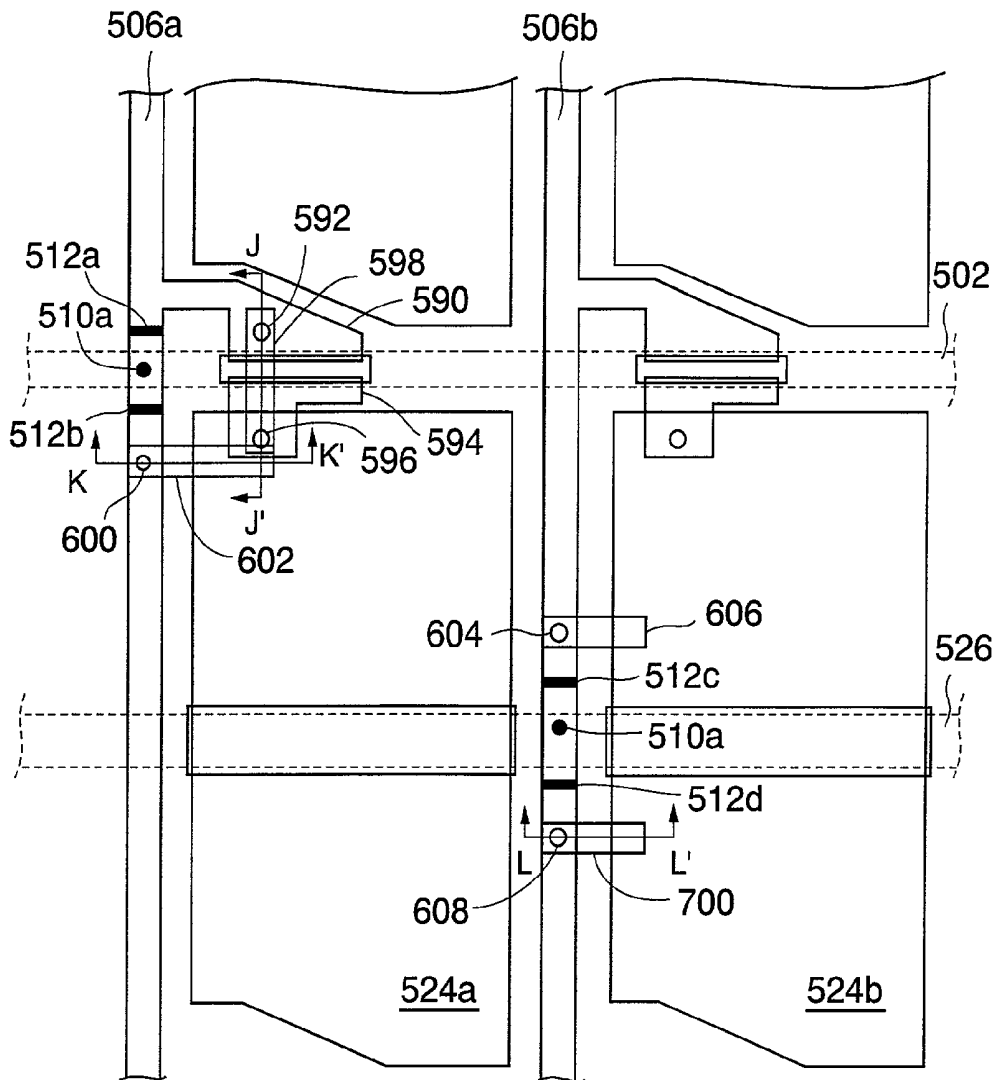
FIG.50

[0109] FIG. 50 is a plan view showing an outline of an example 6 of the liquid crystal display device and its fault repairing method according to the second embodiment of the present invention;

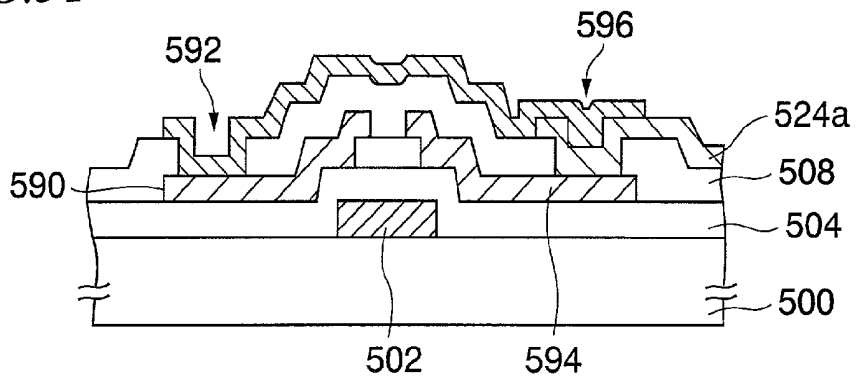
FIG.51

[0110] FIG. 51 is a schematic sectional view (#1) showing the example 6 of the fault repairing method according to the second embodiment of the present invention;

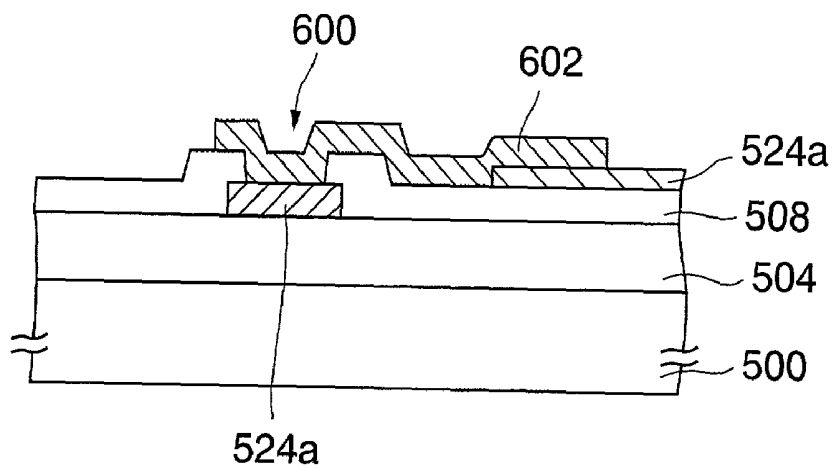
FIG.52

[0111] FIG. 52 is a schematic sectional view (#2) showing the example 6 of the fault repairing method according to the second embodiment of the present invention;

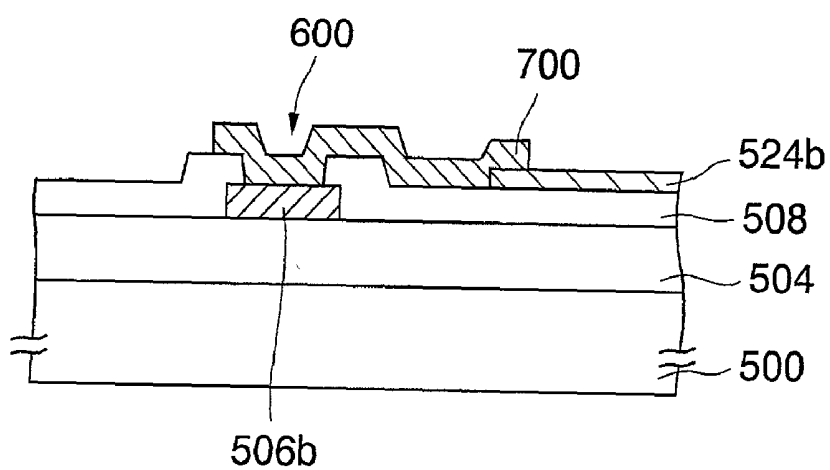
FIG.53

[0112] FIG. 53 is a schematic sectional view (#3) showing the example 6 of the fault repairing method according to the second embodiment of the present invention;

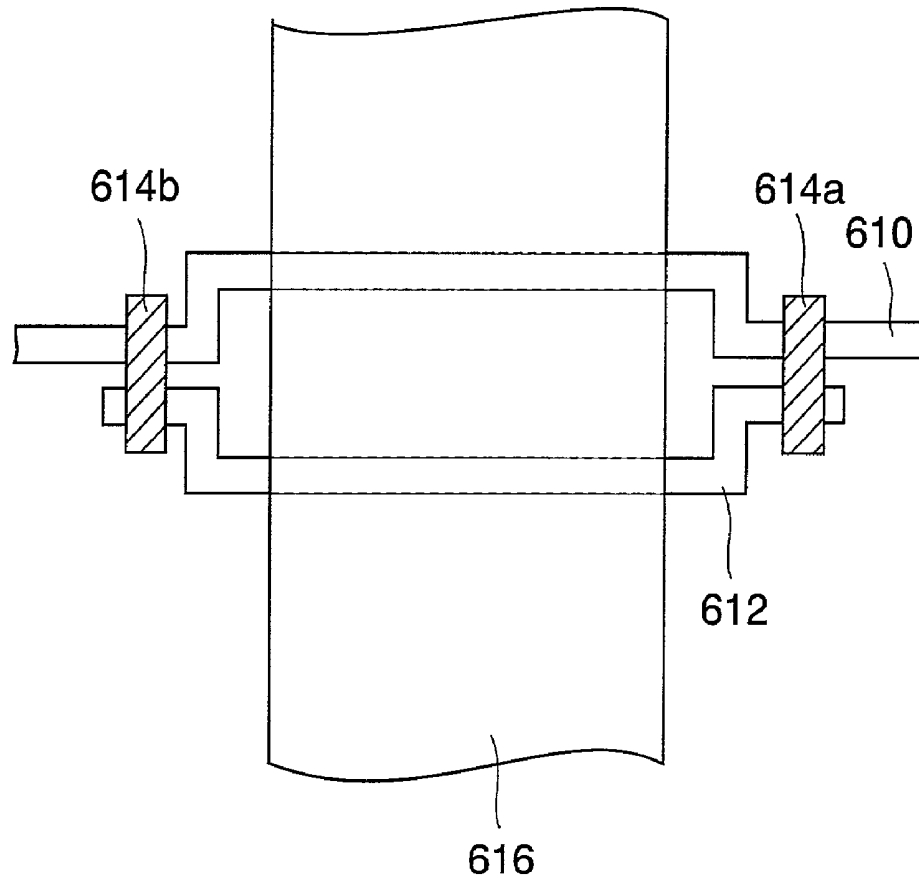
[0113] FIG. 54 is a view (#1) showing the principle of the invention used in a third embodiment of the present invention;

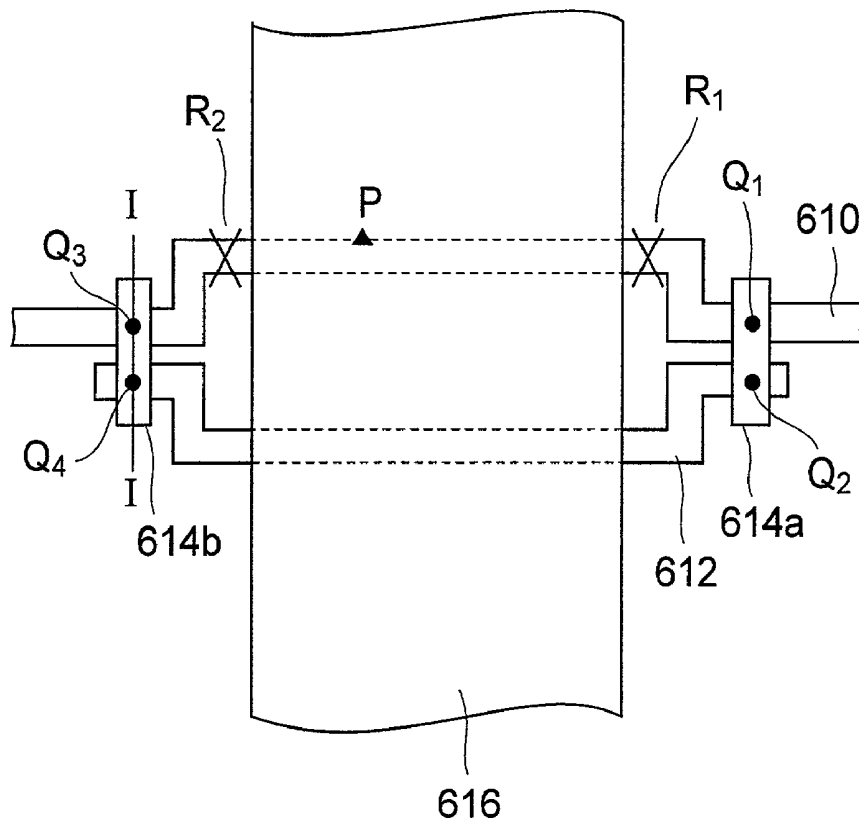
FIG.55

[0114] FIG. 55 is a view (#2) showing the principle of the invention used in the third embodiment of the present invention, i.e., a view showing a short-circuit repairing method;

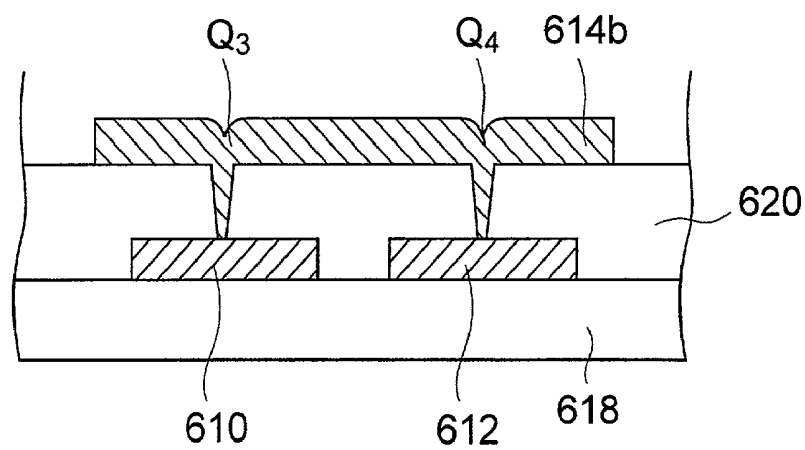
FIG.56

[0115] FIG. 56 is a view (#3) showing the principle of the invention used in the third embodiment of the present invention, i.e., a sectional view taken along a I-I line in FIG. 55;

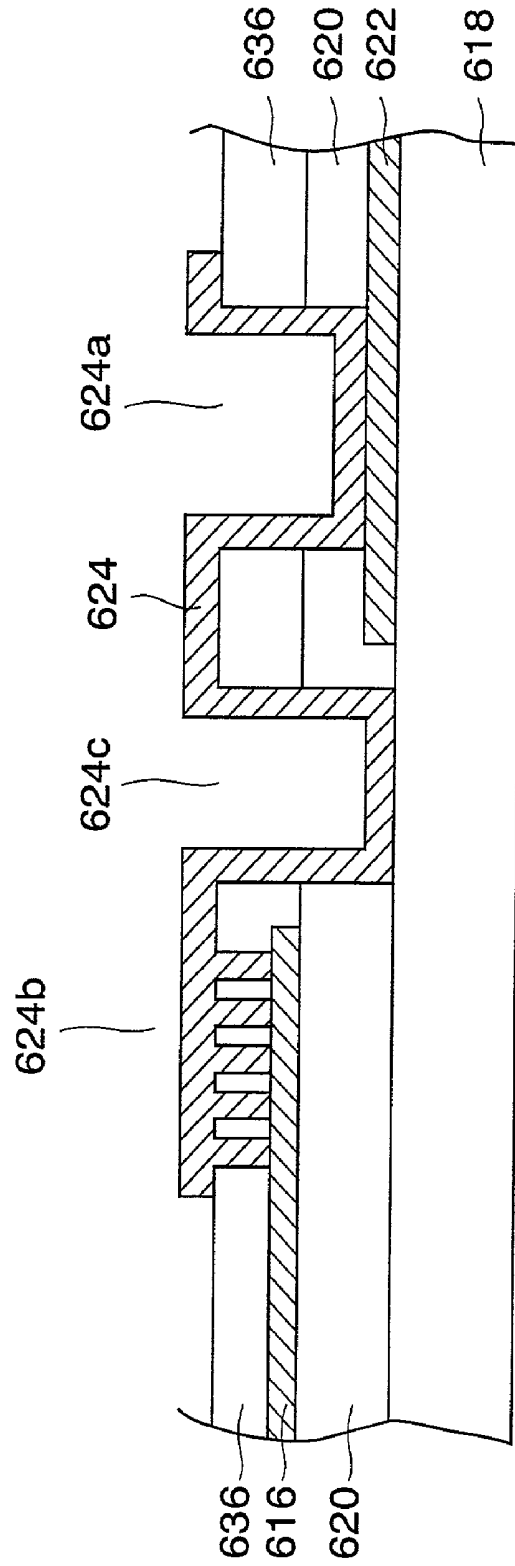
FIG.59

[0118] FIG. 59 is a sectional view taken along a II-II line in FIG. 58;

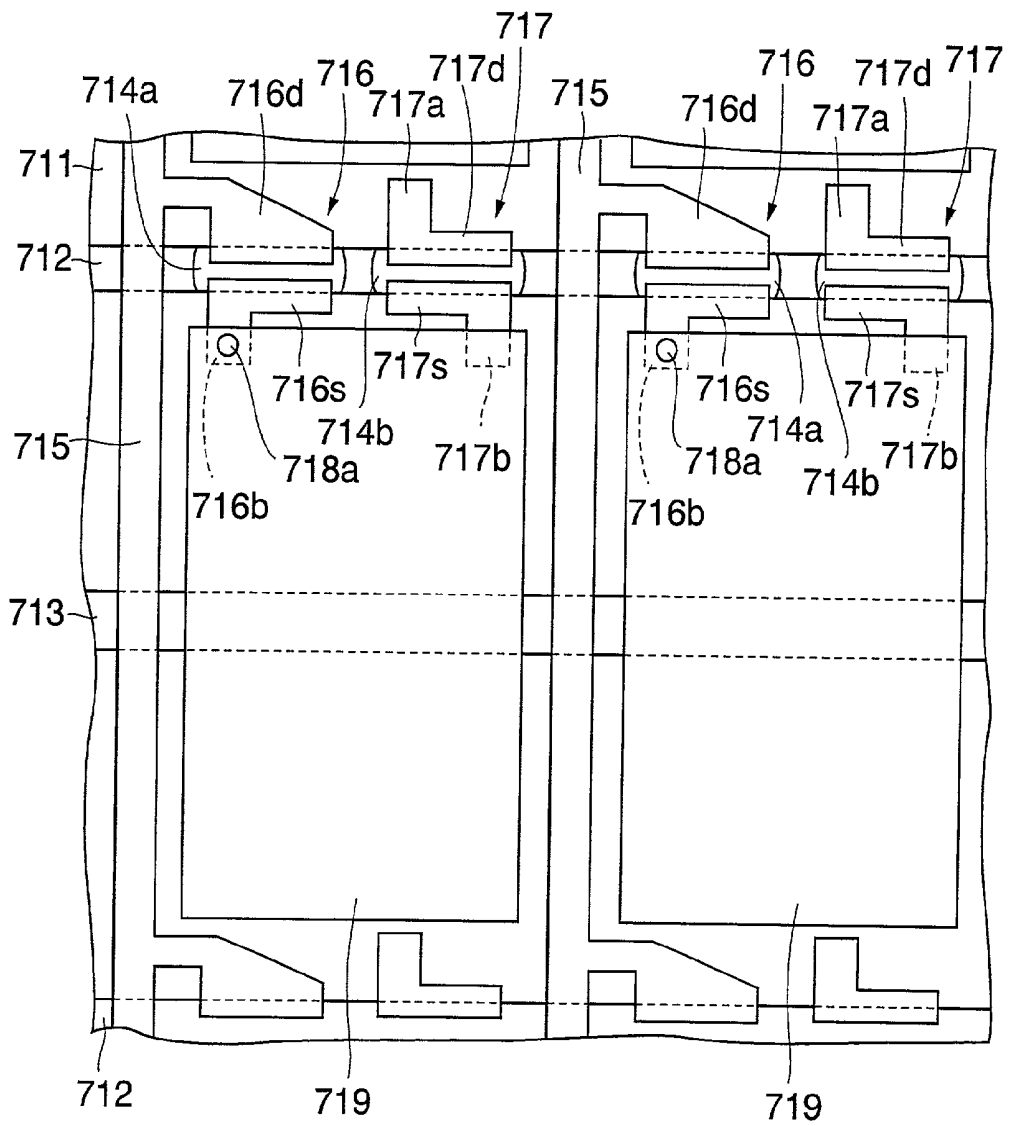
[0119] FIG. 60 is a plan view showing a TFT substrate of a liquid crystal display device according to a fourth embodiment of the present invention;

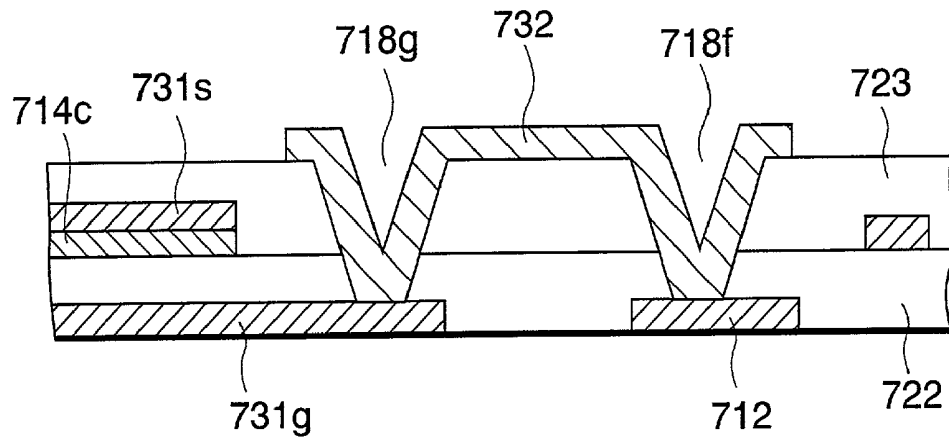
FIG.68

[0127] FIG. 68 is a sectional view taken along a III-III line in FIG. 67;

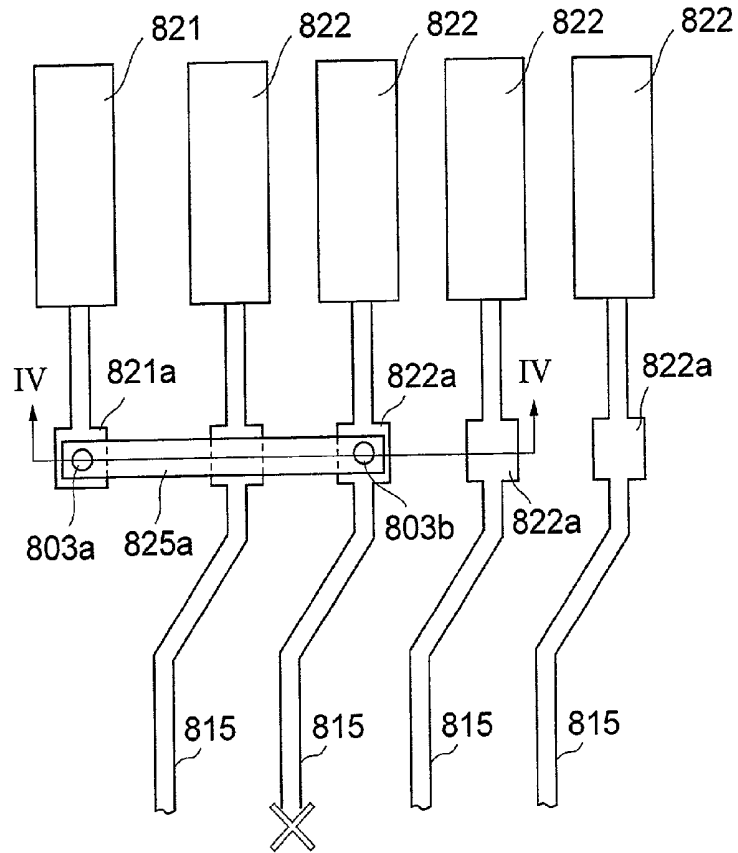
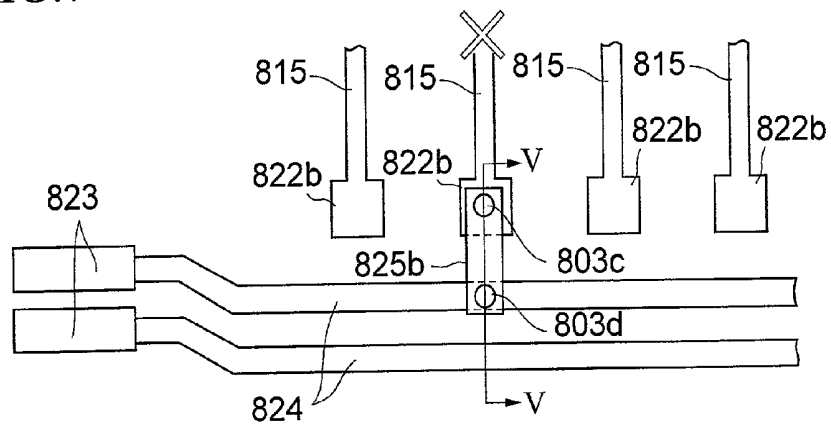
[0129] FIGS. 70A and 70B are schematic views showing an example of a fault repairing method according to the eighth embodiment of the present invention;

[0378] The fault repairing method for the liquid crystal display device according to the eighth embodiment will be explained with reference to FIGS. 70A and 70B and FIGS. 71A and 71B hereunder. FIG. 71A is a sectional view taken along a IV-IV line in FIG. 70A, and FIG. 71B is a sectional view taken along a V-V line in FIG. 70B.

[0379] In this eighth embodiment, it is on the assumption that the disconnection of the data bus line **815** occurs at portions indicated by a \times mark in FIGS. 70A and 70B. Also, in FIGS. 71A and 71B, **802** denotes the first insulating film (gate insulating film) provided to the TAB substrate **800**, and **803** denotes the second insulating film (protection insulating film).

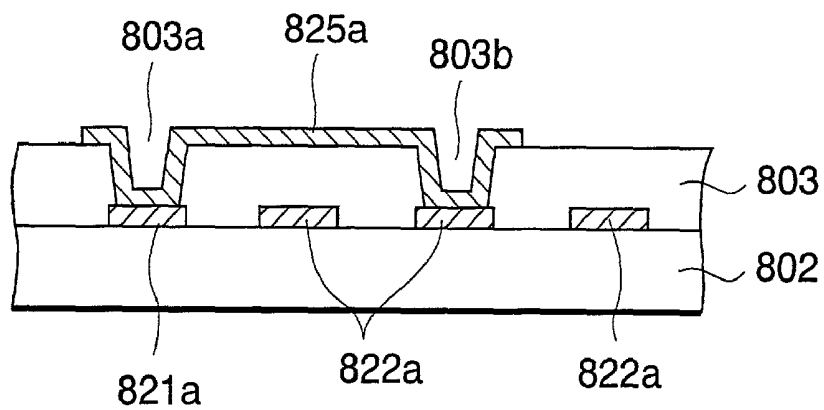
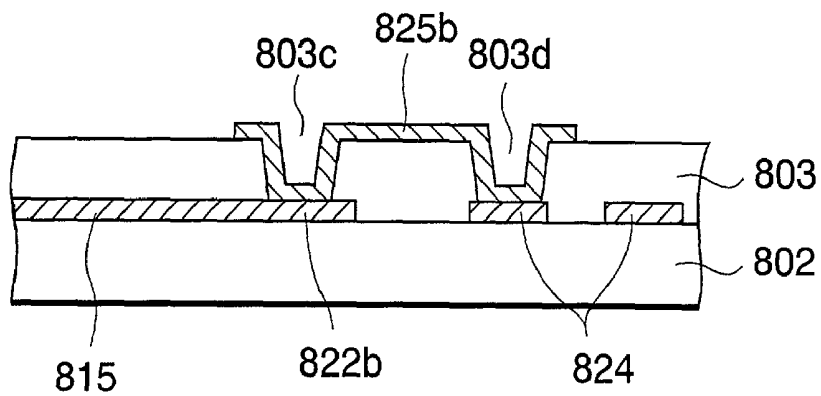
FIG.71A

[0130] FIGS. 71A and 71B are sectional views taken along a IV-IV line and a V-V line in FIG. 70A and 70B respectively;

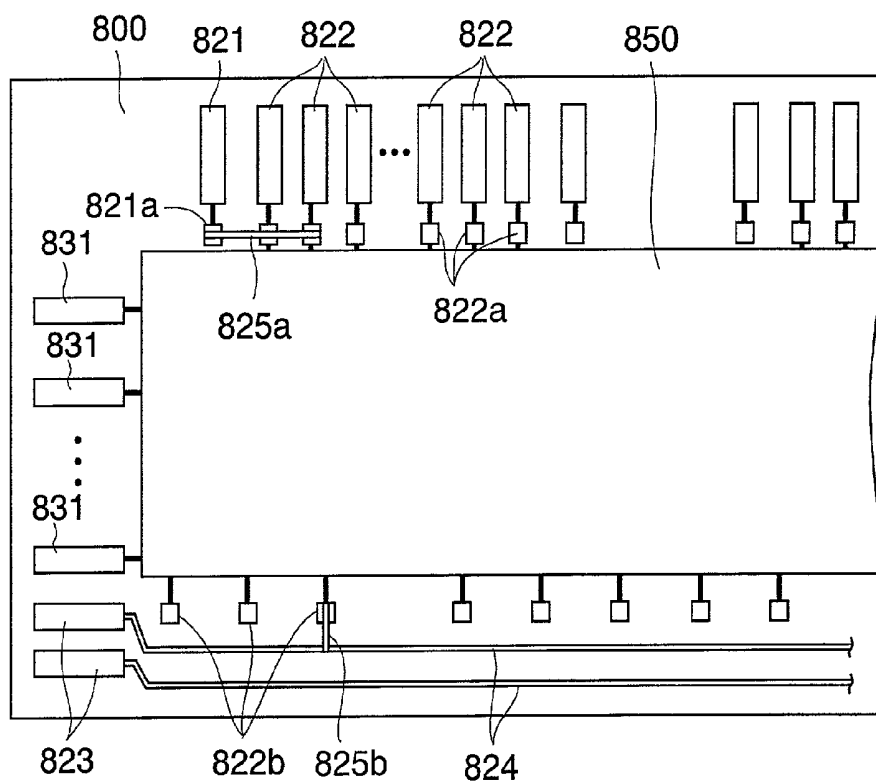
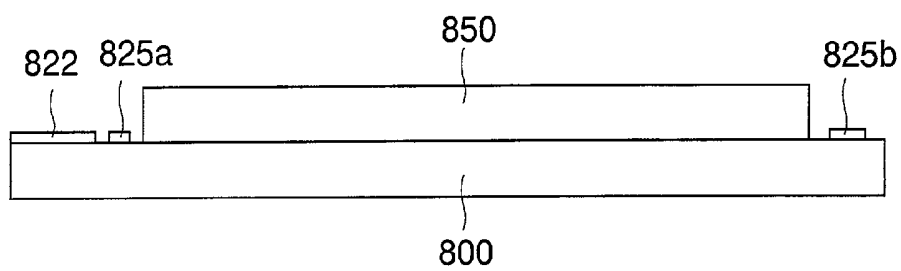
[0131] FIGS. 72A and 72B are views showing another example of the fault repairing method according to the eighth embodiment of the present invention, i.e., views showing an example in which repair terminals and repair wirings are arranged on the outside of a CF substrate;

[0387] Furthermore, as shown in a plan view of FIG. 72A and a side view of FIG. 72B, if the repair terminals **821a**, **822a**, **822b** and the repair wiring **824** are arranged on the outside of the CF substrate **850**, the disconnection of the data bus line **815** can be repaired after the TFT substrate **800** and the CF substrate **850** are jointed together.

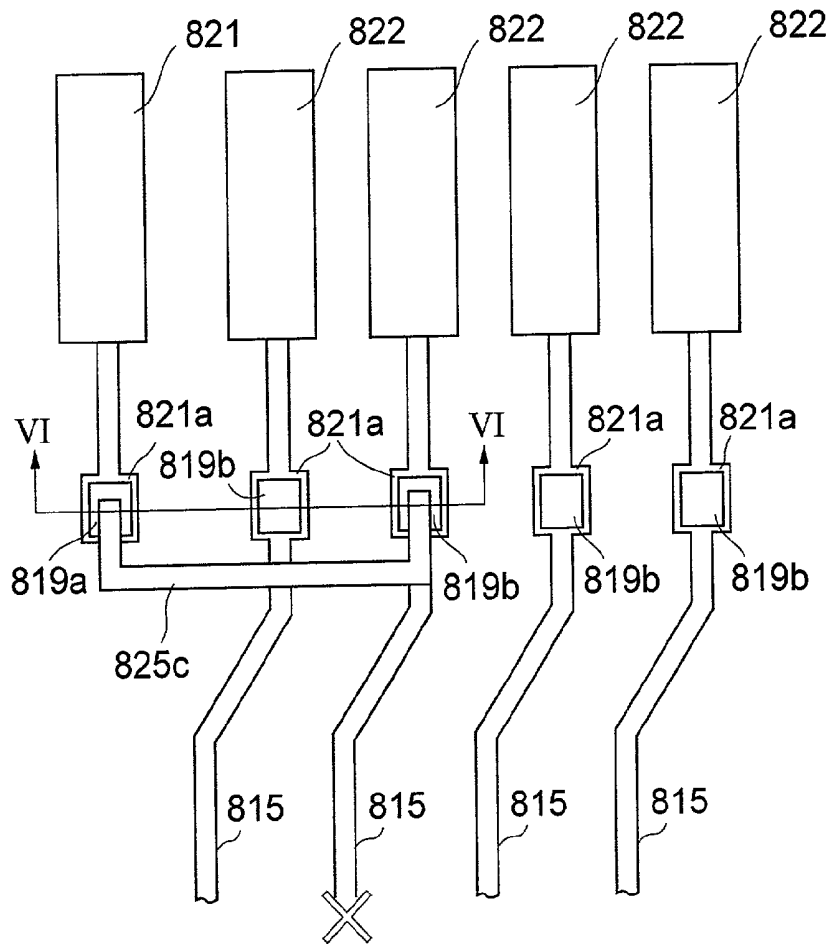
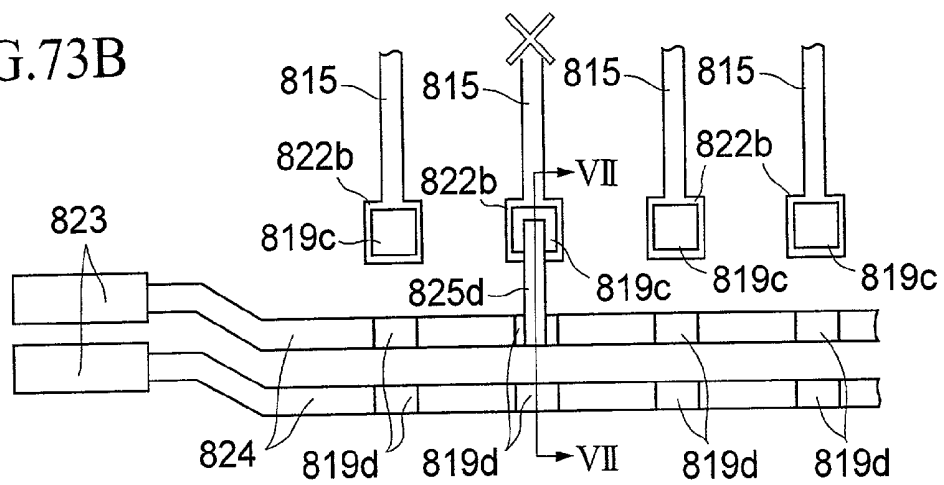
FIG. 73B

[0132] FIGS. 73A and 73B are schematic views showing a fault repairing method according to a ninth embodiment of the present invention; and

[0389] A ninth embodiment of the present invention will be explained with reference to FIGS. 73A and 73B and FIGS. 74A and 74B hereunder. Since the ninth embodiment is basically similar to the eighth embodiment except that the conductive pattern forming method is different, their detailed explanation will be omitted by affixing the same symbols to the same constituent elements in FIGS. 73A, 73B and FIGS. 74A, 74B as those in FIGS. 70A, 70B and FIGS. 71A, 71B. FIG. 74A is a sectional view taken along a VI-VI line in FIG. 73A, and FIG. 74B is a sectional view taken along a VII-VII line in FIG. 73B.

[0392] If the disconnection of the data bus line **815** is caused at a position indicated by a \times mark, as shown in **FIGS. 73A and 73B**, for example, on the TFT substrate constructed in this manner, the conductive pattern **825c** for connecting the pad **819a** and the pad **819b** and the conductive pattern **825d** for connecting the pad **819c** and the pad **819d** are formed by the laser CVD method or by baking the conductive paste.

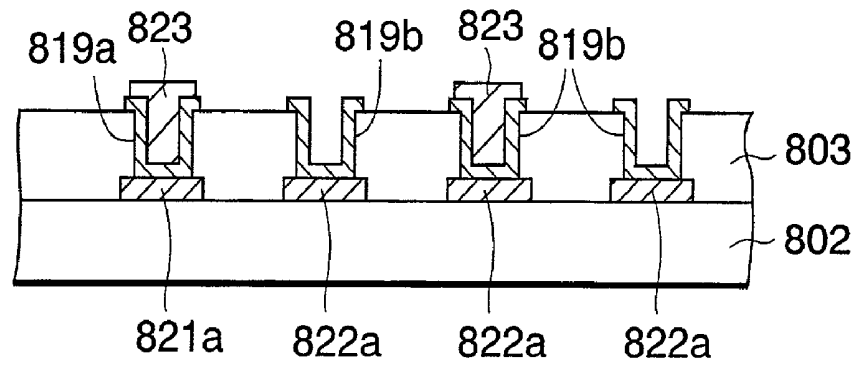
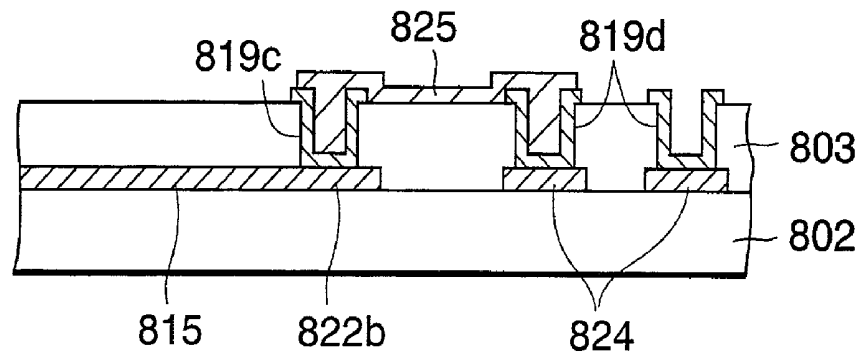
FIG. 74B

[0133] FIGS. 74A and 74B are sectional views taken along a VI-VI line and a VII-VII line in FIGS. 73A and 73B respectively.
