(12) **United States Patent**
Hong et al.

(10) **Patent No.:** **US 6,867,823 B2**
(45) **Date of Patent:** **Mar. 15, 2005**

(54) **PROCESS AND STRUCTURE FOR REPAIRING DEFECT OF LIQUID CRYSTAL DISPLAY**

(73) Assignee: **Hannstar Display Corp.**, Taipei (TW)

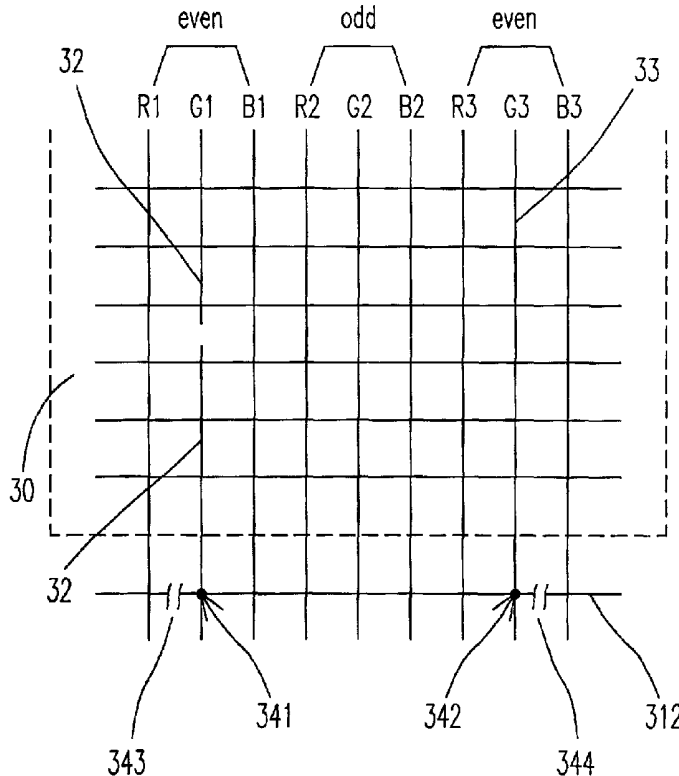
A process for repairing defects applied in producing a liquid crystal display, wherein the liquid crystal display includes a pixel array formed by a plurality of scanning lines crossing with a plurality of data lines. The process includes steps of providing an essential repair line located on one side of the pixel array, welding a first intersection point of a defecting data line and the essential repair line and a second intersection point of a normal data line adjacent to the defecting data line and the essential repair line by a first laser to achieve electrical connection, and cutting a first breaking point and a second breaking point of the essential repair line by a second laser to achieve a broken circuit, wherein the first and second intersection points are located two sides of a line segment constructed by the first and second intersection points respectively.

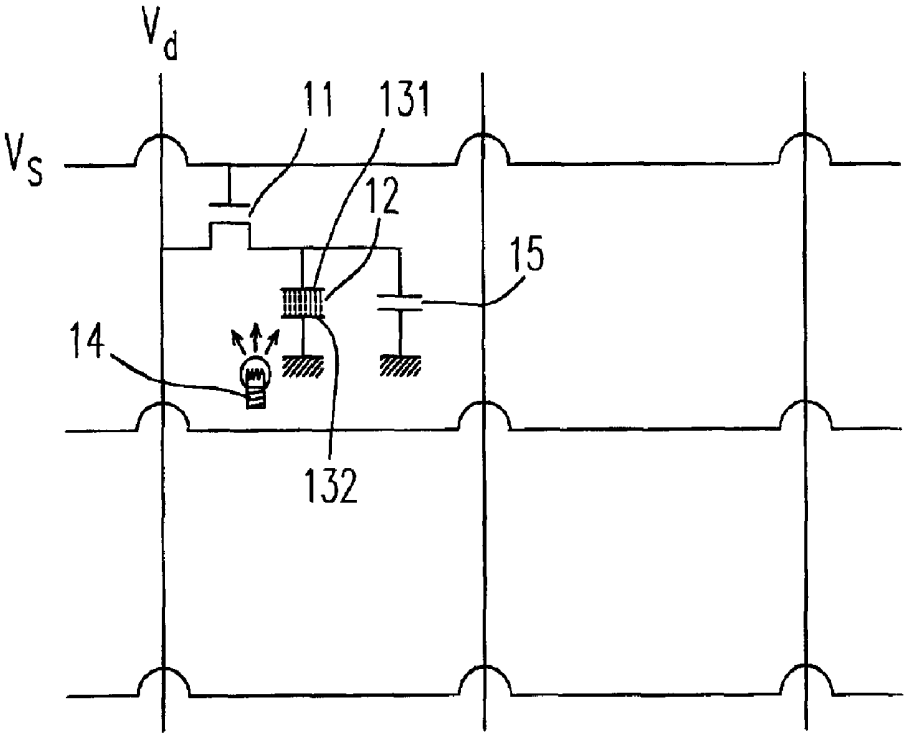
Fig. 1(PRIOR ART)

FIG. 1 is a diagram illustrating a unit circuit block of a thin film transistor liquid crystal display according to the prior art. The thin film transistor **11** is controlled by the voltage V_s of scanning line for switching the statuses of "on" and "off". The voltage V_d of the data line is applied to a liquid crystal **12** located between a pixel electrode **131** and a common electrode **132** for changing the alignment condition of the liquid crystal **12** and further controlling the light penetrating degree of the liquid crystal molecules **12**. Thus, the emissive intensity from a light source **14** at the back of the liquid crystal display will occur change while the light reaches to the eyes of a user for achieving the display effect of the changing in light and shade. The storage capacitance **15** is used for reinforcing the device characteristics.

FIG. 1 is a diagram illustrating a unit circuit block of a thin film transistor liquid crystal display (TFTLCD) according to the prior art;

The thin film transistor liquid crystal display is formed by producing a lot of arrays constructed by the unit circuit as shown in FIG. 1 on a display panel. However, some defects in the data or scanning lines are possible to occur by mistake or through carelessness. For ruling out the defects, a plurality of annular repair lines around an array are established in the layout of the current thin film transistor liquid crystal display. FIG. 2 is a top view illustrating a structure having a plurality of annular repair lines around the array of the thin film transistor liquid crystal display according to the prior art. As shown in FIG. 2, the array **21** has five annular repair lines **201**, **202**, **203**, **204** and **205** therearound. When a data line **22** of the array **21** has a breaking point occurred, the regions **2011** and **2012** are welded and the regions **2013** and **2014** are cut by laser for achieving the repairing effect.

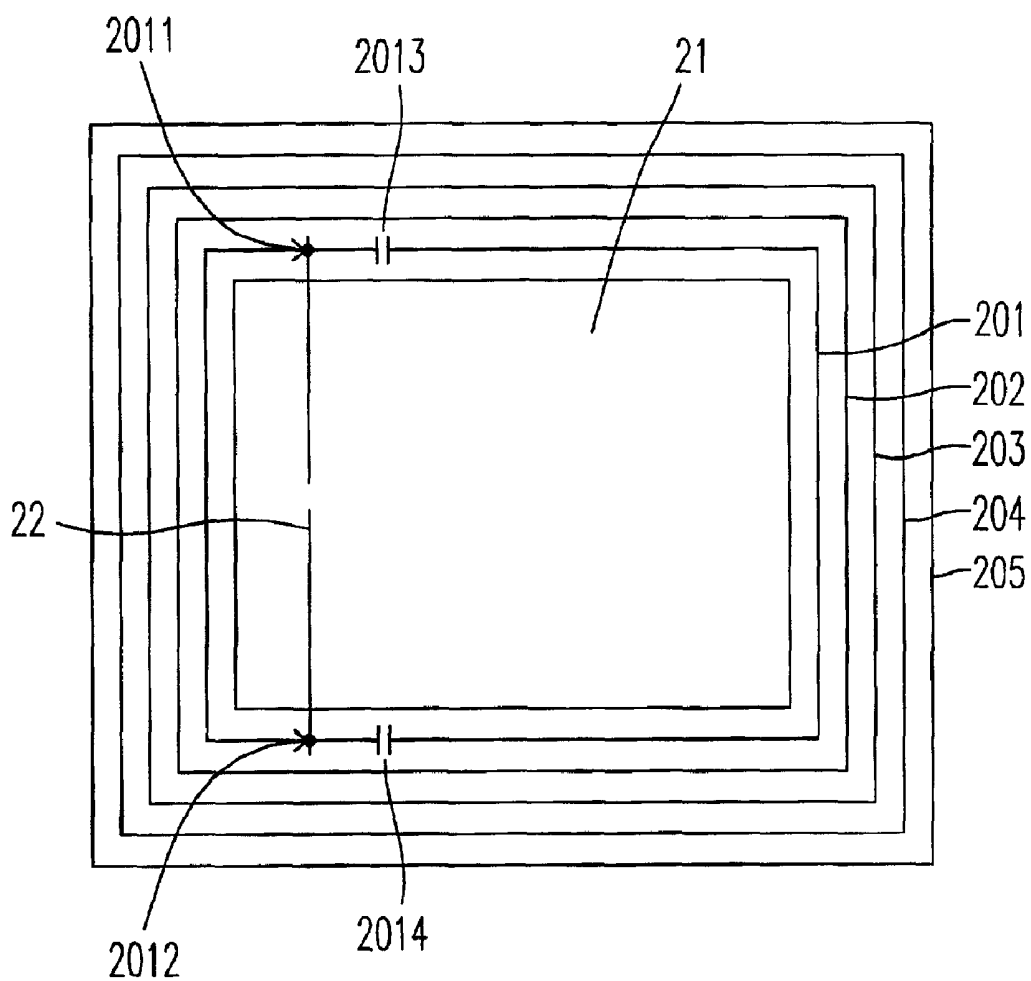
Fig. 2(PRIOR ART)

FIG. 2 is a top view illustrating a structure having a plurality of annular repair lines around an array of the thin film transistor liquid crystal display according to the prior art;

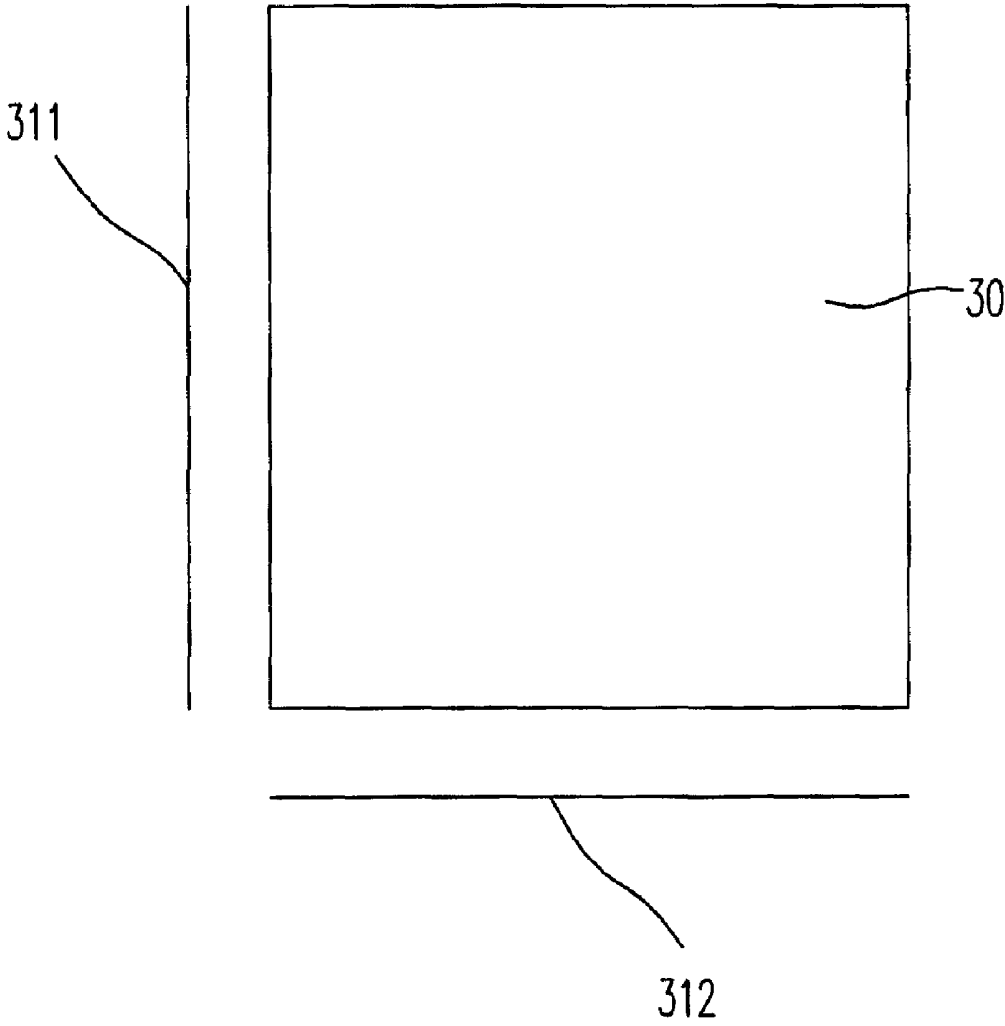
Fig. 3A

FIG. 3A is a diagram illustrating a layout structure according to a preferred embodiment of the present invention;

As shown in FIG. 3A, a rectangle pixel array 30 of the liquid crystal display has a plurality of scanning lines (not shown) and a plurality of data lines (not shown). The present invention provides a repair line 311, 312 located outside of the rectangle pixel array 30, e.g. at one end of the scanning lines or the data lines, for achieving the structure of repairing defects.

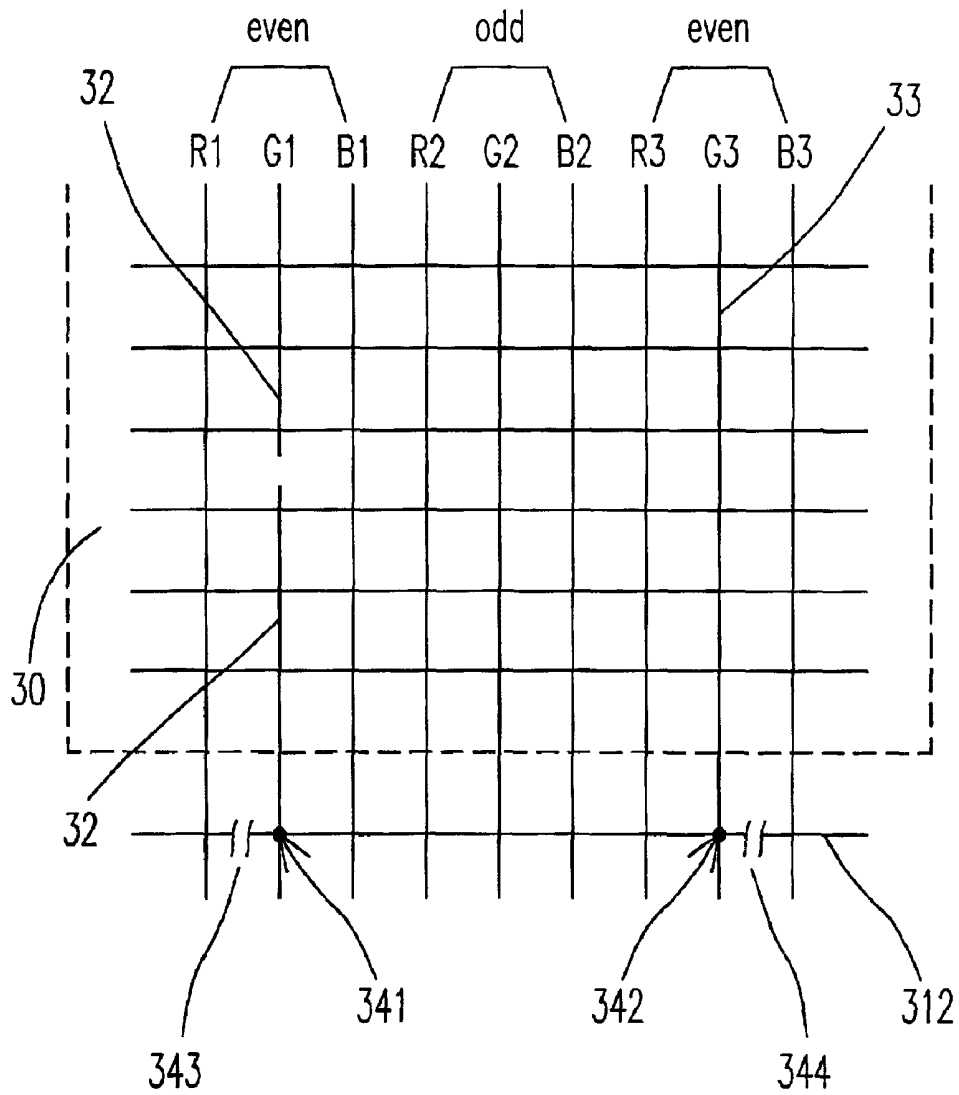
Fig. 3B

FIG. 3B is a diagram illustrating a portion of the layout structure according to the preferred embodiment of the present invention;

The present invention provides a process for repairing defects of a thin film transistor liquid crystal display. Referring to FIG. 3B, a defecting data line 32 is occurred in a portion of layout structure. The process for repairing the defect data line 32 is performed by welding a first intersection point 341 of the defecting data line 32 and the repair line 312 and a second intersection point 342 of a normal data line 33 adjacent to the defecting data line 32 and the repair line 312 by a first laser to achieve electrical connection, and then cutting a first breaking point 343 and a second breaking point 344 of the repair line 312 by a second laser to achieve a broken circuit. As shown in FIG. 3B, the first and second intersection points 343 and 344 are located two sides of a line segment constructed by the first and second intersection points 341 and 342 respectively. Thus, a signal of the normal data line 33 can pass the second intersection point 342 and the first intersection point 341 to repair the defecting data line 32. In addition, the wavelength of the first laser is preferably 1064 nm while the wavelength of second laser, which requires higher energy, is preferably 532 nm.

The selection of the normal data line 33 adjacent to the defecting data line 32 is in accordance with the transmission of the driving system. Generally, for a set of three primary colors (RGB) and even/odd transmission, the normal data

line **33** having the same primary color and the same even (or odd) is preferably selected as shown in FIG. **3B**.

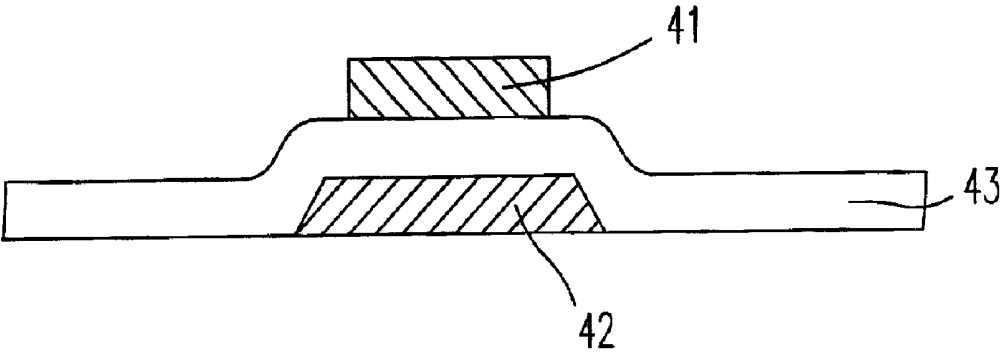
Fig. 4
(PRIOR ART)

In addition, FIG. 4 is a schematic view illustrating a repair structure for a liquid crystal display according to a prior art. When a defect is discovered, an insulation layer **43** between a first metal layer **41** and a second metal layer **42** is needed to be destroyed by a laser. Subsequently, the first metal layer **41** is burned to melt, and the first metal layer **41** is welded with the second metal layer **42** to accomplish the repair.

FIG. 4 is a schematic view illustrating a repair structure according to a prior art; and

Because the melting point of aluminum is in the range from about 550° C. to 660° C., aluminum is beneficial to the performance of welding. The first metal layer **41** is usually made of aluminum. However, due to the low melting point of aluminum, aluminum is easily splashed around when the welding is performed by the laser. Furthermore, a short circuit, a broken circuit, or a Schottky contact is happened to a contact point.

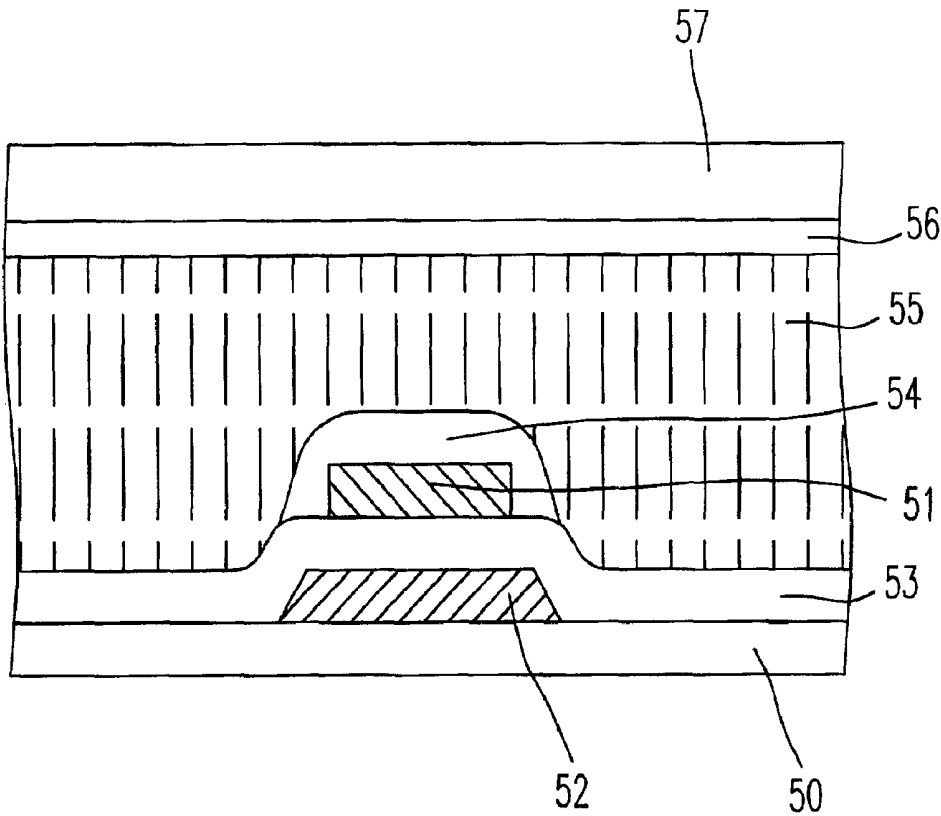
Fig. 5

FIG. 5 is a schematic view illustrating a repair structure according to a preferred embodiment of the present invention.

In addition, the repair line includes a second metal layer **52**, an insulation layer **53**, and a first metal layer **51** formed in sequence on a glass substrate **50** as shown in FIG. **5**. A coating layer **54** is made of a material having a higher melting point than the first metal layer **51**. Furthermore, a liquid crystal **55** and a color filter **56** are disposed between the second metal layer **52** and a second glass substrate **57**.

When a defect of the LCD is found, the insulation layer **53** is destroyed by a laser and the first metal layer **51** is burned to melt. Subsequently, the first metal layer **51** is welded with the second metal layer **52** to accomplish the repair. In the meantime, the coating layer **54** could avoid a splash formed by the first metal layer **51** which is in a melting state. Furthermore, the undesirable contact such as a short circuit, a broken circuit, or a Schottky contact could be avoided.

According to the present invention, the first metal layer **51** is made of aluminum, and the insulation layer **53** is made of silicon nitride (SiN_x). In addition, the coating layer **54** is made of indium tin oxide. The melting point of indium tin oxide is about 1000°C . which much higher than the melting point of aluminum ($550\text{--}660^\circ\text{C}$.), so the coating layer **54** is preferably made of indium tin oxide.

According to the present invention, the second metal layer **52** is made of a conducting material having a melting point much higher than 1000°C . selected from a group consisting of chromium, molybdenum, tungsten molybdate and the combination thereof.

The wavelength of the laser is preferred 1064 nanometer. The intensity of the laser is preferred low energy. Certainly, the repair structure could be inverted, so the second glass substrate **57** is in the bottom and the first glass substrate **50** is on the top. The laser passes from the first glass substrate **50** inward to the repair structure.

According to the present invention, the coating layer **54** coating on the first metal layer **51** could effectively avoid the splashing. Furthermore, the proper wavelength and intensity of the laser could make a good ohmic contact between the first metal layer **51** and the second metal layer **52**.
