(10) **Patent No.:** **US 7,515,243 B2**
(45) **Date of Patent:** **Apr. 7, 2009**

(54) **DISPLAY DEVICE AND METHOD FOR
REPAIRING LINE DISCONNECTION
THEREOF**

(73) Assignee: **Mitsubishi Electric Corporation**,
Tokyo (JP)

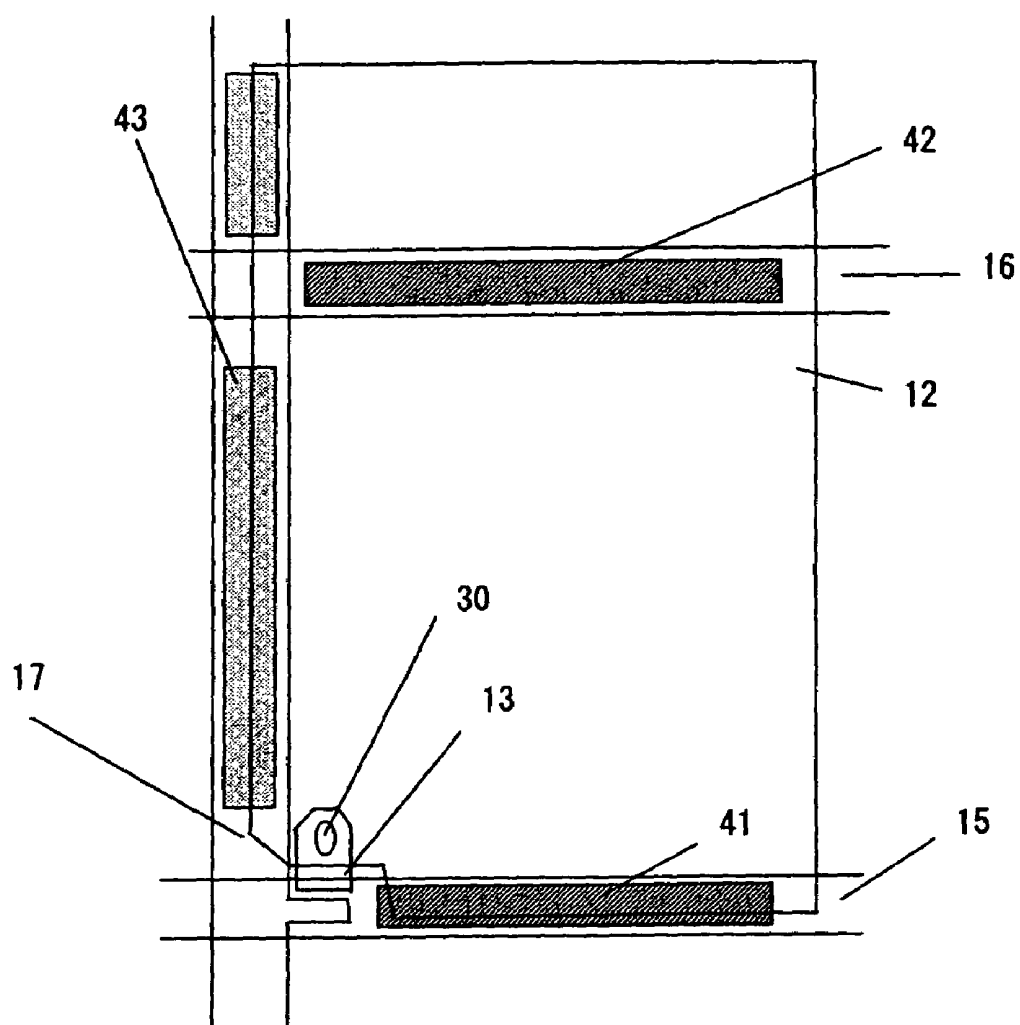
FIG. 1 is a plan view showing a structure of one pixel area of a liquid crystal display device according to the first embodiment of the present invention.

A method for repairing line disconnection according to the present invention will be explained hereinafter with reference to FIGS. 1 to 4. FIG. 1 is a plan view showing a structure of one pixel area of an active matrix liquid crystal display device according to the present invention. FIG. 2 is a plan view showing a structure of the pixel area where each of a gate line, source line, and storage capacitor line has a disconnected portion 28. FIG. 3A is a sectional view showing a structure of the disconnected portion of the gate line. FIG. 4 is a sectional view showing a structure of a TFT area of the active matrix liquid crystal display device. Reference numeral 11 designates a substrate, 12 a pixel electrode, 13 a thin film transistor (TFT), 14 a drain electrode, 15 a gate line, 16 a storage capacitor line, 17 a source line, 21 a gate electrode, 22 a gate insulating film, 23 a silicon semiconductor layer, 24 an etching stopper, 25 the first n⁺ silicon layer, 26 the second n⁺ silicon layer, 27 a source electrode, 28 a disconnected portion, 29 a molten metal, 30 a contact hole, 41 a conductive layer for repairing gate line disconnection, 42 a conductive layer for repairing storage capacitor line disconnection, and 43 a conductive layer for repairing source line disconnection.

As shown in FIG. 1, the pixel electrode 12 is connected with the TFT 13 that is a switching element. The gate electrode 21 of the TFT 13 is connected with the gate line 15, and gate signals input to the gate electrode 21 drives and controls the TFT 13. The source electrode 27 of the TFT 13 is connected with the source line 17, and data (display) signals are input to the drain electrode 14 shown in FIG. 4 through the TFT 13 when the TFT 13 is selected. From the drain electrode 14, the data signals are input to the pixel electrode 12 through the contact hole 30. The gate line 15 and the source line 17 cross each other at right angles, surrounding the pixel electrode 12. The drain electrode 14 of the TFT 13 is connected with the pixel electrode 12. The conductive layer 41, the conductive layer 43, and the conductive layer 42 are provided for the gate line 15, the source line 17, and the storage capacitor line 16, respectively. The conductive layers are island shaped or electrically floating.

If the storage capacitor line 16 is provided between the gate lines 15 as shown in FIG. 1, the conductive layer 43 has to avoid electrical contact with the line 16. The conductive layer 43 is preferably as large as possible to enlarge the area where line disconnection can be repaired. If the storage capacitor line 16 is not provided, on the other hand, the conductive layer 43 has to avoid electrical contact with the adjoining gate line 15, while being as large as possible to obtain a larger repairable area. The conductive layer 43 can be formed between the source line 17 and the pixel electrode 12 with an insulating film interposed therebetween.

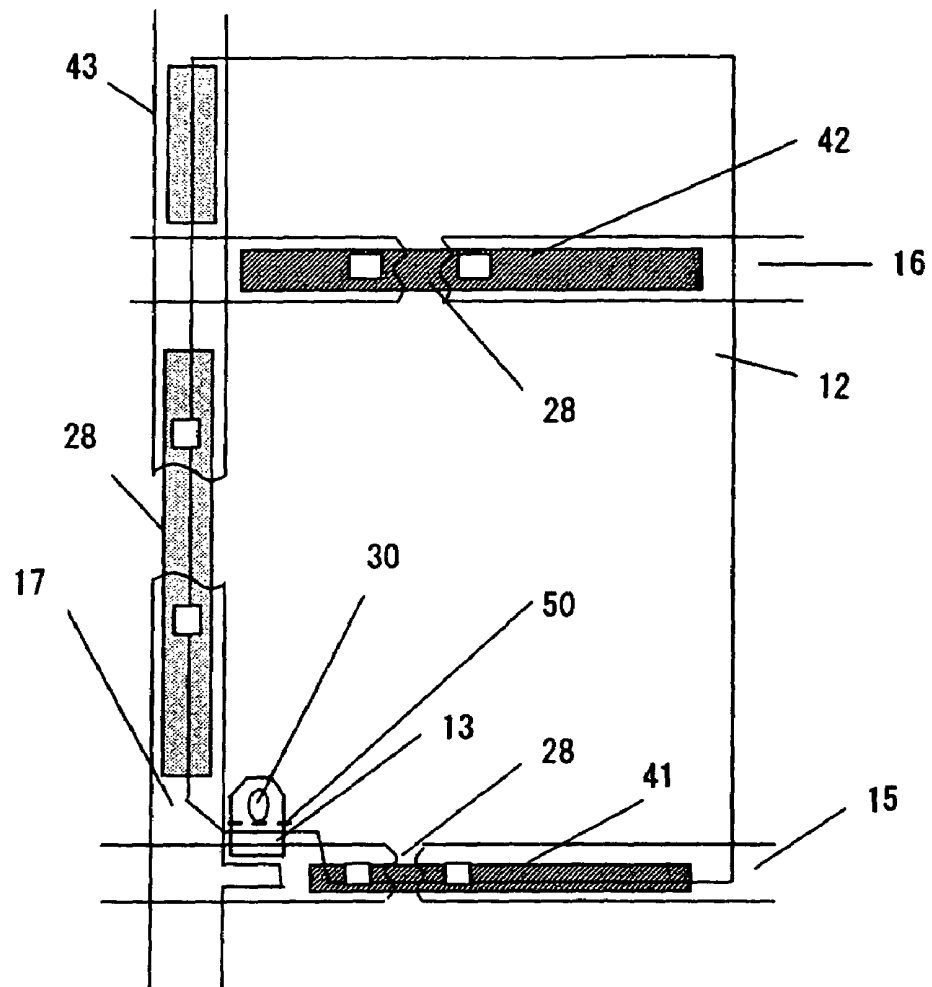
FIG. 2 is a plan view showing a structure of one pixel area of the liquid crystal display device according to the first embodiment of the present invention, where line disconnection occurs.

FIG. 2 shows the case where each of the three lines has the disconnected portion 28. Repair of the disconnection will be explained hereinafter with reference to FIG. 3. The explanation will be given on the repair of the gate line 15. FIG. 3A shows a structure of a cross-section of the disconnected portion of the gate line in one pixel area of an active matrix liquid crystal display device. On the substrate 11 as the bottom layer are provided the gate line 15, the gate insulating film 22, the conductive layer 41, the insulating film 45, and the pixel electrode 12 as the top layer. For example, on the insulating substrate 11 such as a glass substrate, aluminum of approximately 0.3 μm thick is formed as the gate line 15. Next, silicon nitride of approximately 0.3 to 0.5 μm thick is formed as the gate insulating film 22. Then, a conductive metal is provided as the conductive layer 41. The conductive layer 41 melts by laser application. A laser device is a YAG laser, for example. The conductive metal is formed by chromium, tantalum, titanium, aluminum, molybdenum, and the like. Its thickness is approximately 0.1 to 0.2 μm . Further, silicon nitride of approximately 0.1 μm is formed as the insulating film 45.

FIG. 3B shows a cross-section of the gate line 15 when a laser is applied to the square marks on both outsides of the disconnected portion 28 of the gate line 15 shown in FIG. 2. The laser is applied from the side of the gate line which is the side of the substrate 11 where the TFT 13 is not formed. The application of the laser to the marks melts the conductive layer 41 and the gate line 15 to produce the molten metal 29. A bypass route through the gate line 15, the molten metal 29, the conductive layer 41, the molten metal 29 and the gate line 15 is thereby created to let gate signals go through it, avoiding the disconnected portion 28. The disconnection is thereby repaired. Since the bypass route has no contact with the pixel electrode 12, the pixel electrode 12 serves as a shield so that gate signals going through the conductive layer 41 have no adverse effect on liquid crystals arranged on the pixel electrode 12. No error voltage is thereby applied to the pixel electrode 12 to be free from deterioration of display quality.

50 shown in FIG. 2 to separate the pixel from the TFT 13. Though a point defect occurs at the subject pixel, the disconnection of the gate line 15 is repaired. No error voltage is thereby applied to the pixel electrode 12 to prevent deterioration of display quality.

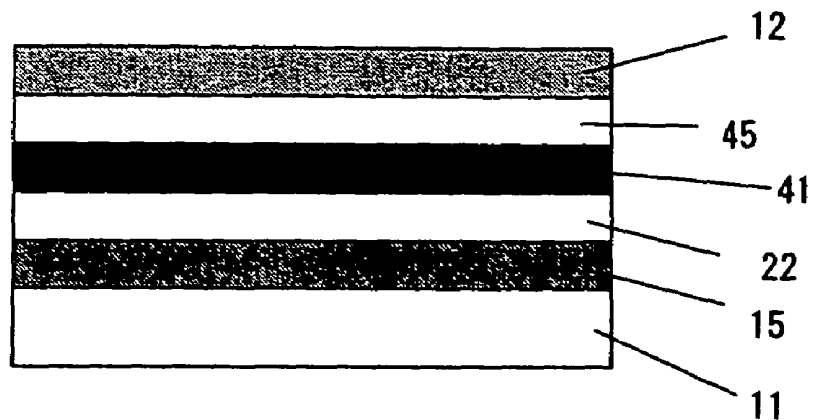
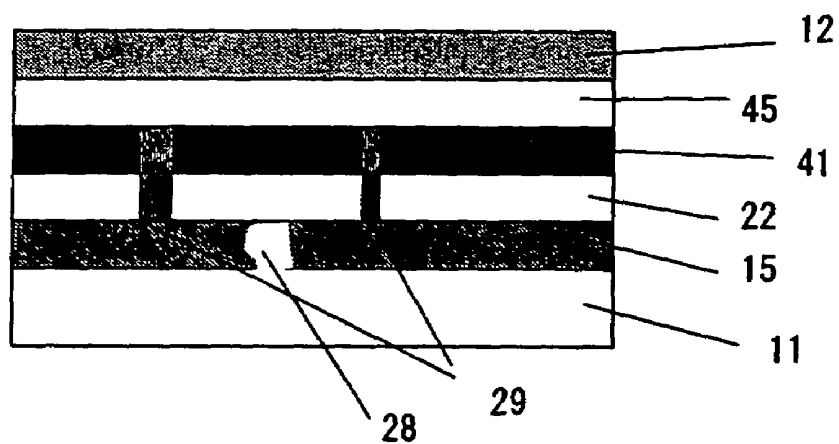
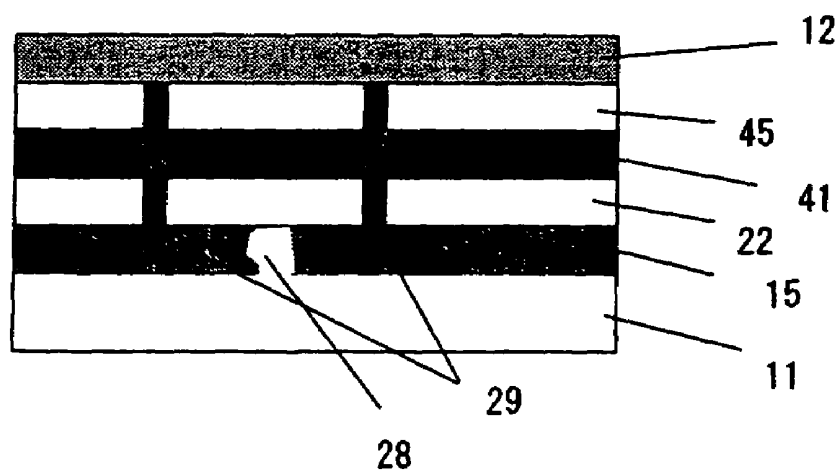
FIGS. 3A, 3B, and 3C are sectional views showing structures of a disconnected portion of a gate line in the liquid crystal display device according to the first embodiment of the present invention.

If a laser is applied from the side of the pixel electrode 12, on the other hand, electrical continuity is provided between the pixel electrode 12 and the gate line 15 as shown in FIG. 3C. Gate signals go through a bypass route through the gate line 15, the molten metal 29, the conductive layer 41, the molten metal 29, and the gate line 15, or through the gate line 15, the molten metal 29, the pixel electrode 12, the molten metal 29, and the gate line 15. The laser is applied to a cut line

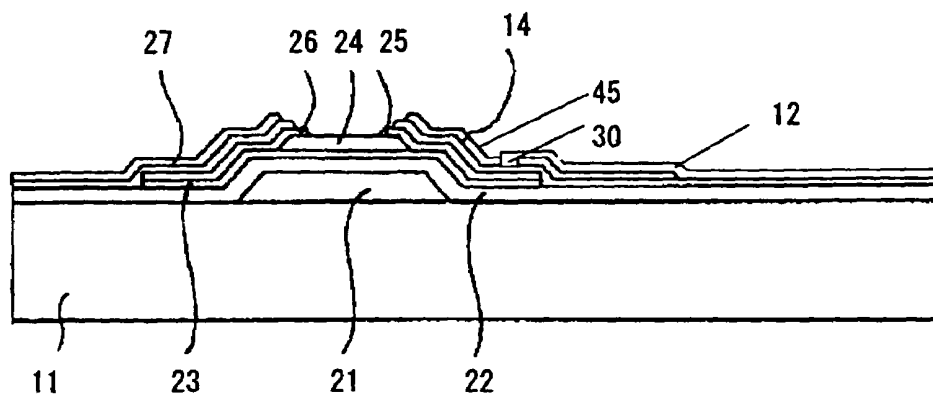
FIG. 4 is a sectional view showing a structure of a TFT area of the liquid crystal display device according to the first embodiment of the present invention.

FIG. 4 shows a sectional view of the TFT area of the active matrix liquid crystal display device. As shown in FIG. 4, on the insulating substrate 11 such as a glass is formed the gate electrode 21. Then, the gate insulating film 22 is formed to cover the gate electrode 21. The silicon semiconductor layer 23 is formed thereon; then, on the middle thereof, the etching stopper 24 as a protective layer of a channel layer, and the insulating layer 45 are successively formed. The gate electrode 21 is formed by patterning a conductive film deposited by sputtering in a photolithography process. The gate insulating film 22, the silicon semiconductor layer 23, and the etching stopper 24 are successively deposited by chemical vapor deposition (CVD), and patterned by the photolithography process.

Next, the first n^+ silicon film 25 and the second n^+ silicon film 26 are formed in isolation from each other. On the second n^+ silicon film 26 is formed the source electrode 27, the two electrically connected. On the first n^+ silicon film 25 is the drain electrode 14, electrically connected. The first n^+ silicon film 25 and the second n^+ silicon film 26 are formed by doping the silicon semiconductor layer 23 with impurities such as P and As. It is therefore possible to form the first n^+ silicon film 25 and the second n^+ silicon film 26 in the same step. The drain electrode 14 and the source electrode 27 are deposited by sputtering, and patterned by the photolithography process.

Then, the contact hole 30 is formed on the insulating film 45 to electrically connect the pixel electrode 12 and the drain electrode 14. The contact hole 30 is formed in the process of resist coating, exposure, development, etching, resist stripping, and so on. The pixel electrode 12 is formed thereon by depositing ITO by sputtering to have electrical connection with the drain electrode 14. The conductive layer 41 according to the present embodiment can be formed in the same layer as the drain electrode shown in FIG. 4. That is, in patterning the conductive layer to form the drain electrode 14 and the source electrode 27, the conductive layer is also left on the gate line 15 as the conductive layer 41. No additional step is therefore required to form the conductive layer 41. Similarly, the insulating layer 45 can be formed at the same time as forming the TFT 13.

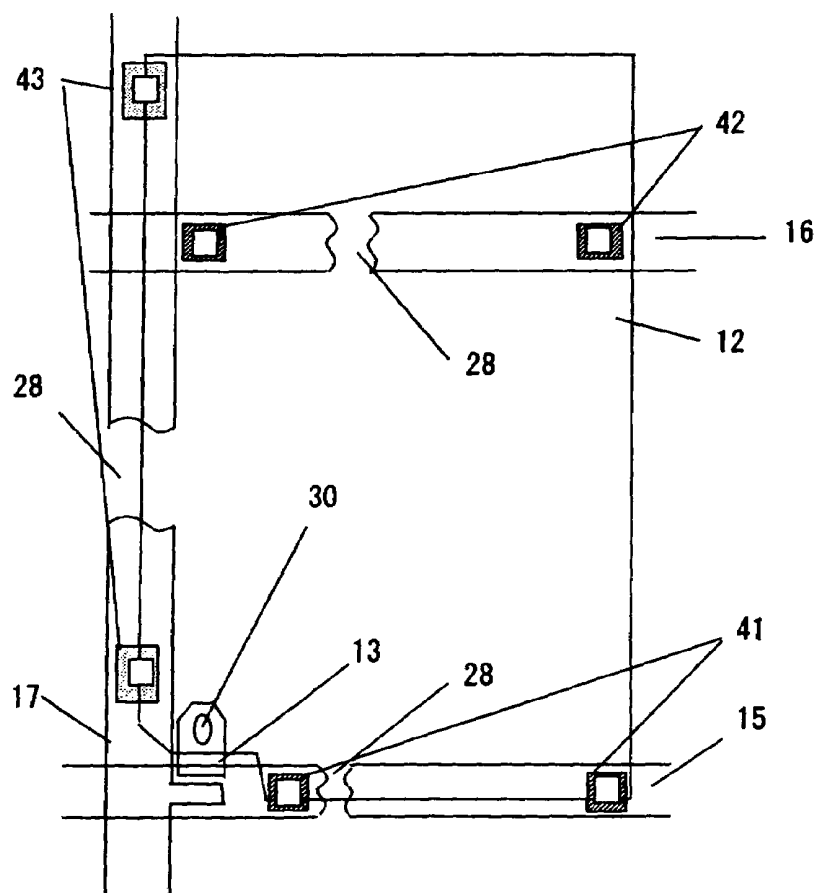
FIG. 5 is a plan view showing a structure of one pixel area of a liquid crystal display device according to the second embodiment of the present invention, where line disconnection occurs.

A method for repairing line disconnection according to the second embodiment of the present invention will be explained hereinbelow with reference to FIGS. 5 and 6. Like FIG. 1, FIG. 5 is a plan view showing a structure of one pixel area of an active matrix liquid crystal display device. FIG. 6 is a sectional view showing a structure of the portion where line disconnected is repaired. The same reference numerals as those in FIGS. 1 to 4 designate the same elements, and redundant description will be omitted. The description of the manufacturing process will be also omitted since it is the same as in the first embodiment.

Below the pixel electrode 12, a pair of the conductive layers 41, a pair of the conductive layers 42, and a pair of the conductive layers 43 are formed in an island shape above the gate line 15, the storage capacitor line 16, and the source line 17, respectively. The conductive layers are electrically floating. In the first embodiment, the conductive layer is provided in a possibly larger area on each of the three lines surrounding one pixel. In the second embodiment, on the other hand, each of the pair of the conductive layers is provided at each end of the three lines. The conductive layers above the gate line 15 and the storage capacitor line 16 can be formed in the same layer as the drain electrode 14 shown in FIG. 4 as with the case with the first embodiment. The conductive layers 41 and 42 have to avoid contact with the source line 17. The conductive layers on one line are preferably separated as far as possible to obtain a larger repairable area.

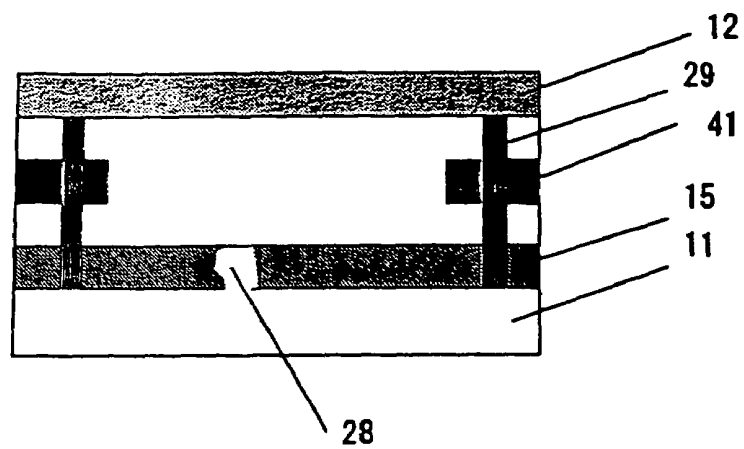
FIG. 6 is a sectional view showing a structure of a disconnected portion of a gate line in the liquid crystal display device according to the second embodiment of the present invention.

FIG. 6 shows a sectional view of the disconnected portion 28 of the gate line in the active matrix liquid crystal display device. The repair of the gate line 15 will be explained hereinbelow. Application of a laser to the conductive layer 41 from the pixel electrode 12 side or the insulating substrate 11 side produces the molten metal 29. It creates a bypass route through the gate line 15, the molten metal 29, the conductive layer 41, the molten metal 29, the pixel electrode 12, the molten metal 29, the conductive layer 41, the molten metal 29, and the gate line 15. Gate signals can thereby avoid the disconnected portion 28 and go through the bypass route. The line disconnection can be thus repaired.

The connection resistance of an aluminum element and ITO used for the pixel electrode 12 is extremely high. The repair of the gate line 15 in the conventional liquid crystal display device results in the cross-section structure shown in FIG. 8B in which the pixel electrode 12 and the gate line 15 have the direct contact. Therefore, when a laser is applied to

connect them, the connection electrical resistance almost reaches one megohm, which is above the limit of the connection resistance for repairing disconnection. For the above reason, when repairing the disconnection as in FIG. 6, the conductive layer to produce the molten metal 29 is preferably formed by the material other than aluminum, such as chromium. The conductive layer can be formed in the same layer as the drain electrode 14 shown in FIG. 4. In order that the gate line 15 and ITO of the pixel electrode 12 are connected via the material such as chromium, tantalum, titanium, molybdenum to avoid direct contact, the source line 17 is formed by the above material, not aluminum. The connection resistance is thereby kept within 100 K Ω that is substantially the same value as the connection resistance of the drain electrode 14 and the pixel electrode 12 through the contact hole 30. Therefore, disconnection of the gate line 15 formed by aluminum can be also repaired.

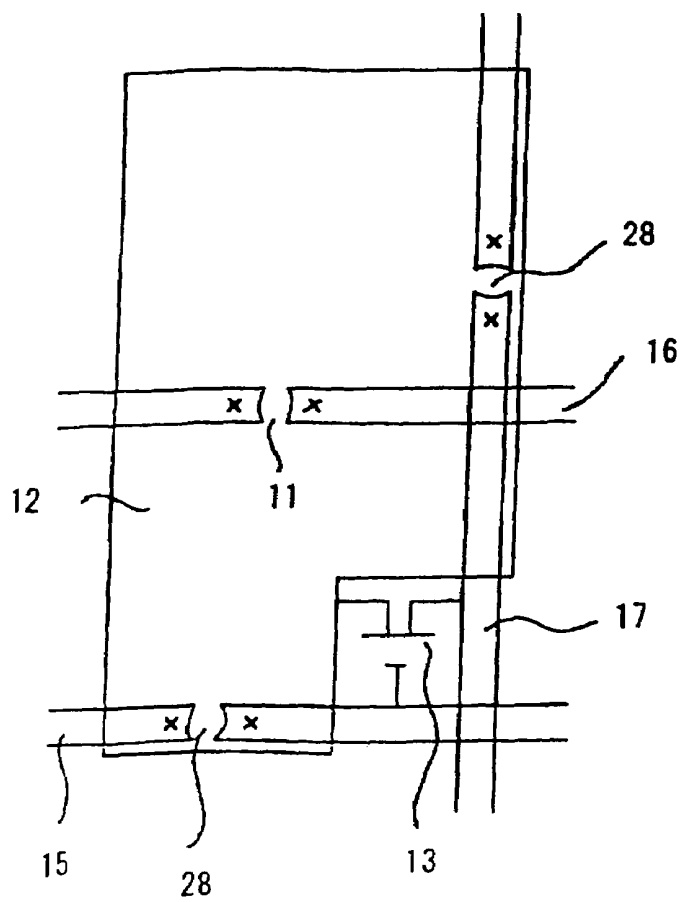
FIG. 7 Background Art

FIG. 7 shows a configuration of a conventional active matrix liquid crystal display device. FIG. 7 is a plan view showing a structure of one pixel area of the liquid crystal display device. Reference numeral 12 designates a pixel electrode, 13 a thin film transistor (TFT), 15 a gate line, 16 a storage capacitor line, 17 a source line, and 28 a disconnected portion.

The active matrix liquid crystal display device shown in FIG. 7 is provided with a matrix of plurality of the pixel electrodes 12, each of which is connected with the TFT 13 that is a switching element. The gate electrode of the TFT 13 is connected with the gate line 15, and gate signals input to the gate electrode control and drive the TFT 13. The source electrode of the TFT 13 is connected with the source line 17, and data (display) signals are input to the pixel electrode 12 through the TFT 13 when the TFT 13 is selected. The gate line 15 and the source line 17 cross each other at right angles, surrounding the pixel electrode 12. The drain electrode of the TFT 13 is connected with the pixel electrode 12.

FIG. 7 is a plan view showing a structure of one pixel area of a conventional liquid crystal display device.

As shown in FIG. 7, the pixel electrode 12 is arranged to partially overlap the gate line 15. They are electrically isolated by the gate insulating film 22 to enlarge the area of the pixel electrode 12, that is, to increase the aperture ratio. Also, an additional capacitor is formed by placing the gate insulation film 22 between the pixel electrode 12 and the gate line 15.

As shown in FIG. 7, there are cross marks on both outsides of the disconnected portion 28 of the gate line 15. A laser is applied to the marks. The gate line 15 or the pixel electrode 12 is molten to produce the molten metal 29 as shown in FIG. 8B. A bypass route through the gate line 15, the molten metal 29, the pixel electrode 12, the molten metal 29, and the gate line 15 is thereby created; therefore, the disconnection is repaired. Disconnection of the source line 17 and the storage capacitor line 16 is also repaired in the same way.

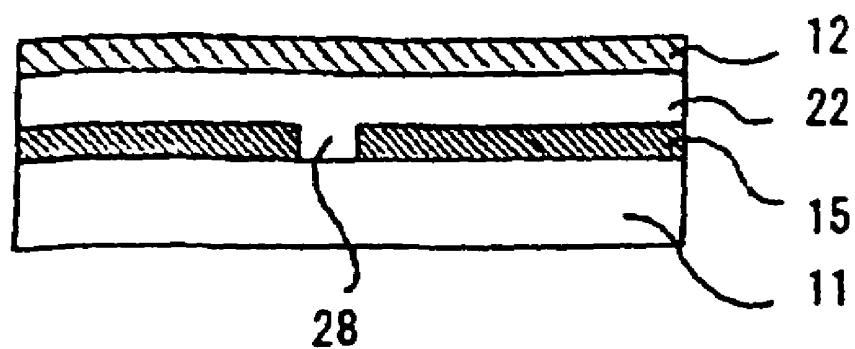
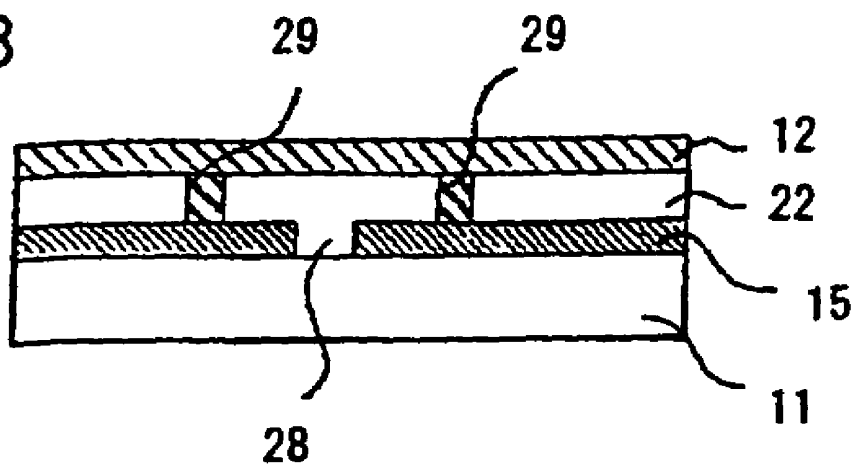
A method for repairing signal line disconnection is described in Japanese Patent Application Laid-Open No. H09-113930, for example. The method according to the first embodiment of the above prior art will be explained hereinbelow. FIG. 8A shows a structure of a cross-section of a disconnected portion of a gate line. The same reference numerals as those in FIG. 7 designate the same elements, and redundant description will be omitted. Reference numeral 11 designates a substrate, 22 a gate insulating film, and 29 a molten metal.

FIGS. 8A and 8B are sectional views showing structures of a disconnected portion of a gate line in the conventional liquid crystal display device.

The above conventional technique, however, has the following problems. In the first embodiment of the invention disclosed in Japanese Patent Application Laid-Open No. H09-113930, the connection resistance of the pixel electrode 12 and the molten metal 29 can be high. The pixel electrode 12 is formed by Indium Tin Oxide (ITO), and the connection resistance with chromium, tantalum, titanium, and molybdenum used for the gate line 15 and the storage capacitor line 16 significantly differs depending on conditions of film deposition and film surface. There is a case where the connection resistance reaches several megohms, which results in decrease in the rate of successful repair. Use of aluminum for the gate line 15 is especially problematic since the connection resistance of an aluminum element and ITO used for the pixel electrode 12 is extremely high. Therefore, when a laser is applied to connect them, the connection electrical resistance almost reaches one megohm, which is above the limit of the connection resistance for repairing disconnection. Besides, the application of a laser to the pixel electrode 12 causes the ITO to be peeled off and a fragment of the ITO is stuck in between a counter electrode and the pixel electrode to trigger unexpected short-circuit.

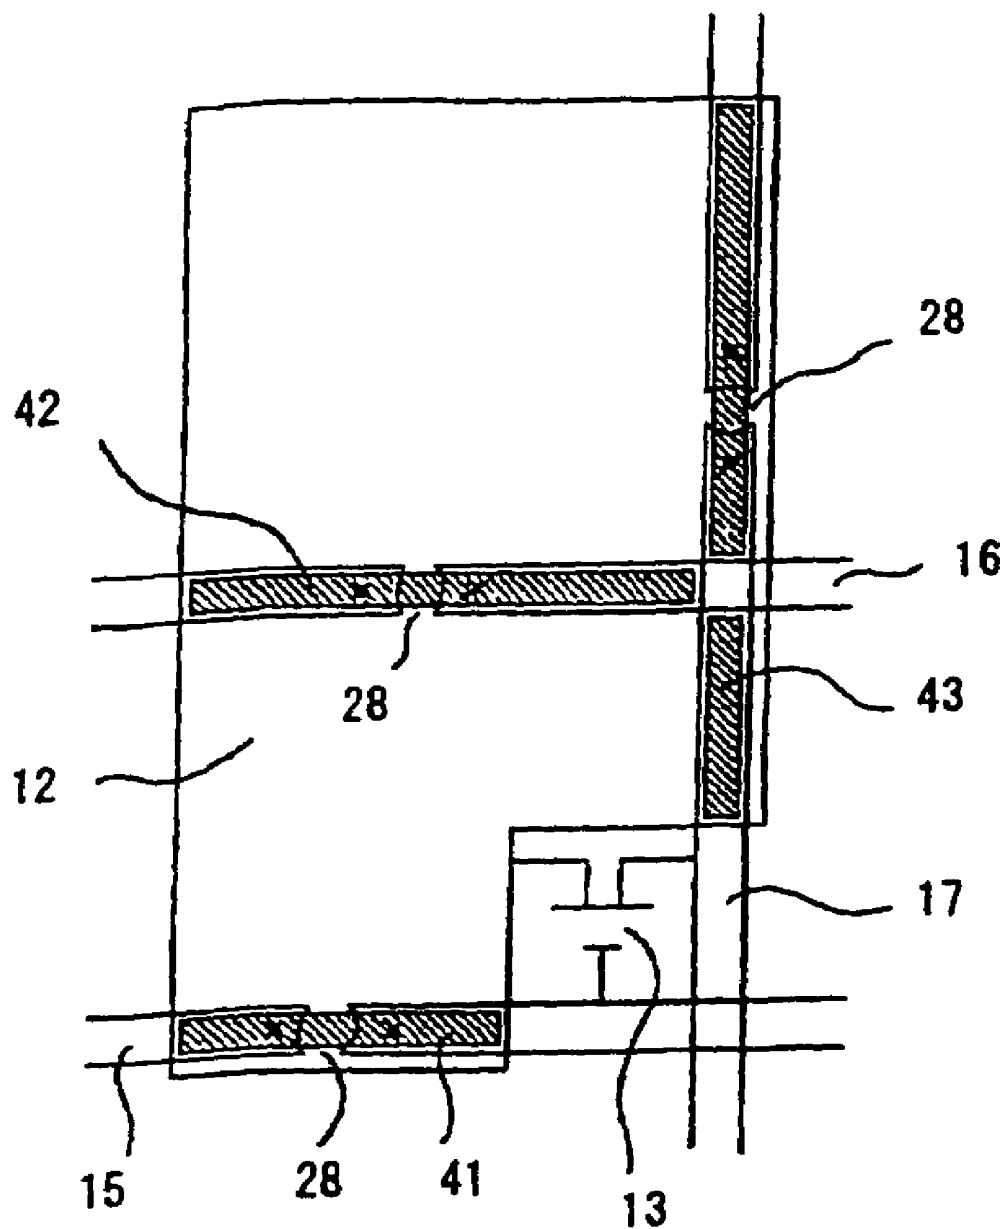
FIG. 9 Background Art

FIGS. 9 and 10 show a structure of one pixel area of the liquid crystal display device where disconnection is repaired according to the second embodiment of the invention disclosed in Japanese Patent Application Laid-Open No. H09-113930. FIG. 9 is a plan view of a structure of one pixel area where disconnection is repaired, and FIG. 10 is a sectional view thereof. The same reference numerals as those in FIGS. 7 and 8 designate the same elements, and redundant description will be omitted. Reference numeral 41 designates a conductive layer for repairing gate line disconnection, 42 a conductive layer for repairing storage capacitor line disconnection, and 43 a conductive layer for repairing source line disconnection.

As shown in FIGS. 9 and 10A, the pixel electrode 12 partially overlaps the gate line 15 with the insulating film interposed therebetween. On the part of the pixel electrode 12 overlapping the gate line 15 is formed a conductive metal layer. The conductive metal layer provided for repairing disconnection of the gate line 15 will be referred to hereinafter as a conductive layer 41. Similarly, conductive metal layers for repairing disconnection of the source line 17 and the storage capacitor line 16 will be referred to as a conductive layer 42 and a conductive layer 43, respectively.

FIG. 9 is a plan view showing a structure of one pixel area of a conventional liquid crystal display device.

In the following, a description will be given on the case where the gate line 15 is disconnected. As shown in FIGS. 9 and 10A, on the insulating substrate 11 are formed the gate line 15 and the storage capacitor line 16. The gate insulating film 22 is formed thereon. Next, the source line 17, the TFT 13, and an insulating layer are formed. Then, the pixel electrode 12 is formed. Further, the conductive layer 41 for repairing gate line disconnection is formed. The conductive layer 41 is provided on the area where the pixel electrode 12 overlaps the gate line 15 with the gate insulating film 22 interposed therebetween. The conductive layer 41 is formed in an island shape above the gate line 15 except the crossing with the source line 17.

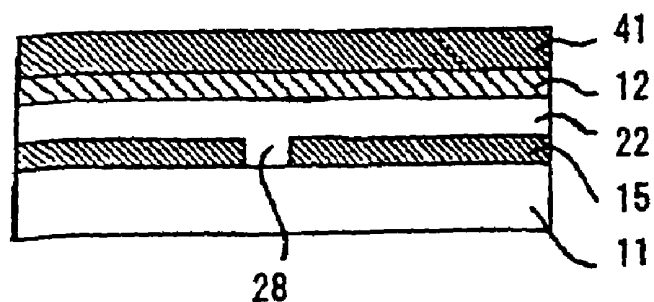
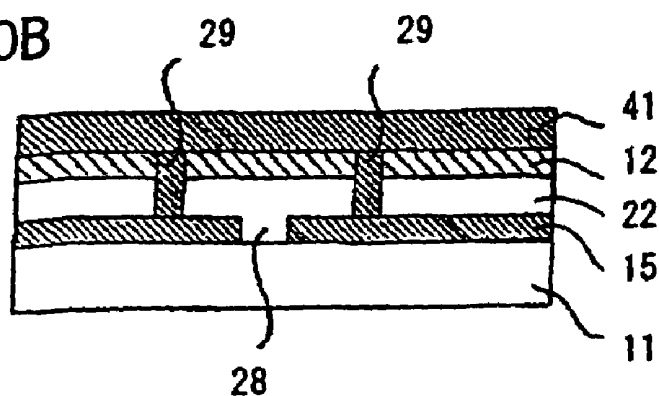
The case where disconnection occurs at the disconnected portion 28 of the gate line 15 of an active matrix liquid crystal display device will be explained hereinbelow. A laser is applied to the positions at both outsides of the disconnected portion 28 (the positions shown by the cross marks in FIG. 9) through the conductive layer 41. The molten metal 29 produced by the laser application electrically connects the conductive layer 41 and the gate line 15. The disconnected gate line 15 regains continuity by a bypass line through the molten metal 29, the conductive layer 41, and the molten metal 29. It

FIGS. 10A and 10B are sectional views showing structures of a disconnected portion of a gate line in the conventional liquid crystal display device.

The repair method described in the second embodiment of the invention disclosed in Japanese Patent Application Laid-Open No. H09-113930 also has problems. According to the method, the conductive layer for repairing line disconnection is additionally provided on the pixel electrode 12. Therefore, the manufacturing process requires an additional step of forming the conductive layer. Also, the conductive layer is placed on the pixel electrode applying an electric field to liquid crystals. Therefore, after the repair, an electric potential of a source signal, gate signal, or common signal is directly applied to the liquid crystals through the conductive layer. It causes noise to have an adverse effect on operations of the liquid crystals, resulting in poor display quality.

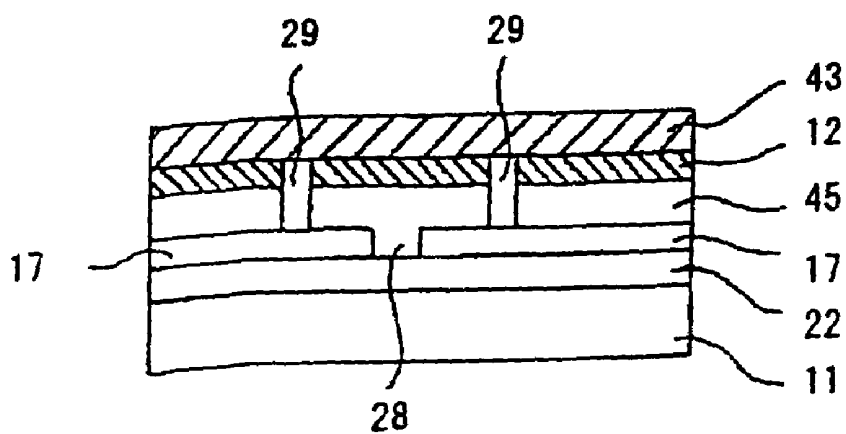
Disconnection of the source line 17 can be also repaired in the same way as shown in FIG. 11. Further, the storage capacitor line 16 can be repaired in the same manner.

FIG. 11 is a sectional view showing a structure of a disconnected portion of a source line in the conventional liquid crystal display device.
